# Flicka Friends

*Issue # 71*

*Refitting s/y DULCINEA*

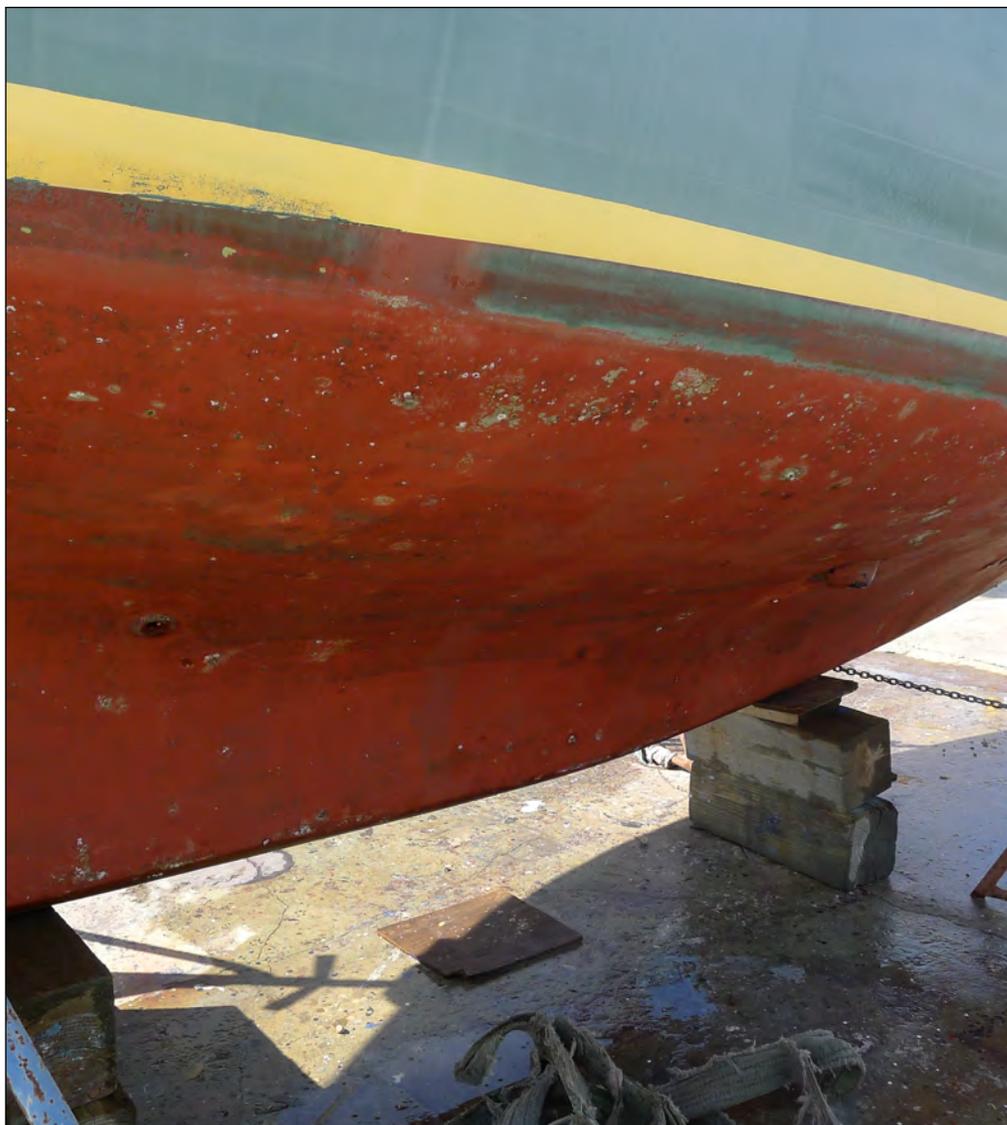
Topsides washed down and bottom pressure washed. I was surprised just how much bottom paint was intact after over 10 years since last haul-out.  
 Photo: Jamie White © 2020

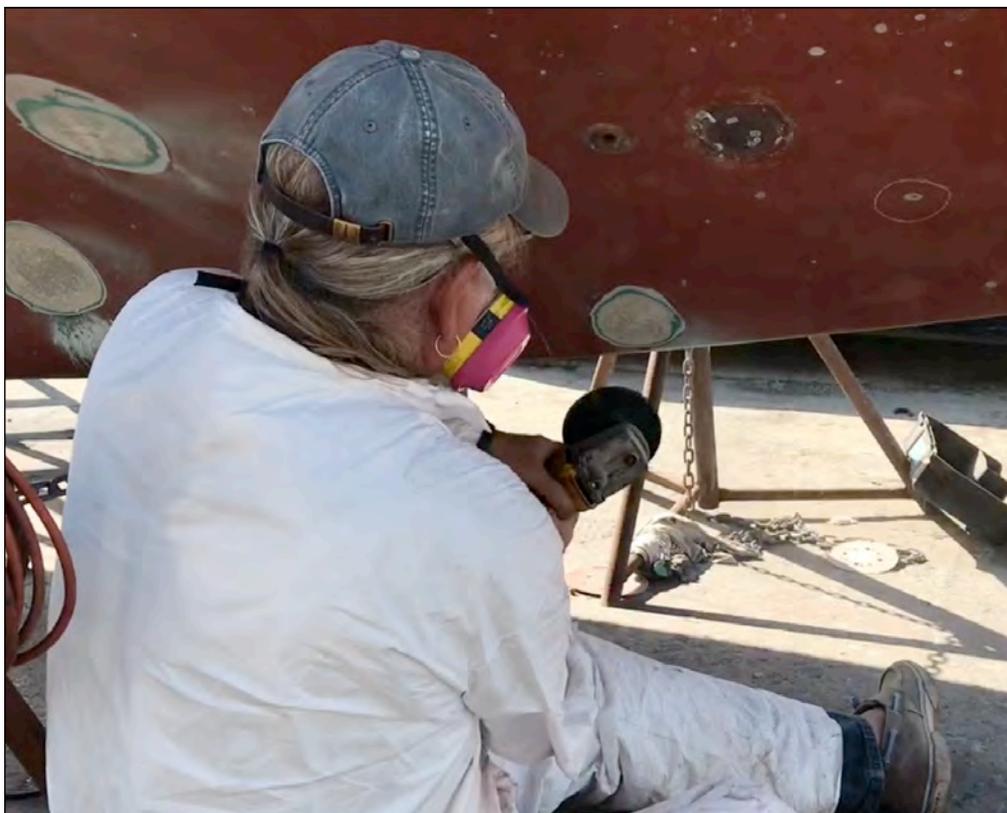
Beginning to grind down a blister until sound fiberglass is found.  
*Photo: Ruth Downes © 2020*

I found that a 7” grinder with 36 grit worked great for opening up the blister and doing the initial dishing out. How much to dish out? I would grind back at a shallow slope (about 12:1 ratio of laminate thickness to area to be dished out) until I reached dry, clean fiberglass and removed all the rotten, decomposed material.

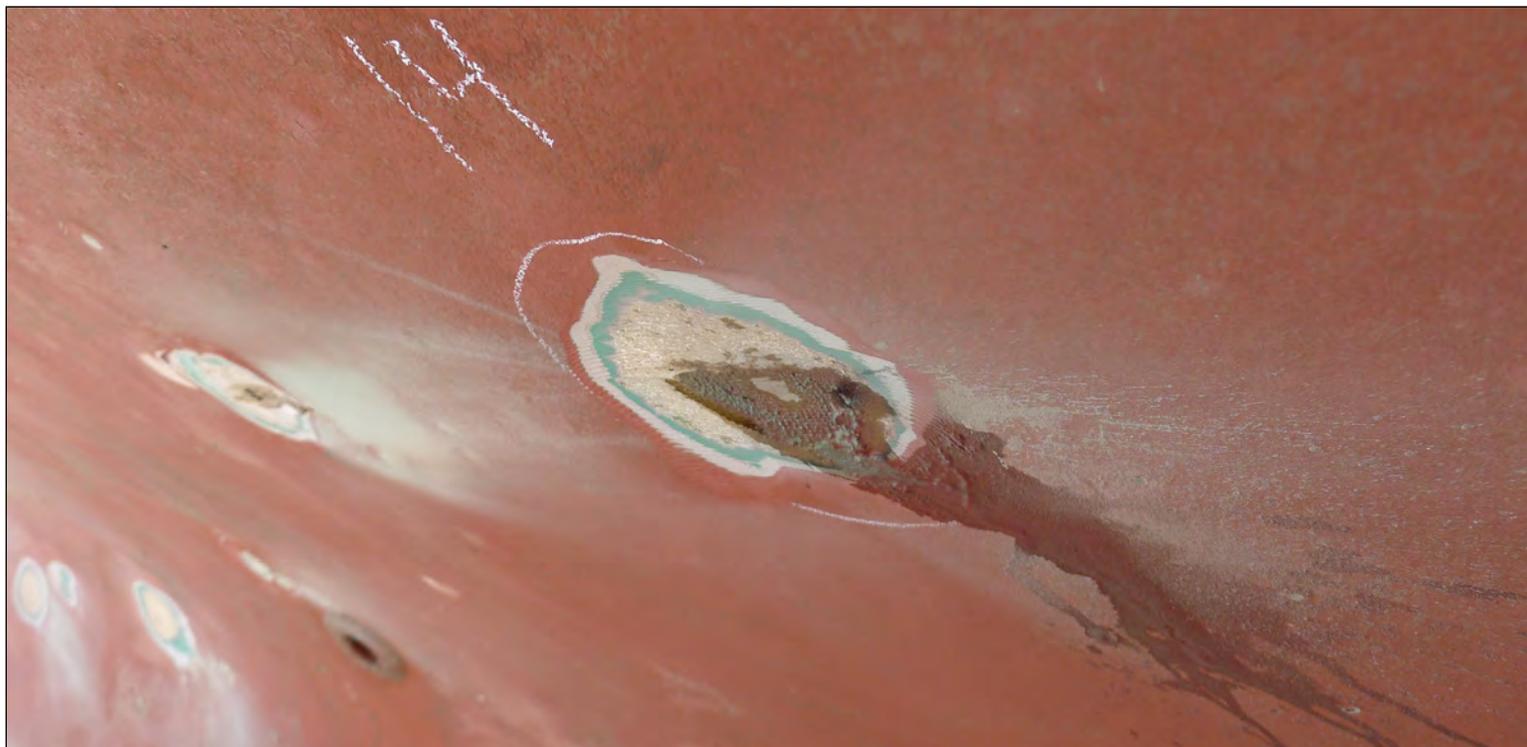
Slowly grinding down until sound dry fiberglass mat or roving is reached.  
 Only several blisters went deep enough to touch the structural roving.

If the laminate looks damaged, you will need to remove enough laminate until you reach healthy fiberglass material. You will know if the laminate is good if you do not see any white fibers. It will be dark and transparent. Once the bad material is ground out you will have what looks like a dimple in the hull.

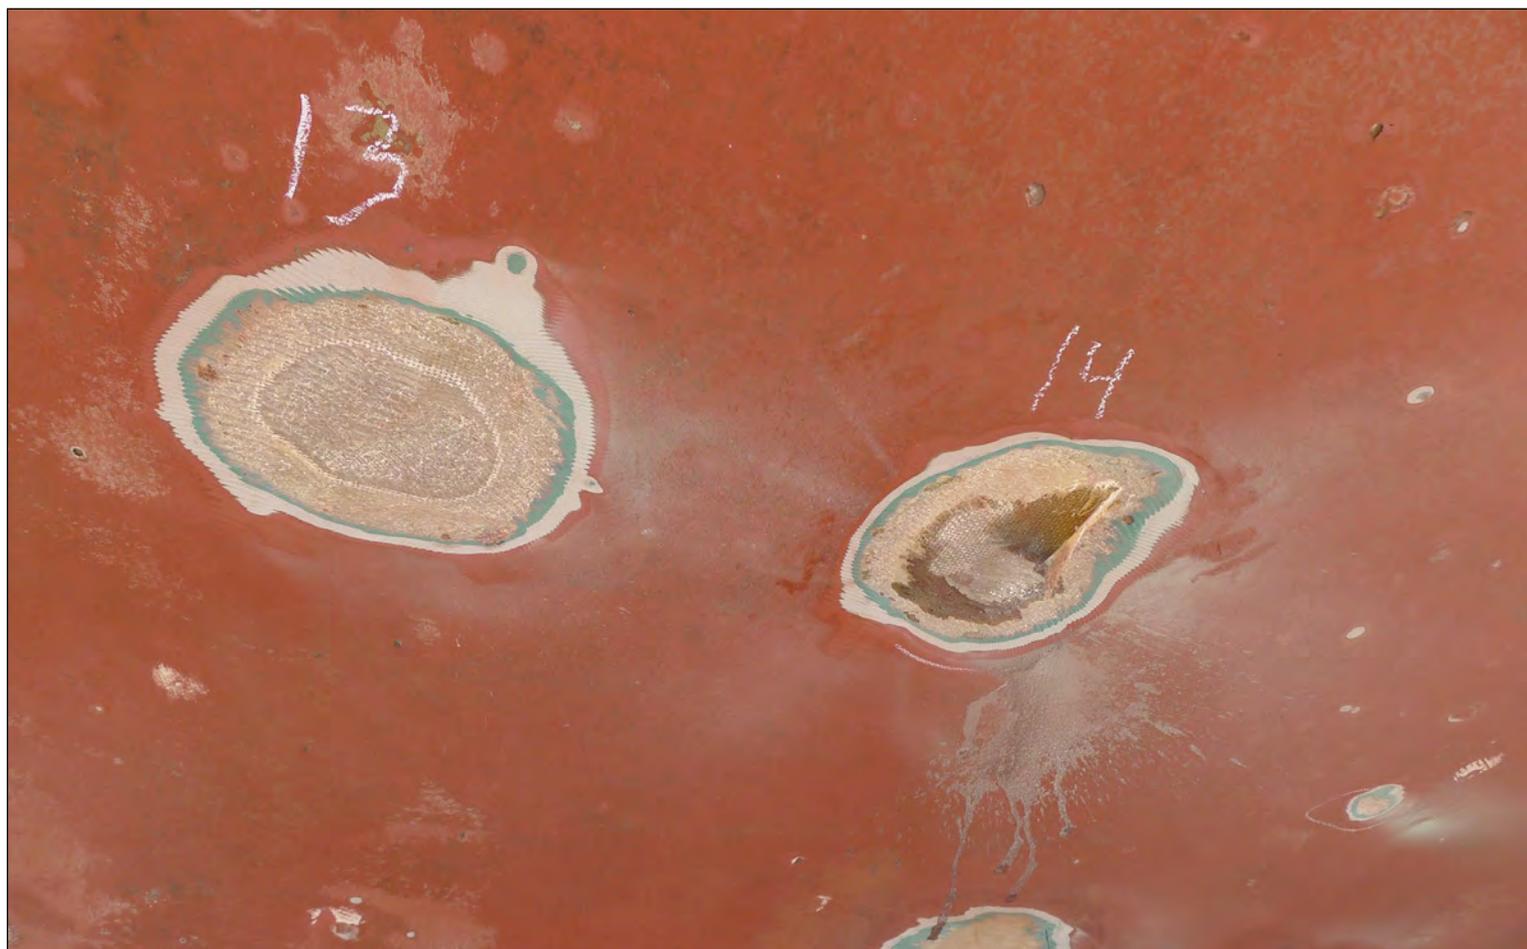
Blister #13 grinding done – a bit more grinding needed to #14.

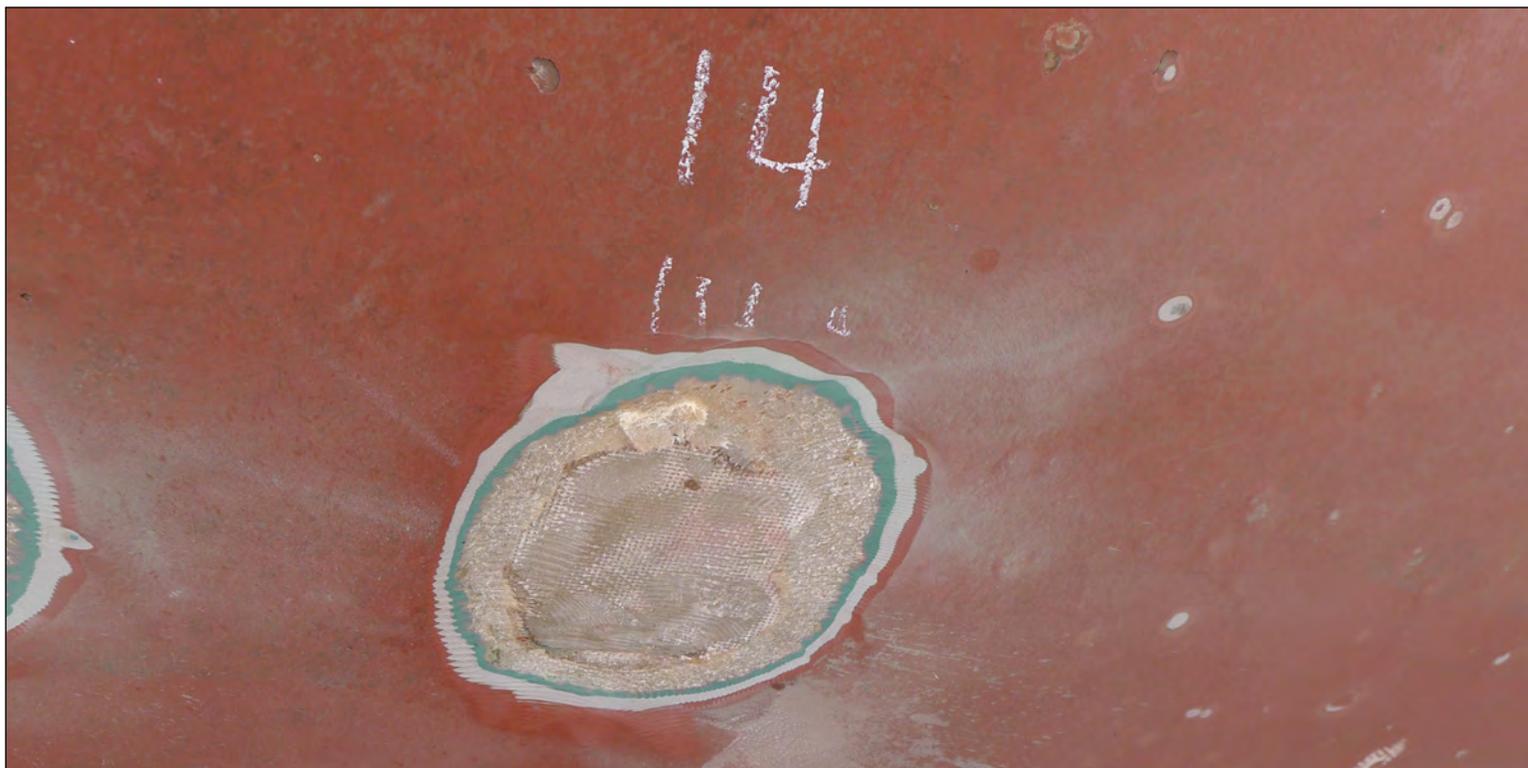
Blister #14 grinding almost completed. Note the different layers and that the blister did not extend into the structural roving.  
*Photo: Jamie White © 2020*

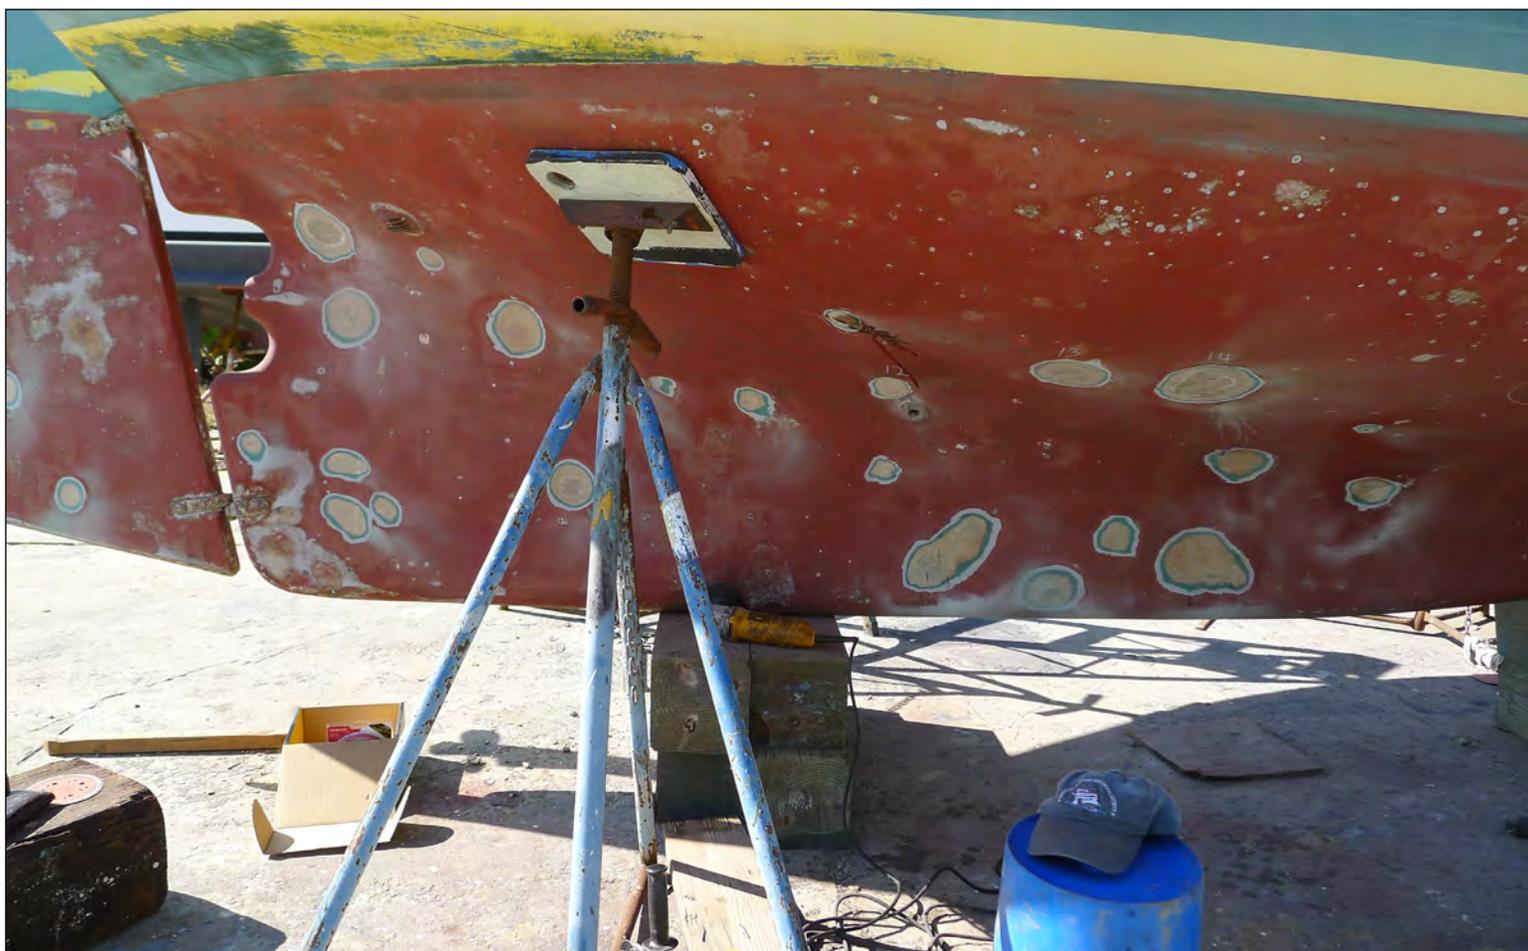
Starboard side ground down – next step finish port side and start laying up fiberglass cloth.  
*Photo: Jamie White © 2020*

Place each layer of reinforcement into its spot on the repair, ensuring proper orientation if the area is not symmetrical... remember to roll over the area as noted to remove air bubbles (especially important).

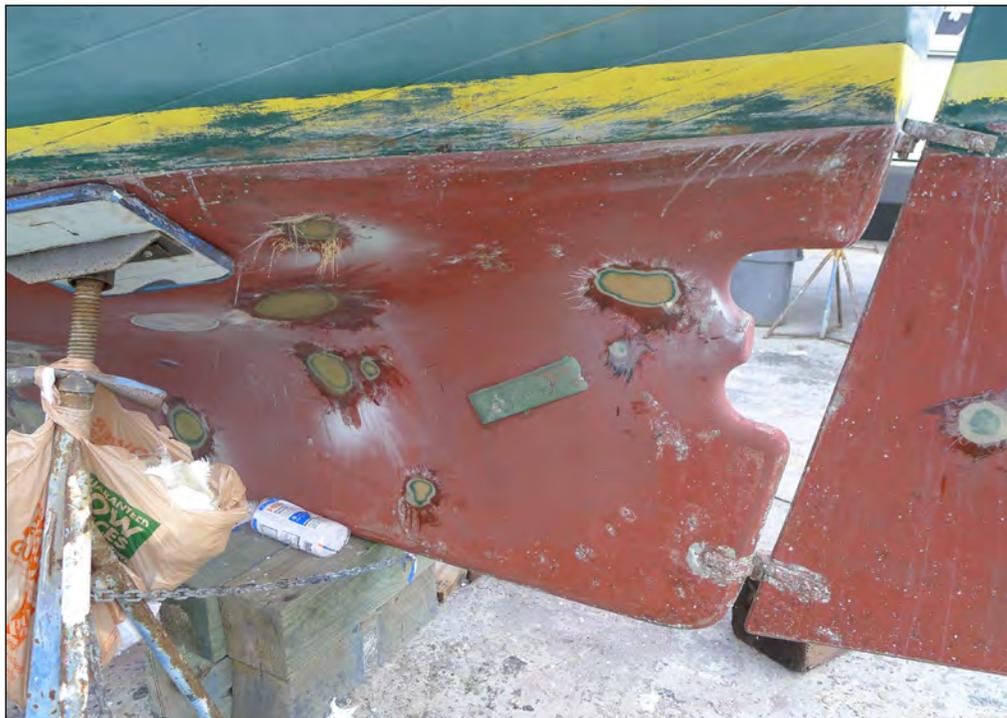
It may look bad, however over 90% of the blisters were only in the cosmetic gelcoat and skin coat.  
*Photo: Jamie White © 2020*

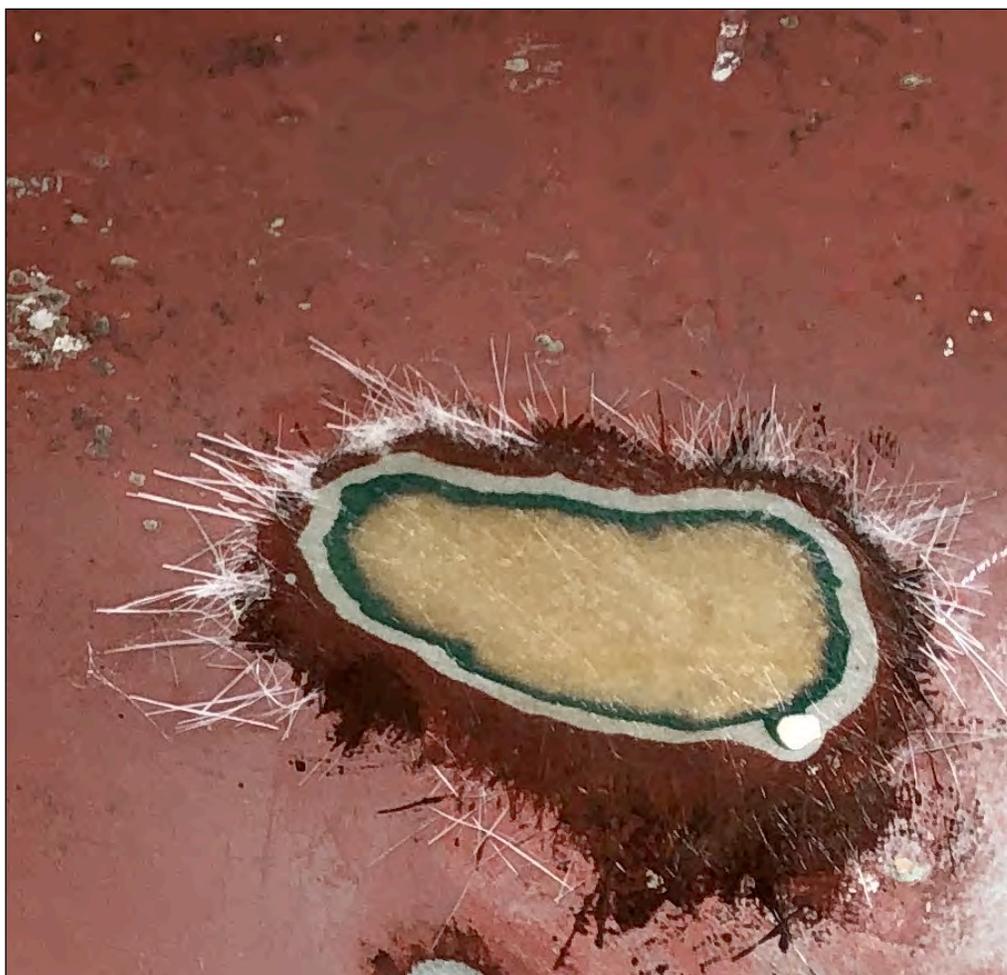
The needle-like ends of the cured fiberglass are easily sanded down.  
*Photo: Jamie White © 2020*

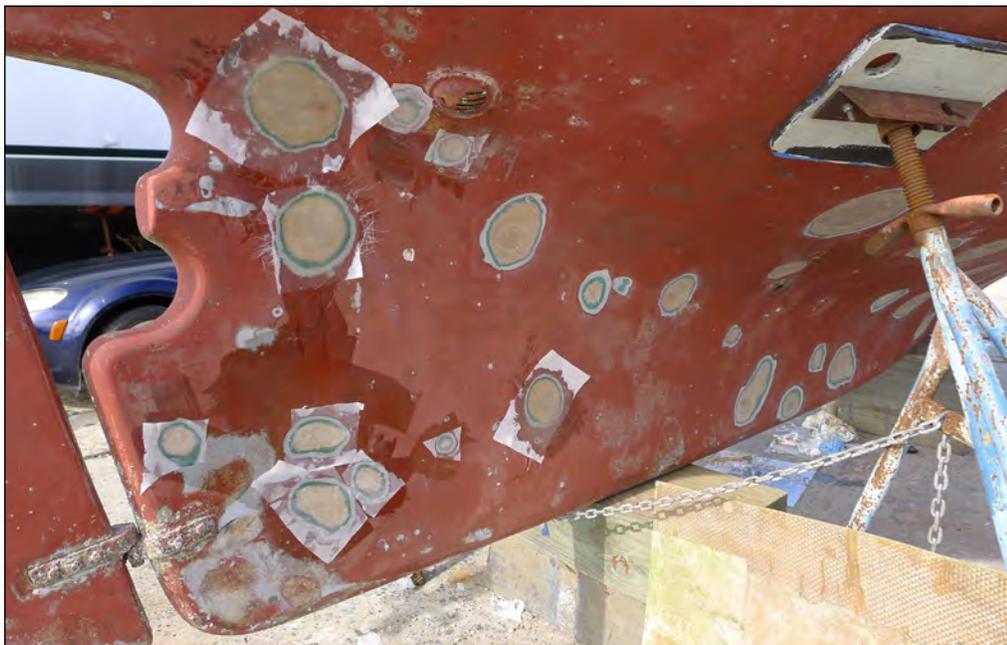
Peel-Ply on the starboard side bister repairs.  
*Photo: Jamie White © 2020*

Without it and its ability to leave a smooth and amine blush clean surface, I had to do a lot of sanding smooth followed by a thorough fresh water washdown to remove the amine blush caused by the epoxy curing process.

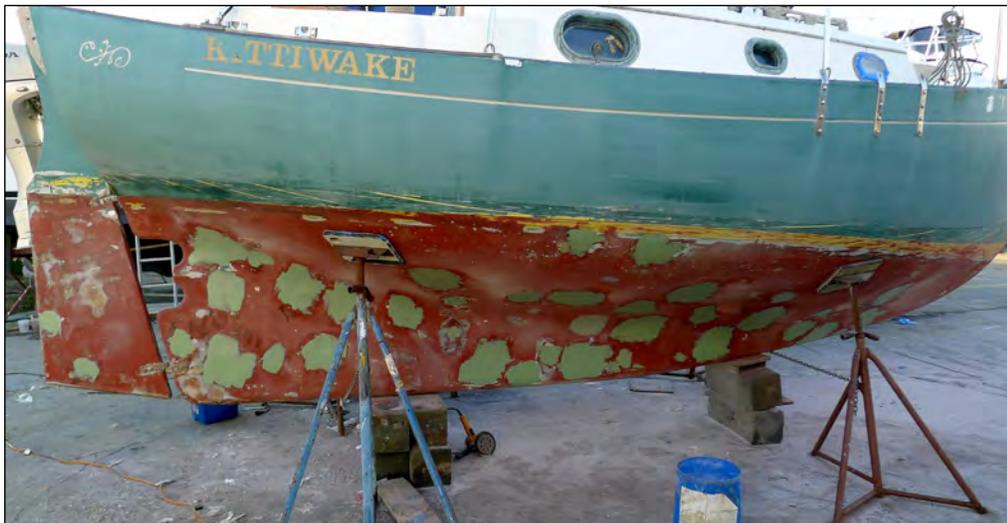
Two-part marine grade epoxy filler was applied over the repairs.  
*Photo: Jamie White © 2020*

Two-part Marine grade epoxy filler applied over repaired areas. I saw several folks at the yard using automotive filler that works great on a Mustang or Corvette, but eventually absorbs water on a Flicka 20.

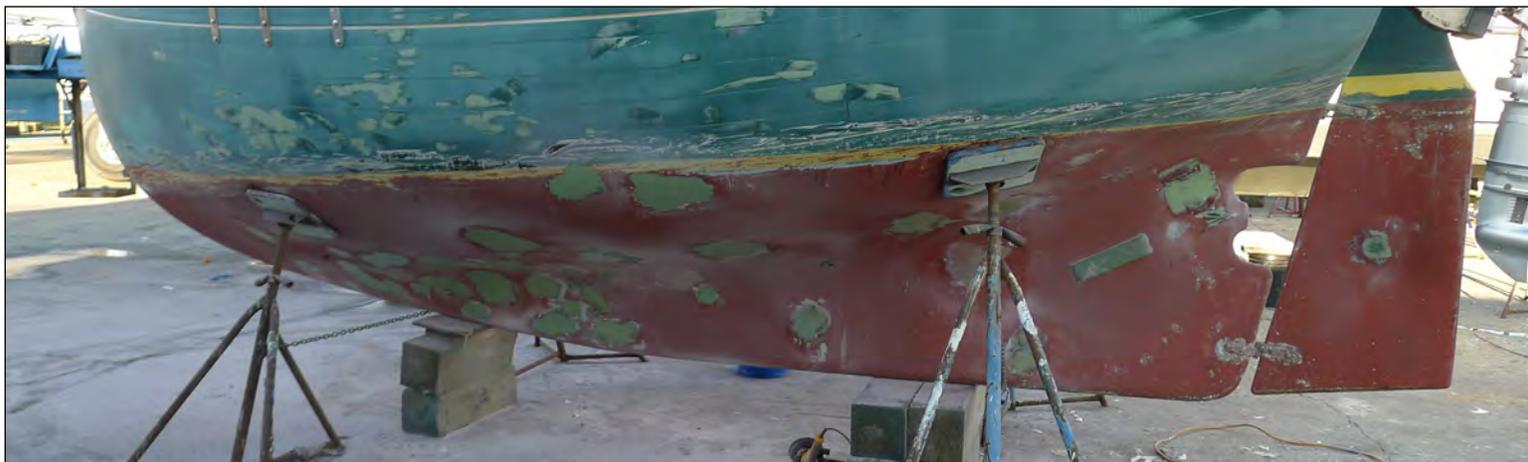
Others in the yard were improperly using automotive filler that will absorb water.  
*Photo: Jamie White © 2020*

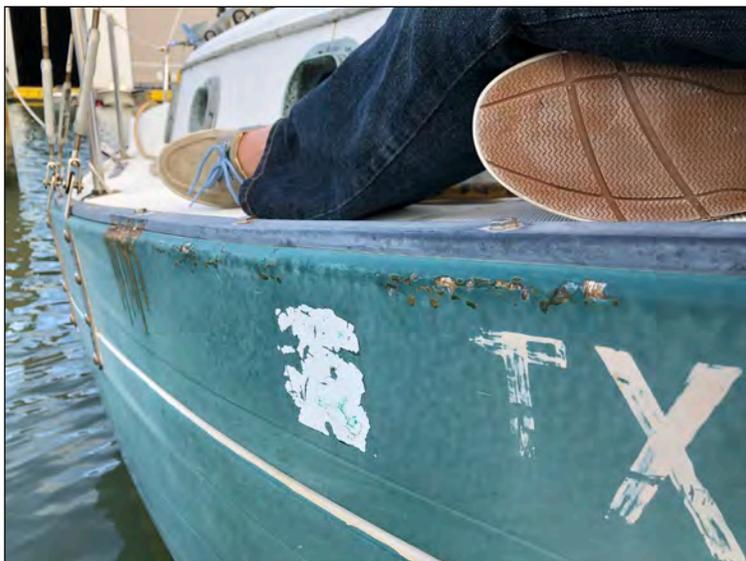
Dings and crazing possibly from rubbing alongside mooring poles in her berth.  
*Photo: Jamie White © 2020*

After all the topsides dings and gouges were repaired, I gave the topsides 2 coats of INTERLUX-404/414 two-part Epoxy Primekote. I rolled and tipped the final two topcoats of Sea Green INTERLUX-Brightside® One-Part Polyurethane Paint with good results.

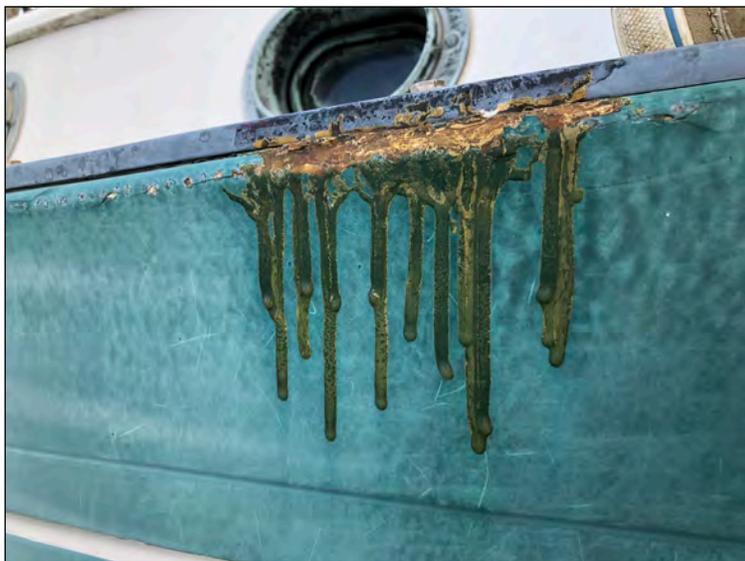
Previous repair along the starboard deck / hull joint.  
*Photo: Jamie White © 2020*

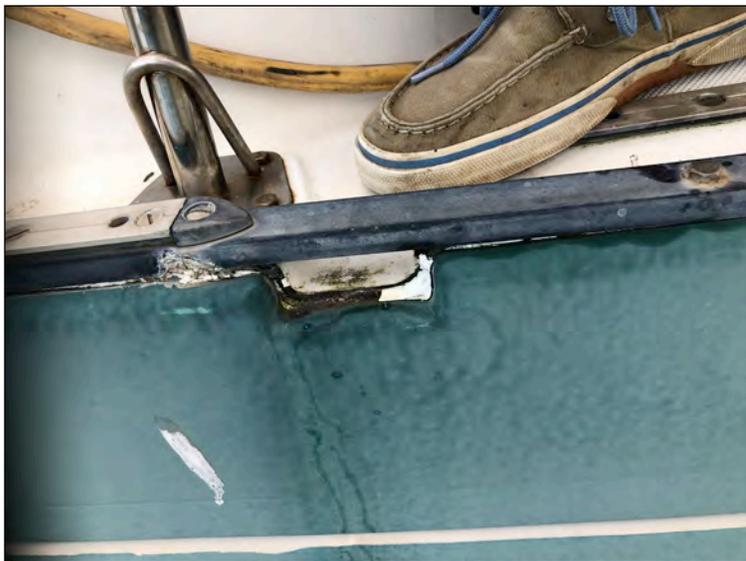
Unfinished repair at both scuppers needed to be redone.  
*Photo: Jamie White © 2020*

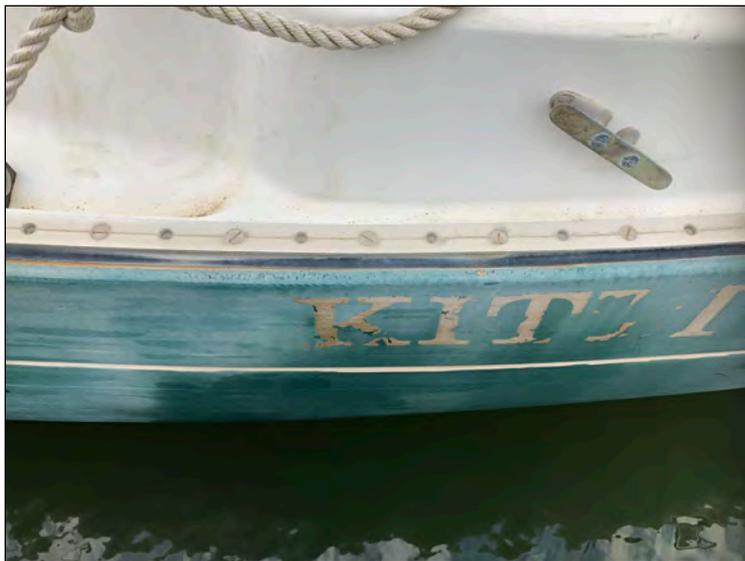
Examples of pinholes in gelcoat at turn of topsides under the toe rail.  
*Photo: Jamie White © 2020*

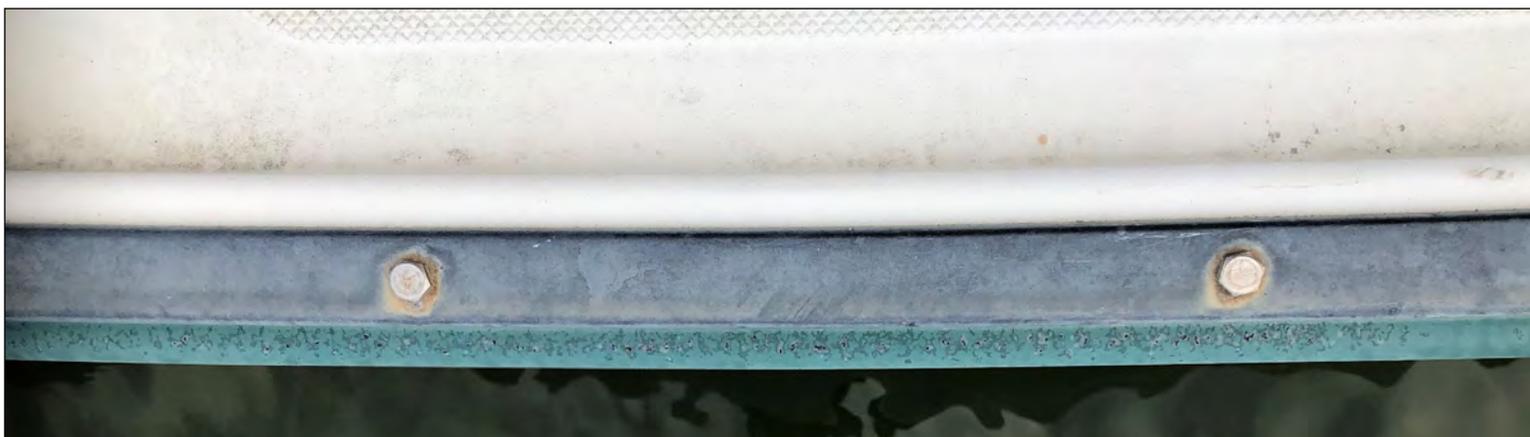
Examples of pinholes in gelcoat at turn of topsides under the toe rail.  
*Photo: Jamie White © 2020*

**Repair Topsides Dings, Gouges, and Pinholes:**

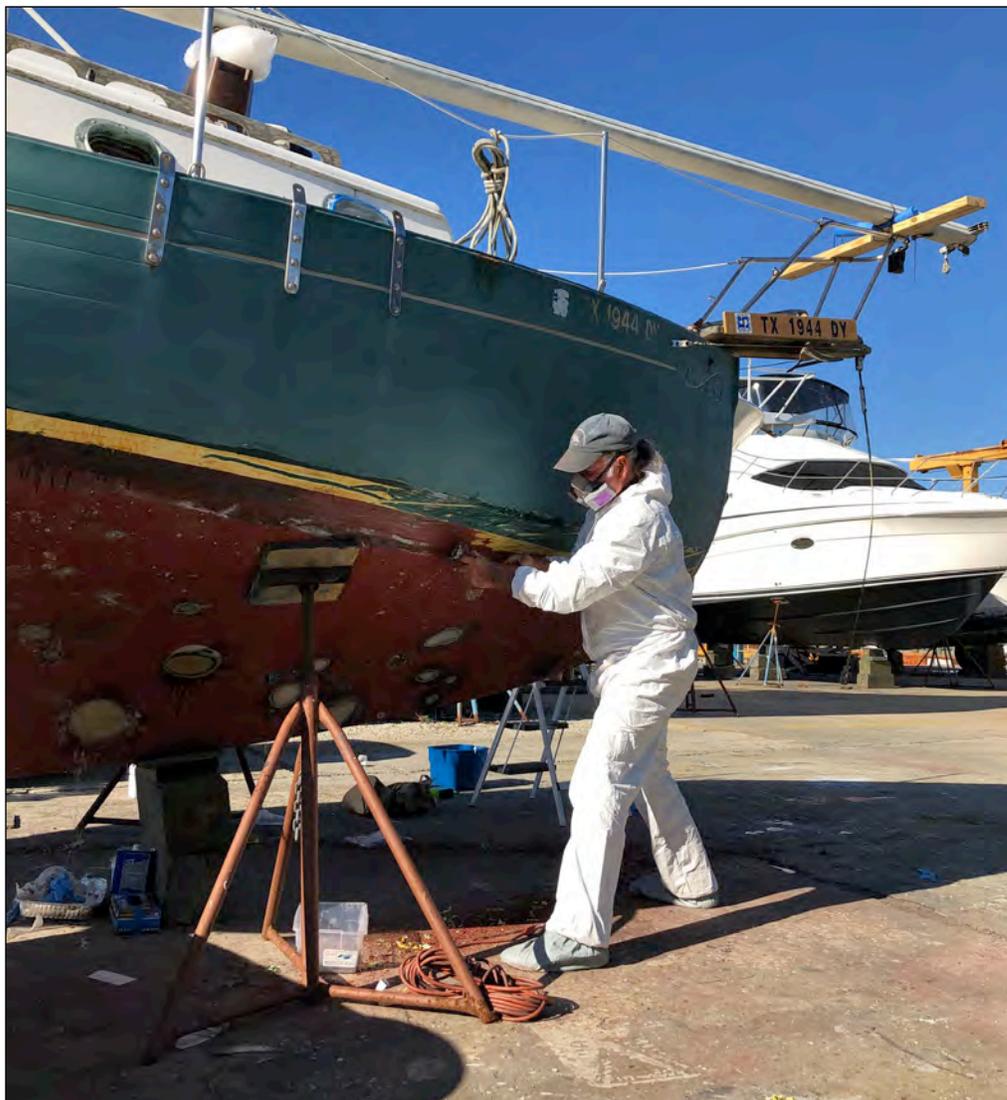
The yellow boot stripe was removed before applying the bottom paint.  
**Photo: Ruth Downes © 2020**

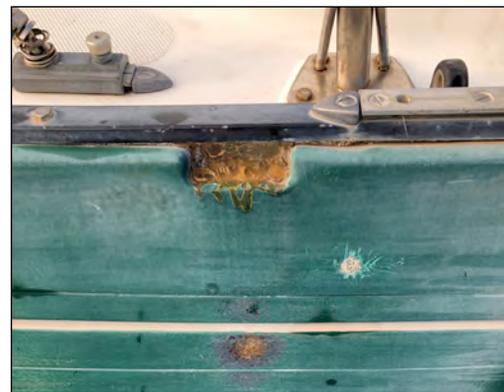
The previous repair to the port scupper.  
**Photo: Jamie White © 2020**

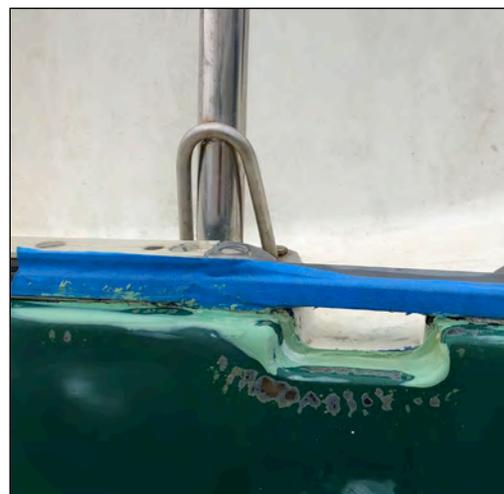
Repair to starboard scupper using strips of fiberglass cloth under two-part epoxy filler and fairing compound by **Total Boat**.  
 I highly recommend it  
**Photo: Jamie White © 2020**

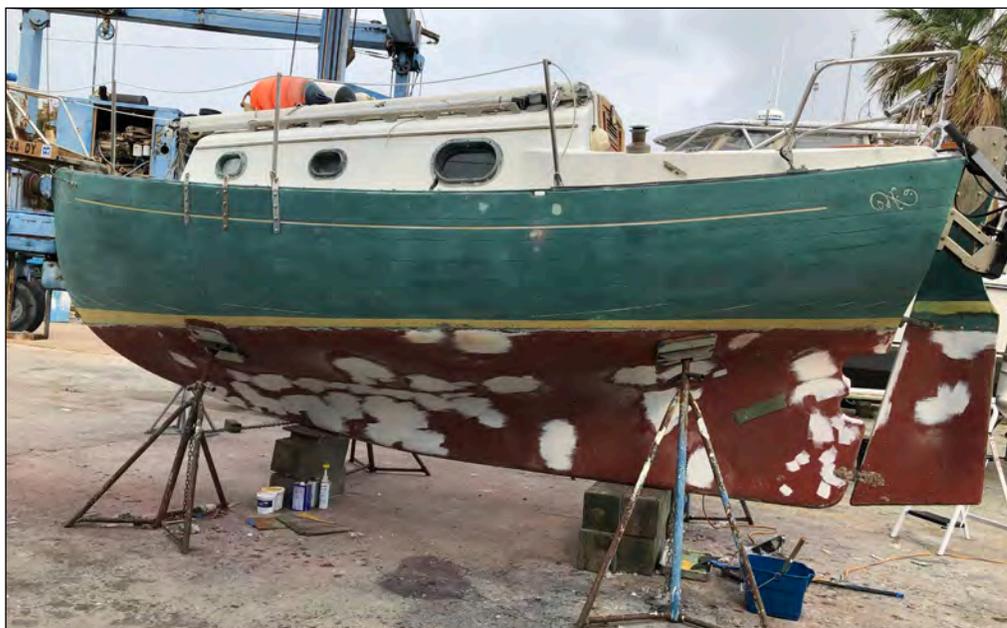
The repaired areas were covered with four coats of barrier coat.  
**Photo: Jamie White © 2020**

Before applying bottom paint, I went over all the repaired areas with four coats of Interlux InterProtect 2000E Barrier Coat Epoxy Primer.

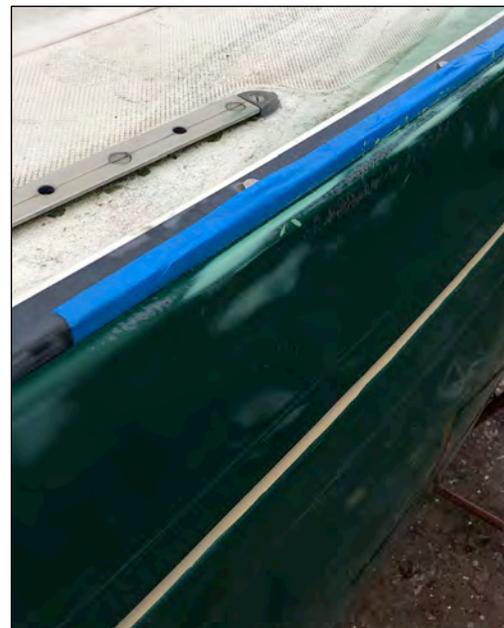
Hull repair along the hull/deck seam.  
**Photo: Jamie White © 2020**

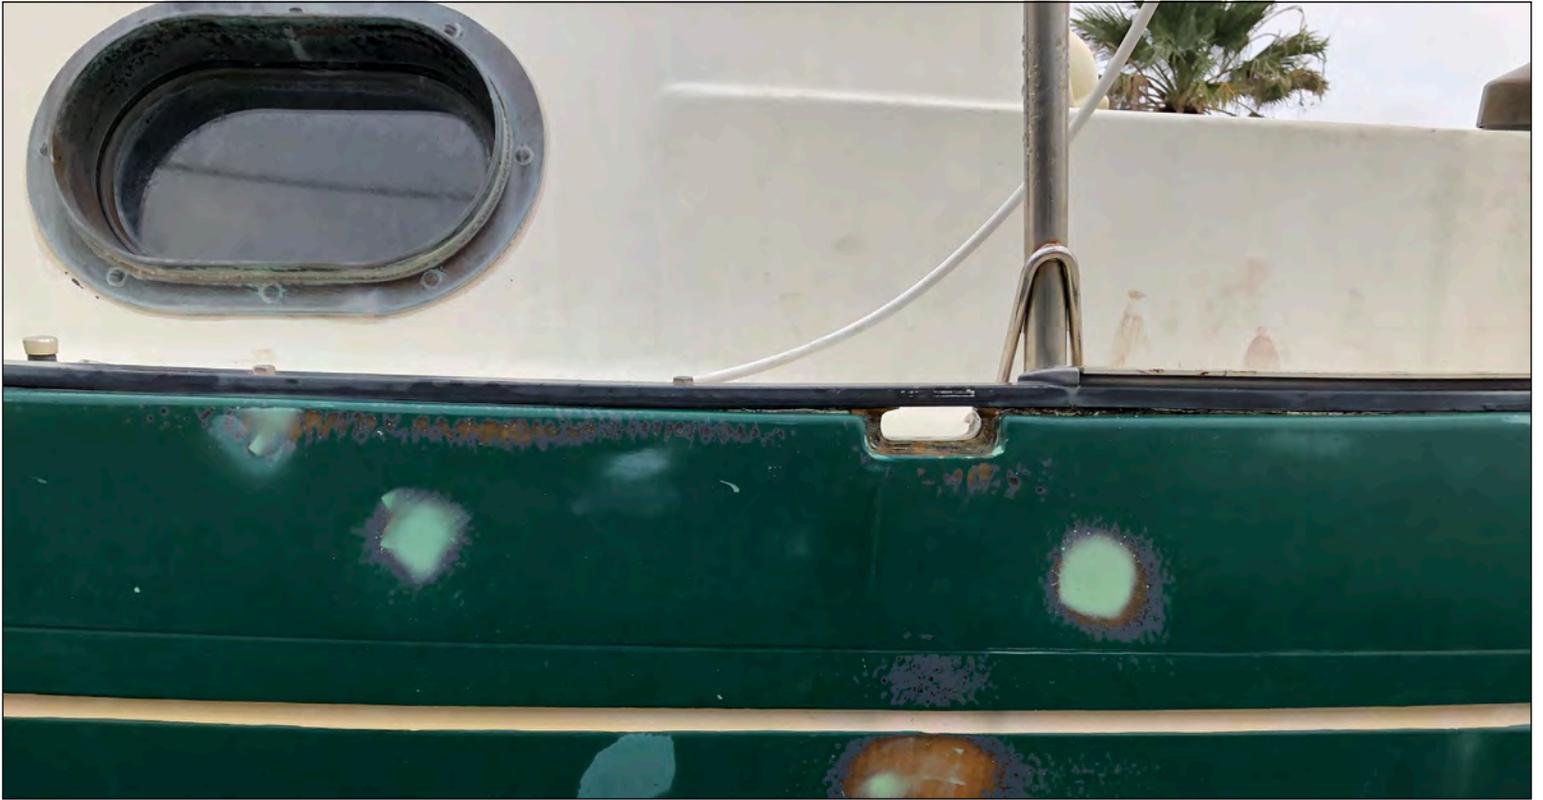
Port deck seam and various repairs including the port scupper.  
*Photo: Jamie White © 2020*

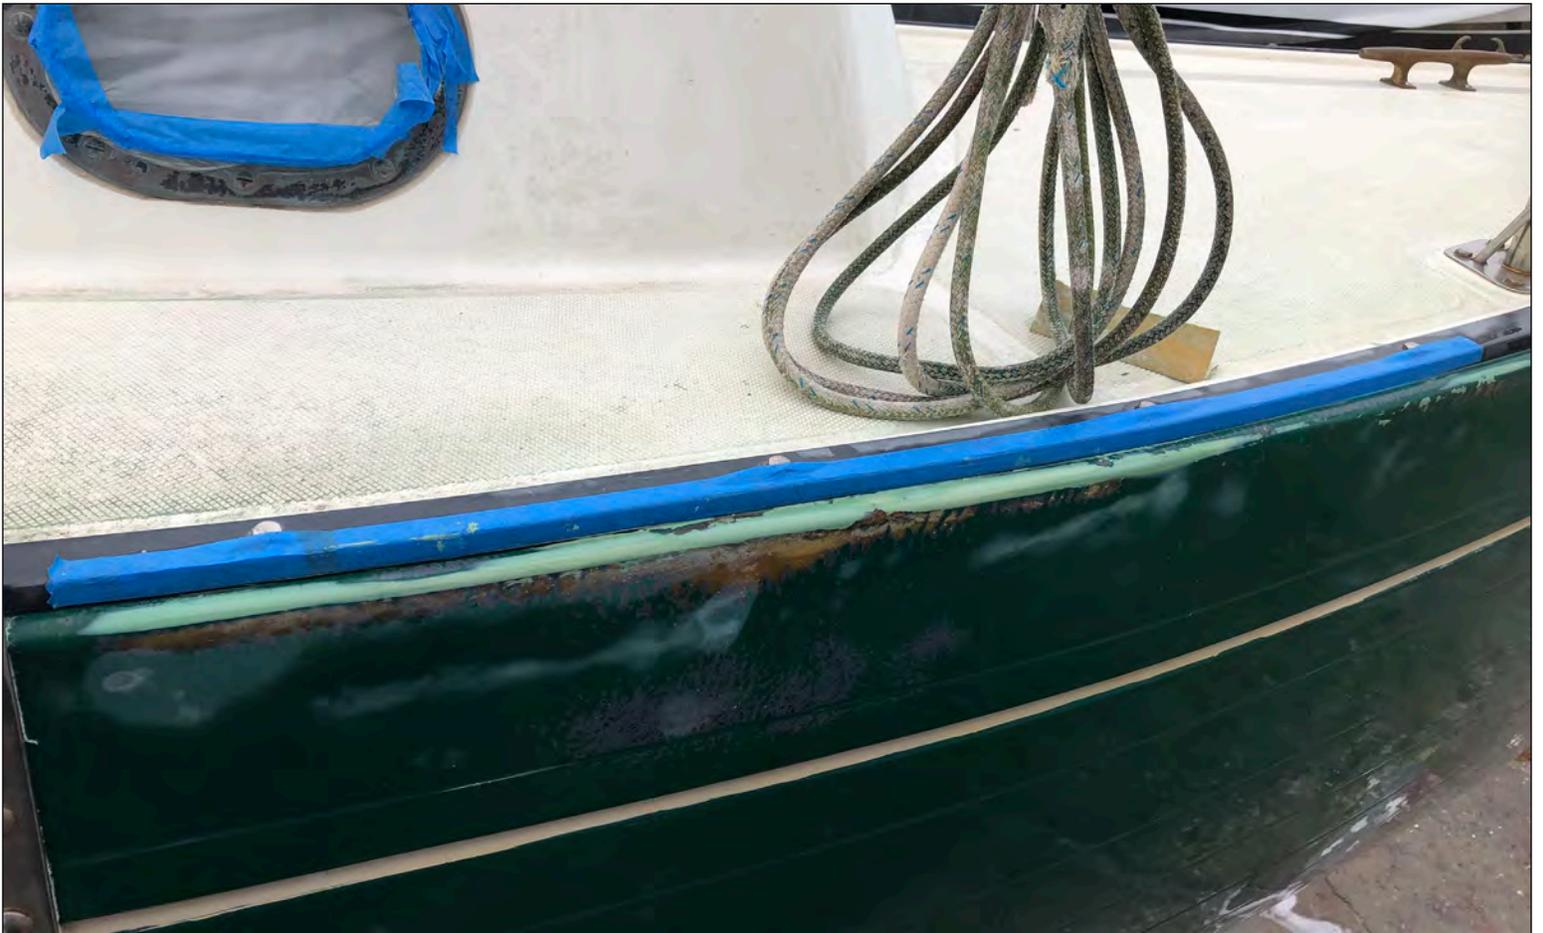
Repairs to the gelcoat on the starboard hull at the deck connection.  
*Photo: Jamie White © 2020*

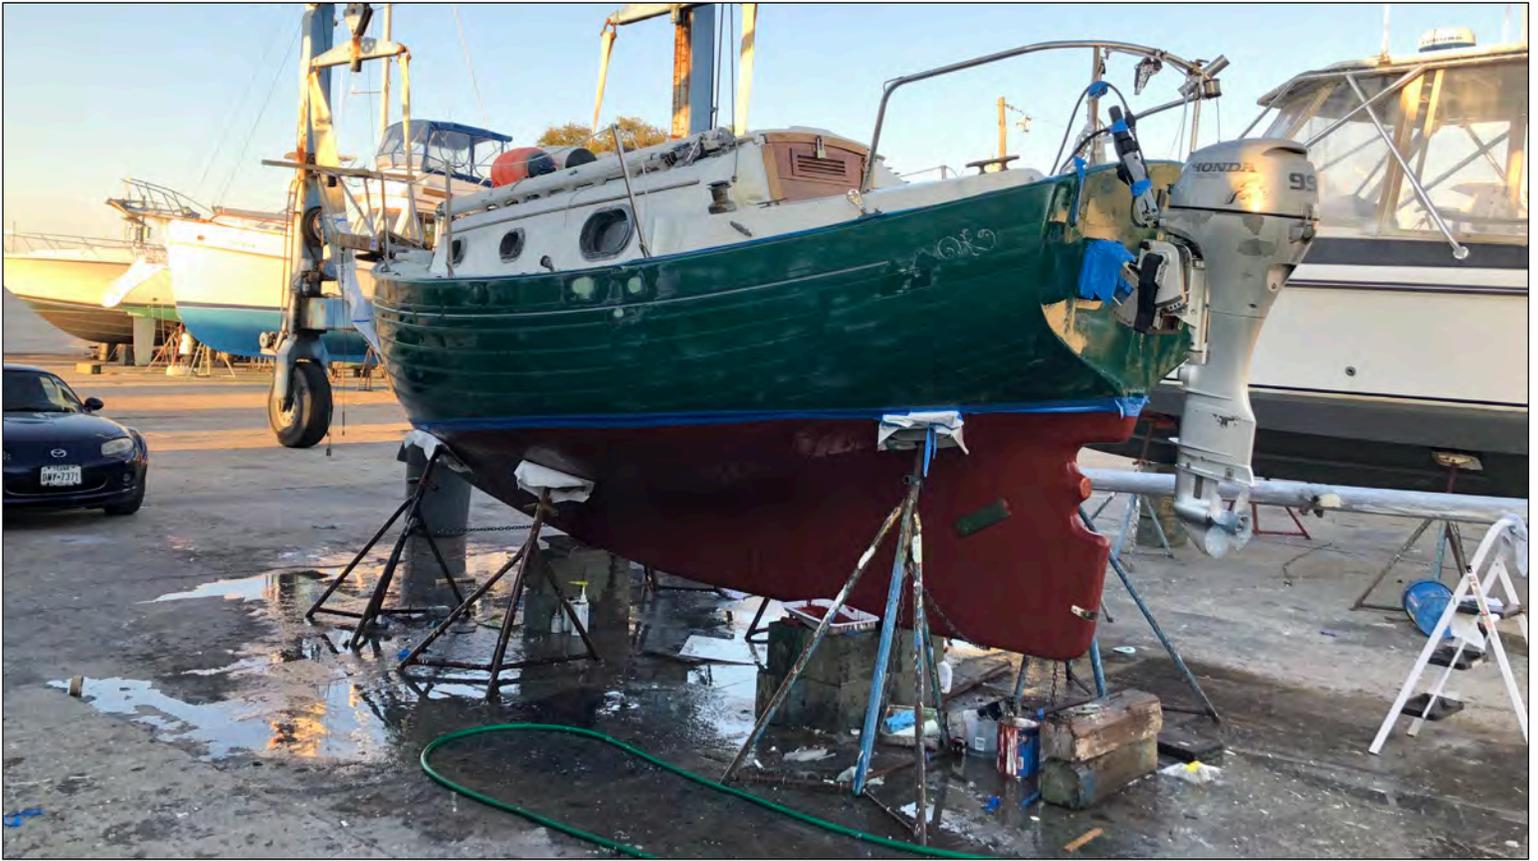
The final coat of bottom paint before priming and painting the topsides.  
*Photo: Jamie White © 2020*

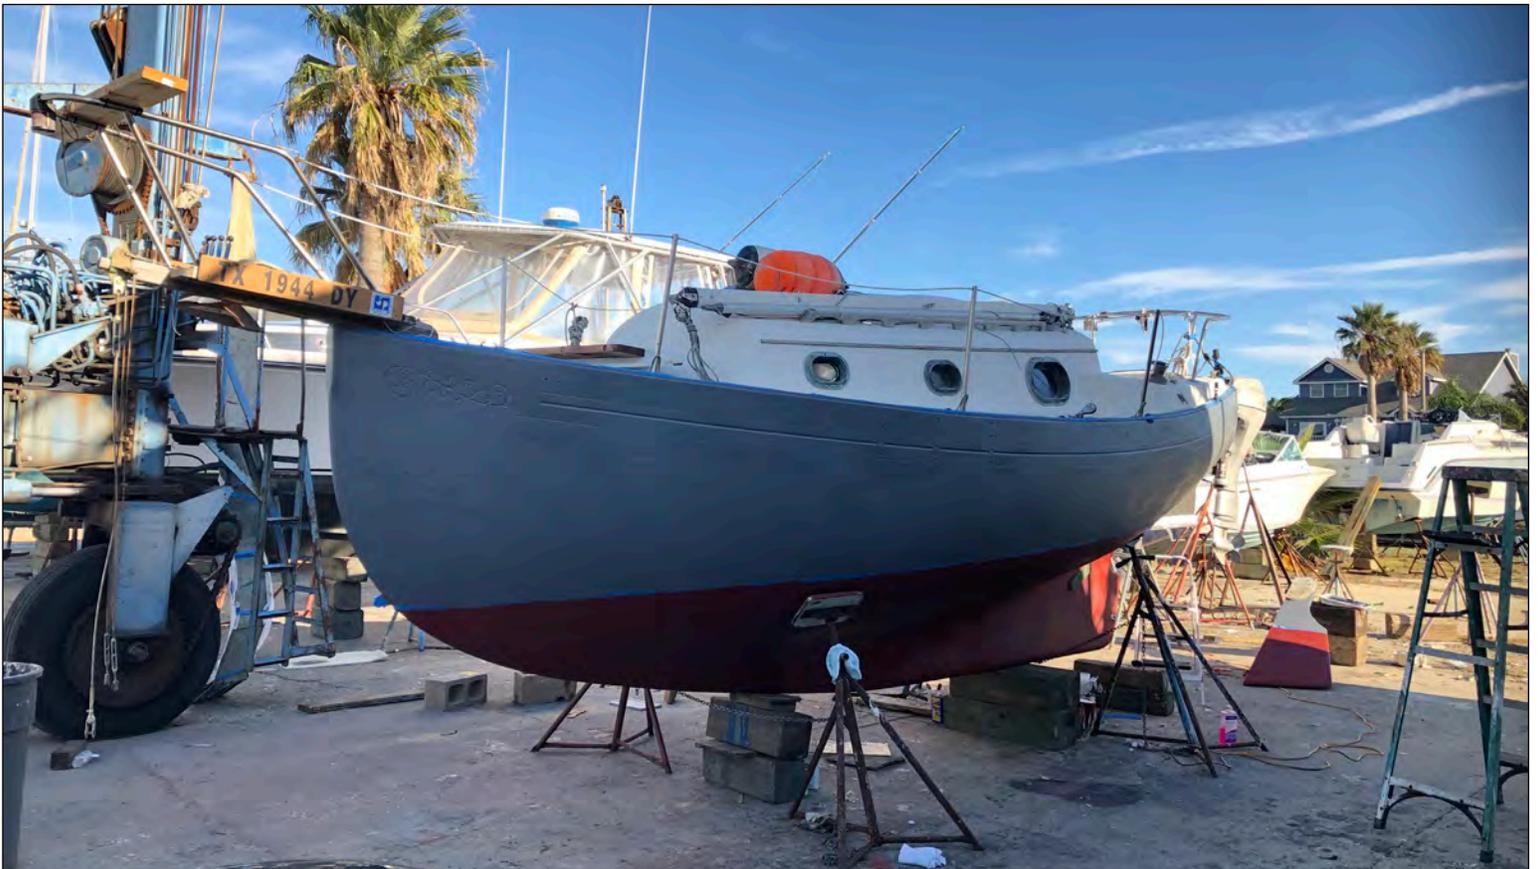
Two primer coats were applied to the topside of the hull.  
*Photo: Jamie White © 2020*
