# Flicka Friends

*Issue # 71*

*Refitting s/y DULCINEA*

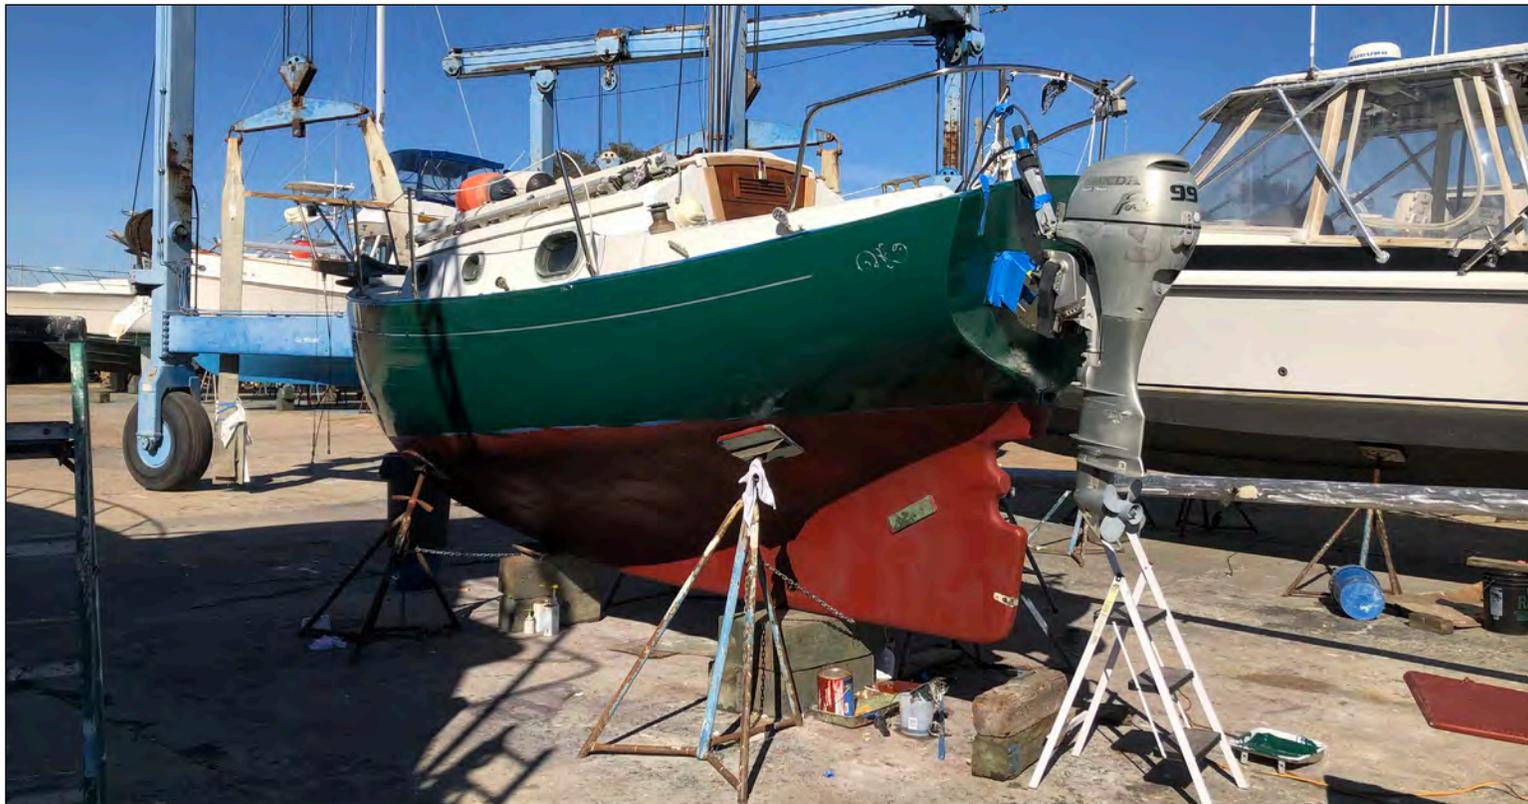
First topcoat of Interlux Sea Green Brightside paint.  
*Photo: Jamie White © 2020*

After all the topsides dings and gouges were repaired, I gave the topsides 2 coats of INTERLUX-404/414 two-part Epoxy Primekote. I rolled and tipped the final two topcoats of Sea Green INTERLUX-Brightside® One-Part Polyurethane Paint with good results.

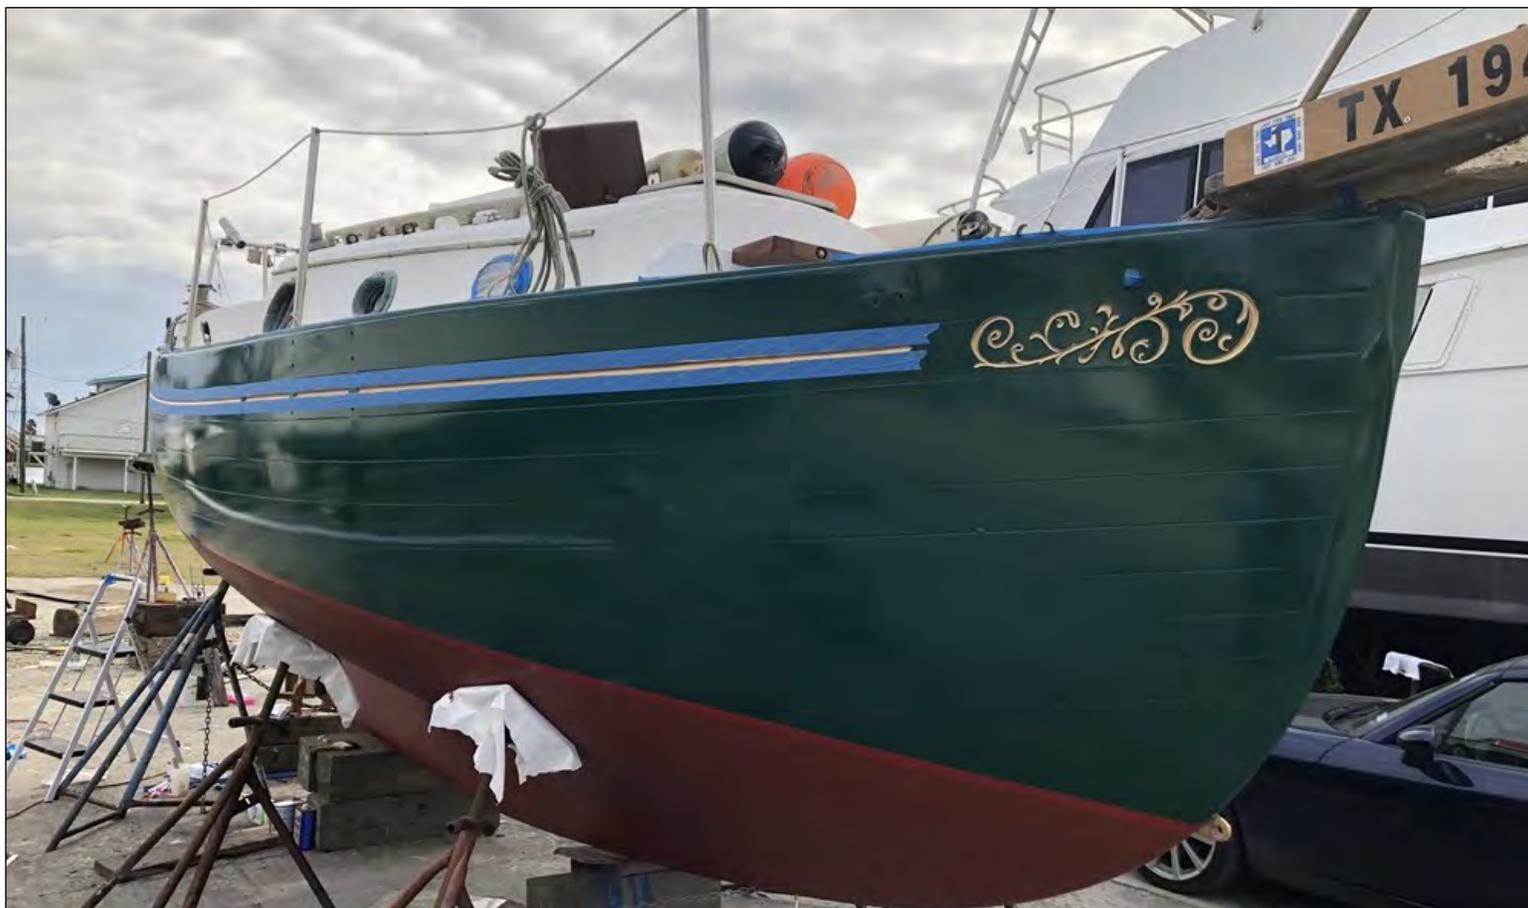
Second topcoat Sea Green and second coat of Gold Leaf paint for scroll work and cove stripe.  
 I applied faux gold leaf vinyl lettering on both quarters with her soon-to-be new name of *DULCINEA*.  
*Photo: Jamie White © 2020*

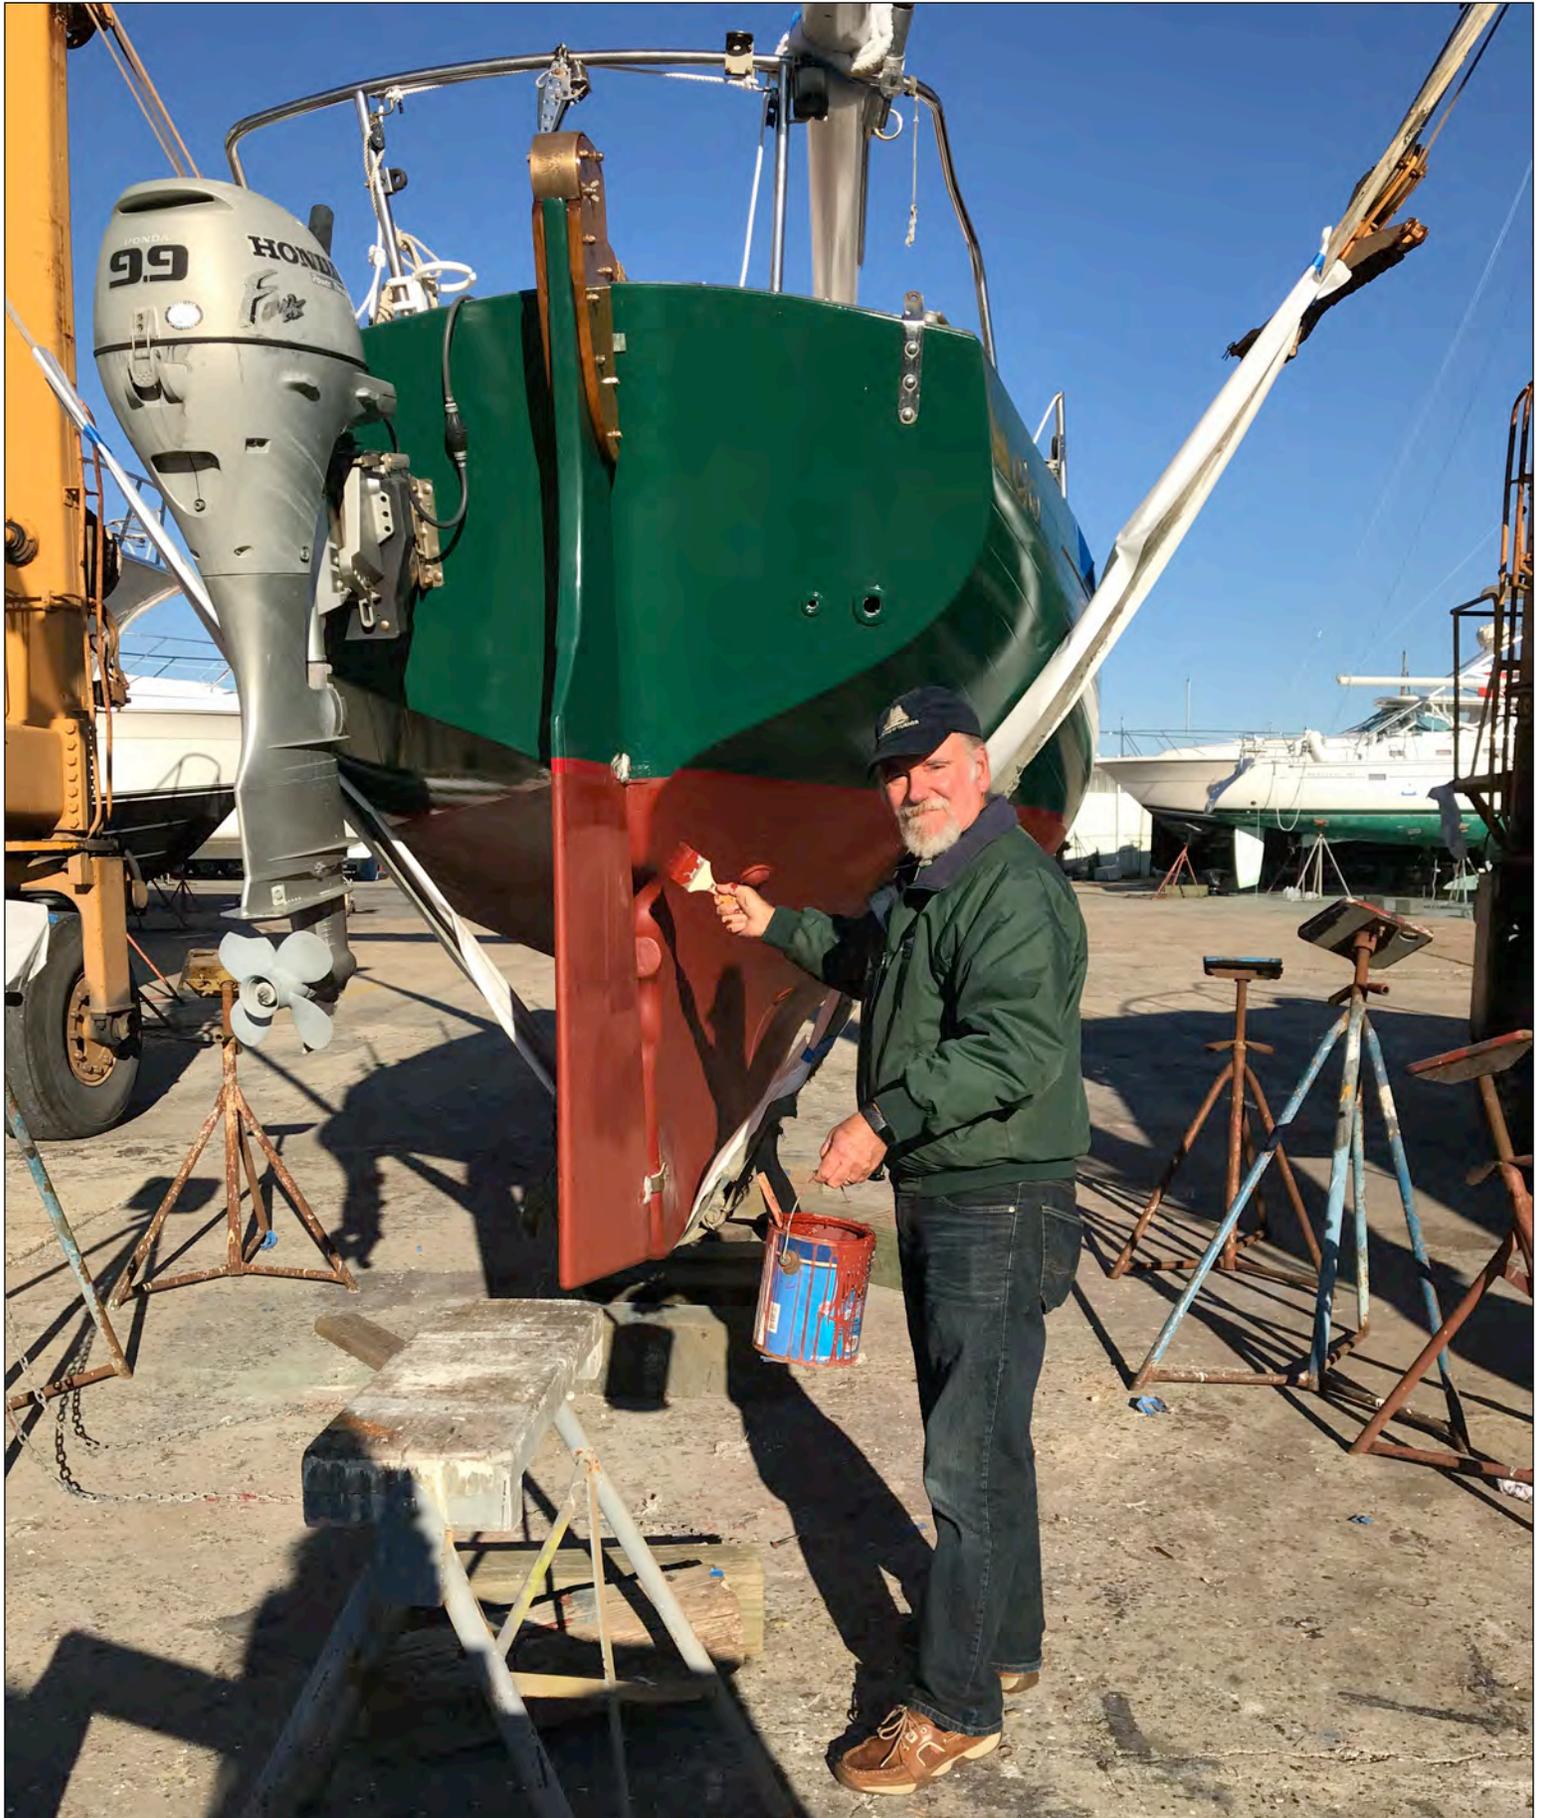
Final touch up of the bottom paint before launching. Note the refinished cheeks on the rudder.

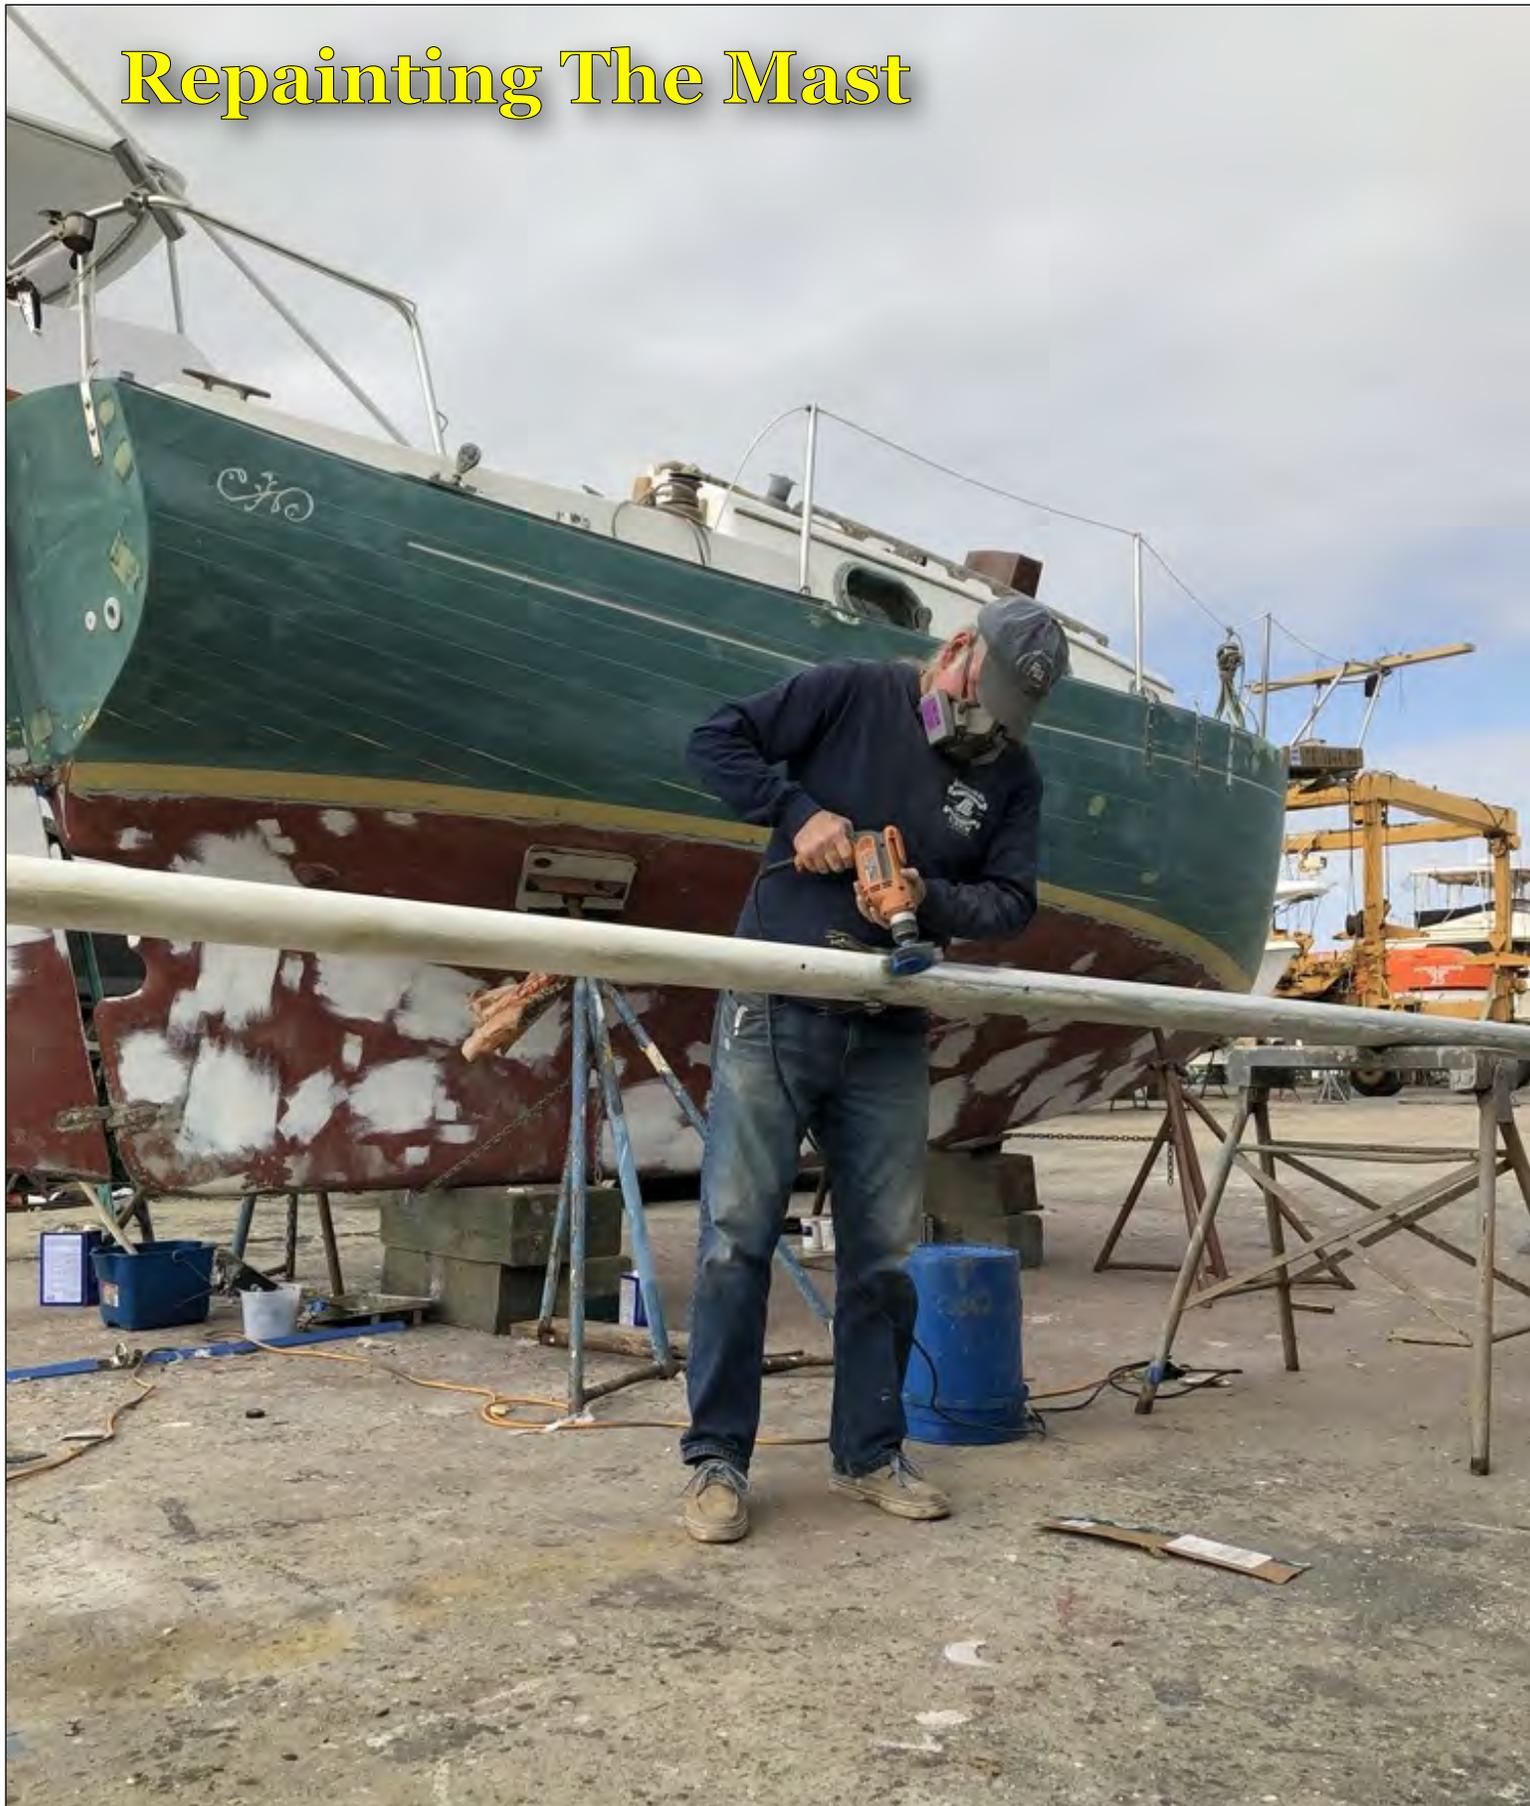
Paint removal from the mast during the refit of Pacific Seacraft Flicka # 302.  
*Photo: Ruth Downes © 2020*

After removing all the old paint, I sanded the aluminum mast using 220 grit paper followed by a mild acid etch of white vinegar and water. Then I applied an aluminum etching primer followed by three topcoats of white INTERLUX–Brightside® One-Part Polyurethane Paint. After it dried, I affixed the hardware, bedded with LanoCote® to combat galvanic corrosion where dissimilar metals are fastened together.  
**Photo: Jamie White © 2020**

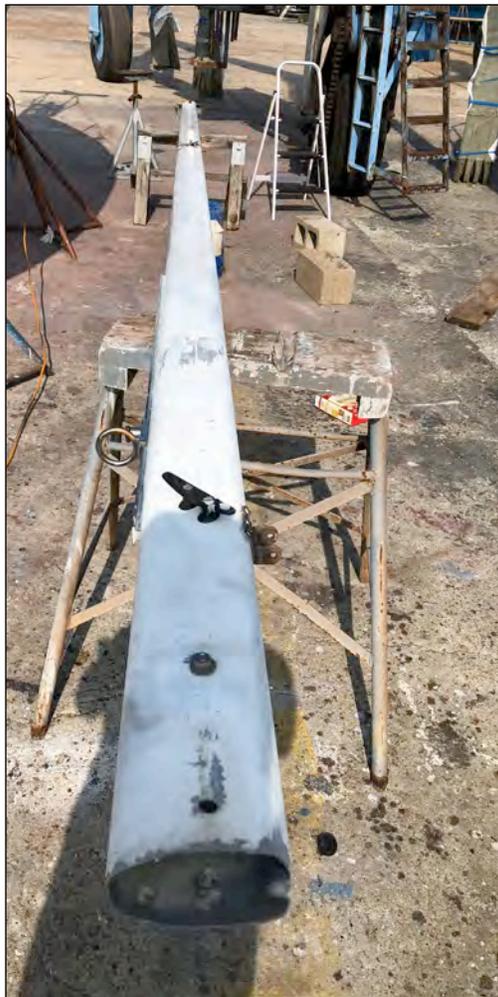
A mast looking for a paintbrush. Getting ready to remove all hardware, tracks, and masthead sheave box before removing oxidized coating.  
**Photo: Jamie White © 2020**

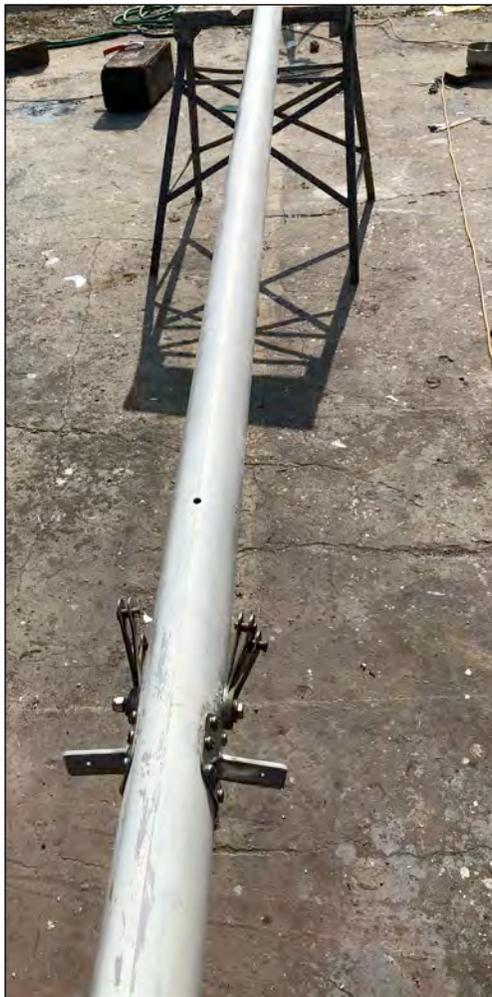
Removing paint and oxidation with a combination of chemical strippers and soft abrading wheels on an electric drill.  
**Photo: Jamie White © 2020**

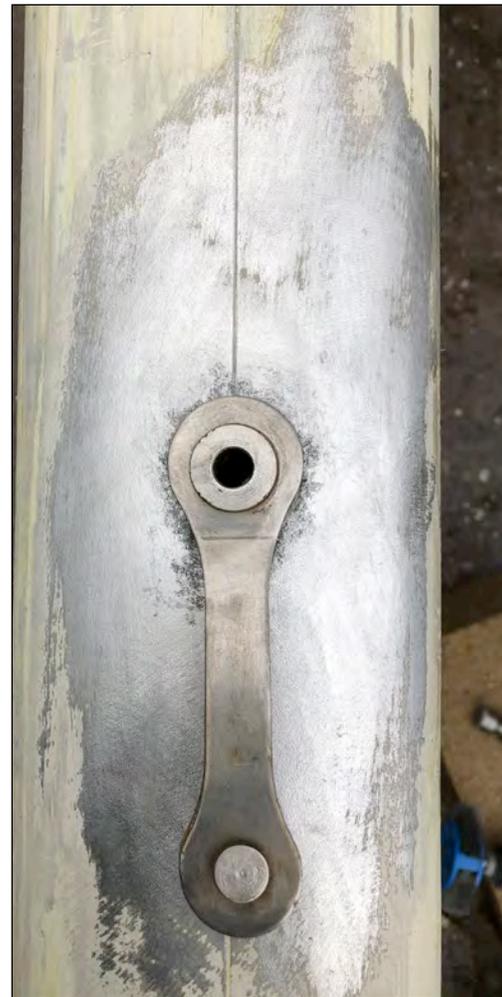
After doing a dye-pen test of the tangs, I decided to not remove them at this haul-out, as they showed no fissures or cracks.  
**Photo: Jamie White © 2020**

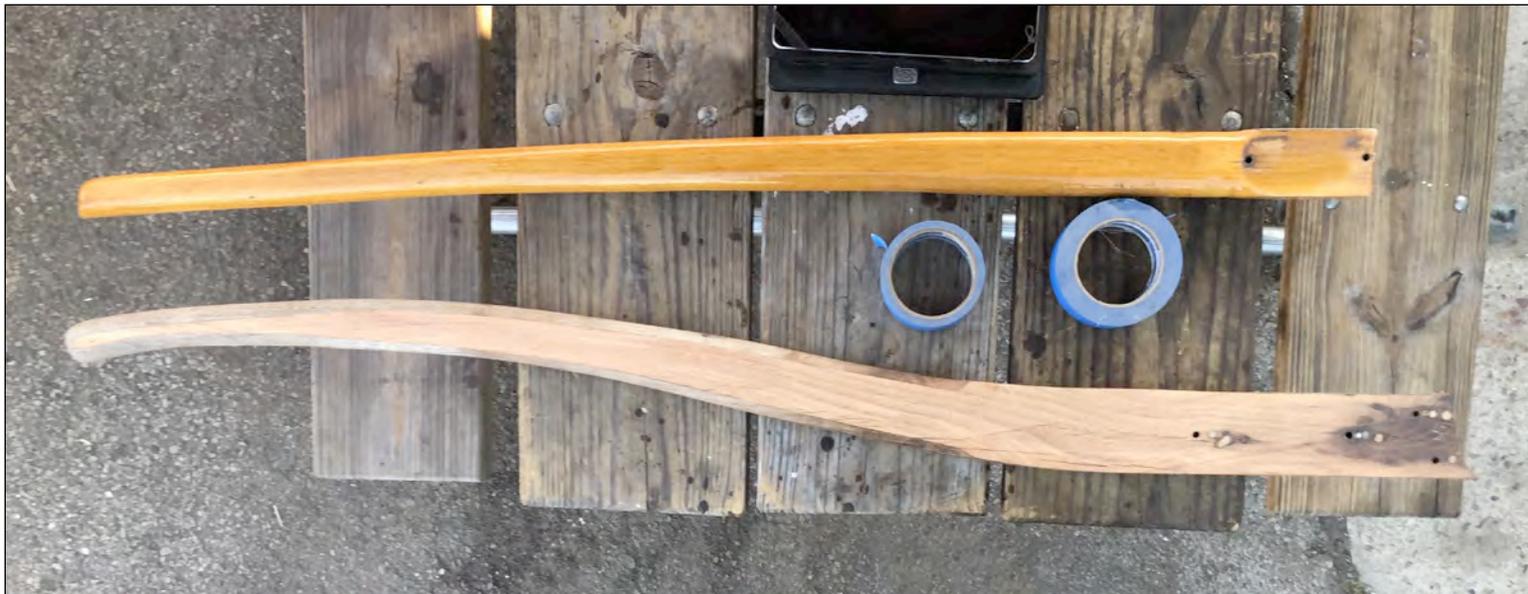
Reshaping the tiller. The tiller at top of photo is a spare tiller I purchased at Minney's that will serve as a back up or emergency tiller.  
*Photo: Jamie White © 2020*

When I was in San Pedro rigging the brig *SWIFT of IPSWICH* I made a pilgrimage to Minneys Yacht Surplus in Newport Beach [Minney's Yacht Surplus](#). *DULCINEA*'s old tiller was rotten and broken, so I was overjoyed when I found a solid teak tiller at Minney's.

The new tiller was from a larger 48' ketch and I had to reshape it to fit *DULCINEA*'s cockpit and rudder.

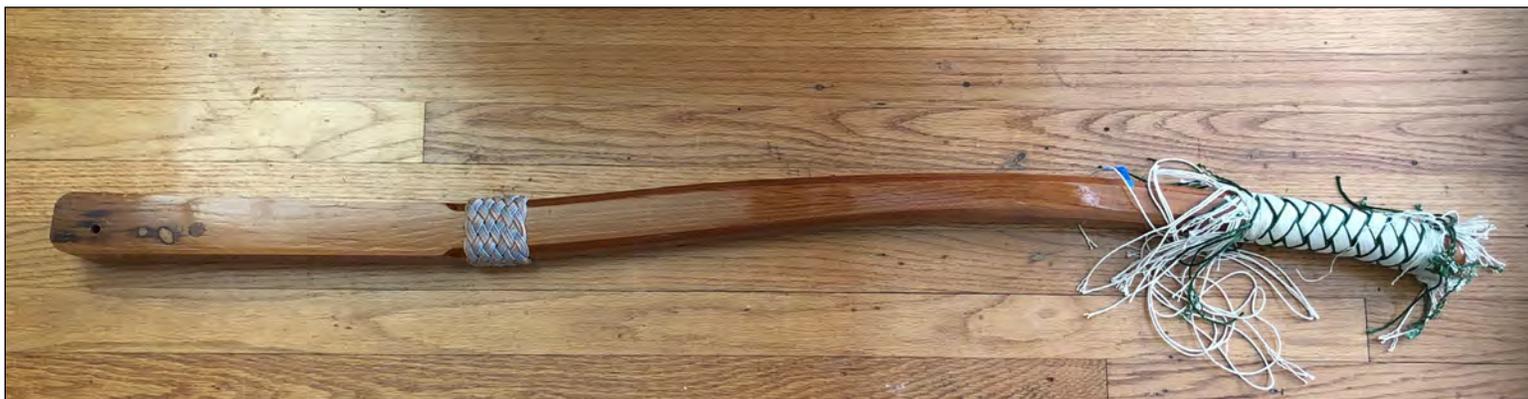
Tiller varnish and fancy rope work being worked.  
*Photo: Jamie White © 2020*

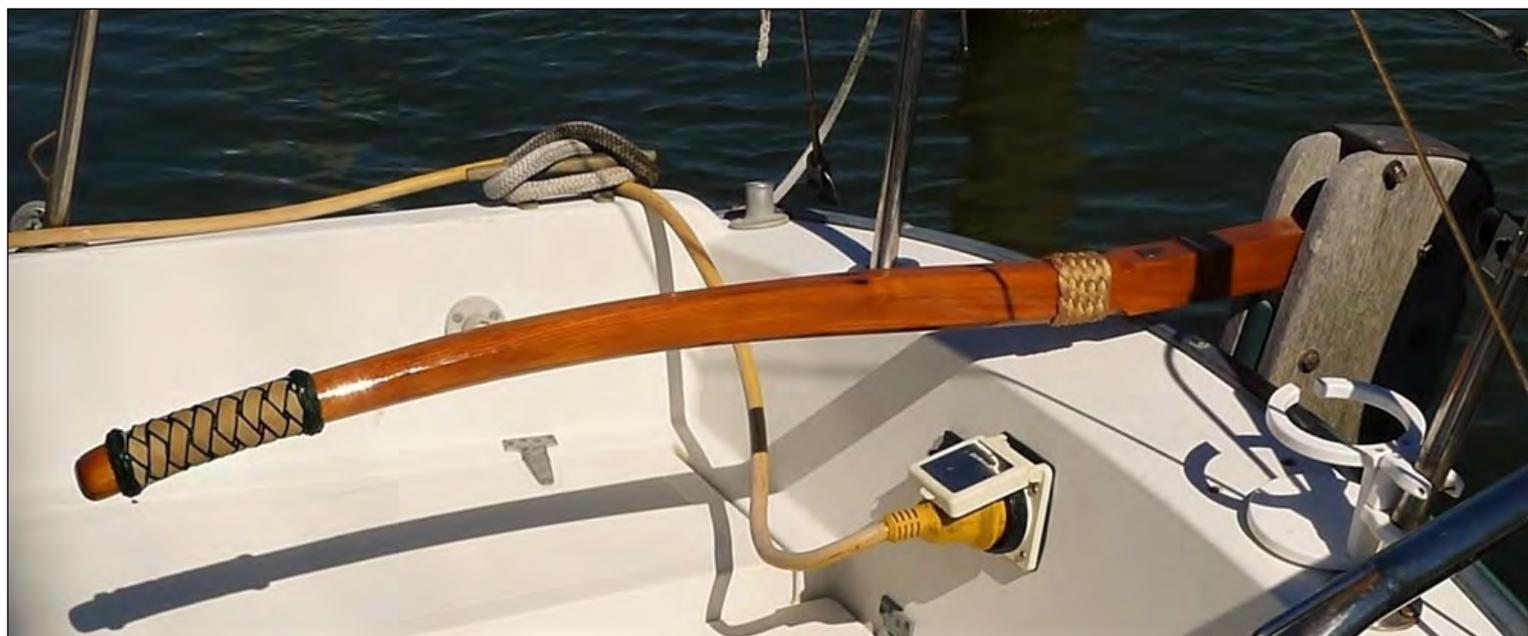
The completed tiller and rope work aboard s/y *DULCINEA*.  
*Photo: Jamie White © 2020*

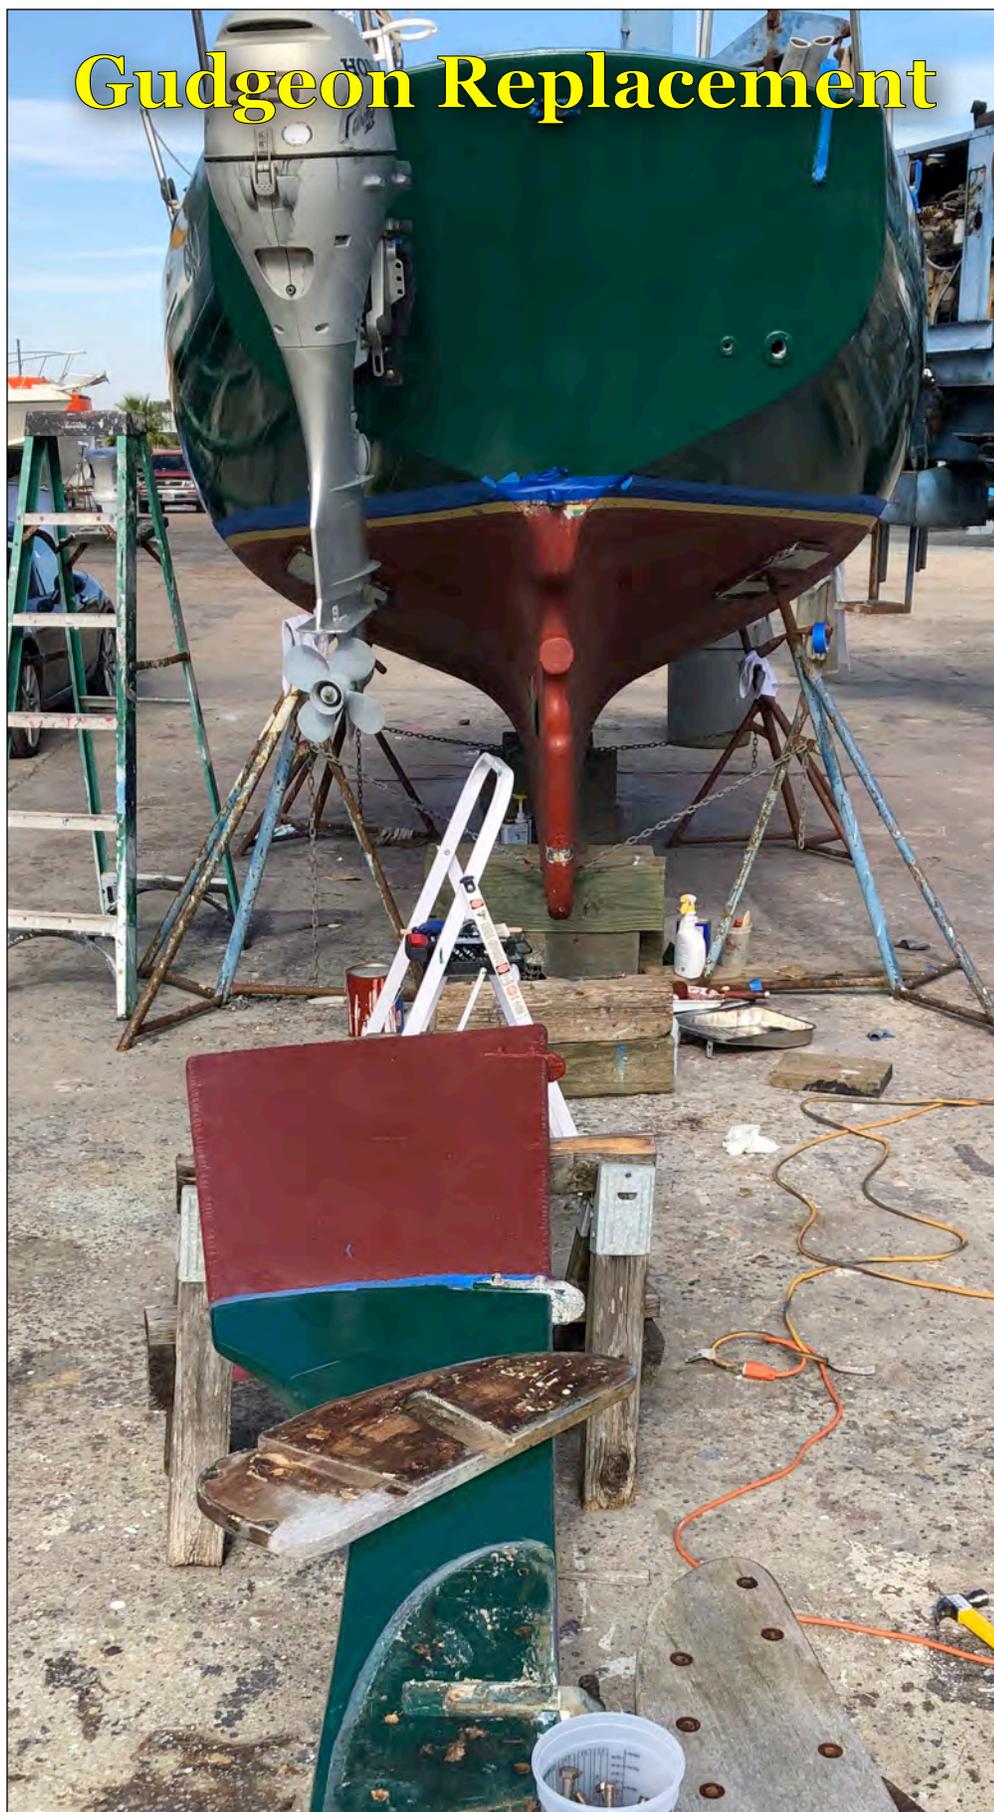
Rudder removed and rudder head cheek plates ready for sanding.

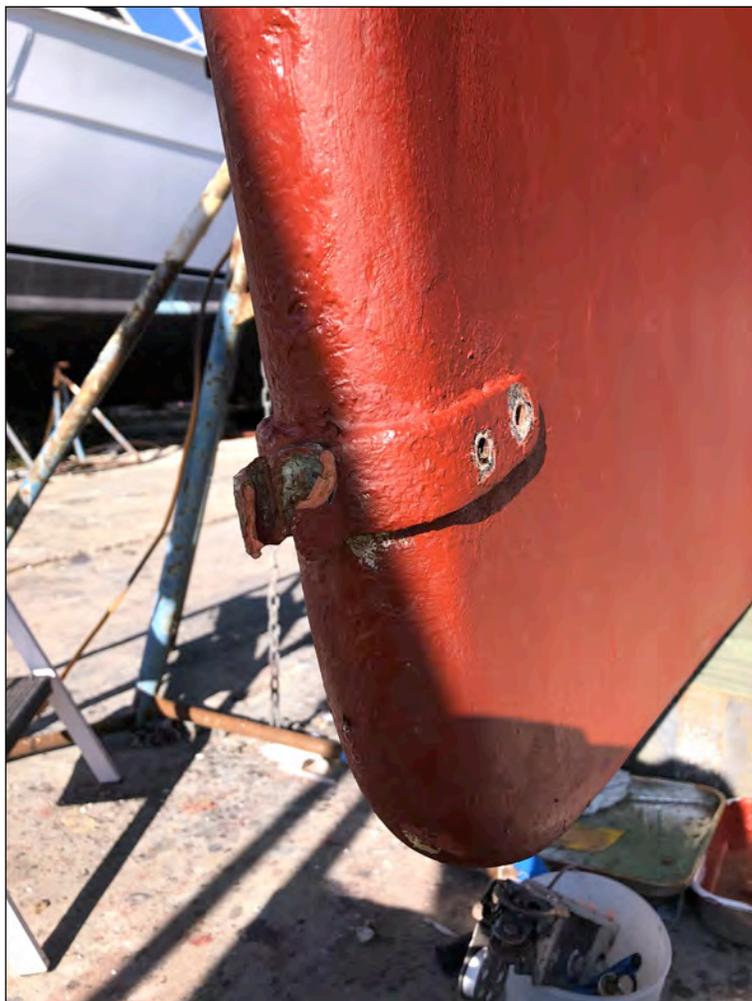
While the upper rudder gudgeon was in good condition with a tight fitting pintle, the lower one was corroded and exhibited a pink hue – a sure indication of galvanic issues.

Broken lower gudgeon.  
*Photo: Jamie White © 2020*

I discovered that Pete Langley, owner of Port Townsend Foundry in Washington, had the original wooden patterns from Pacific Seacraft and quickly cast a new gudgeon for me. It is a beautiful example of his craftsmanship. If you are in need of new gudgeons, give him a call.

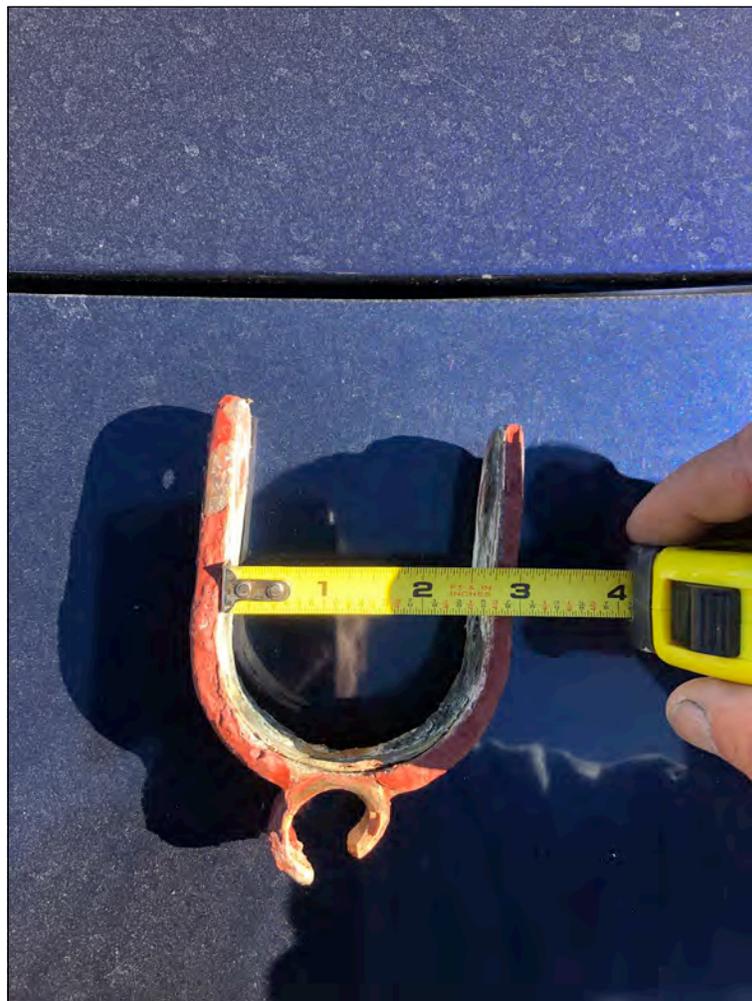
Measuring the gudgeon for a replacement.  
*Photo: Jamie White © 2020*

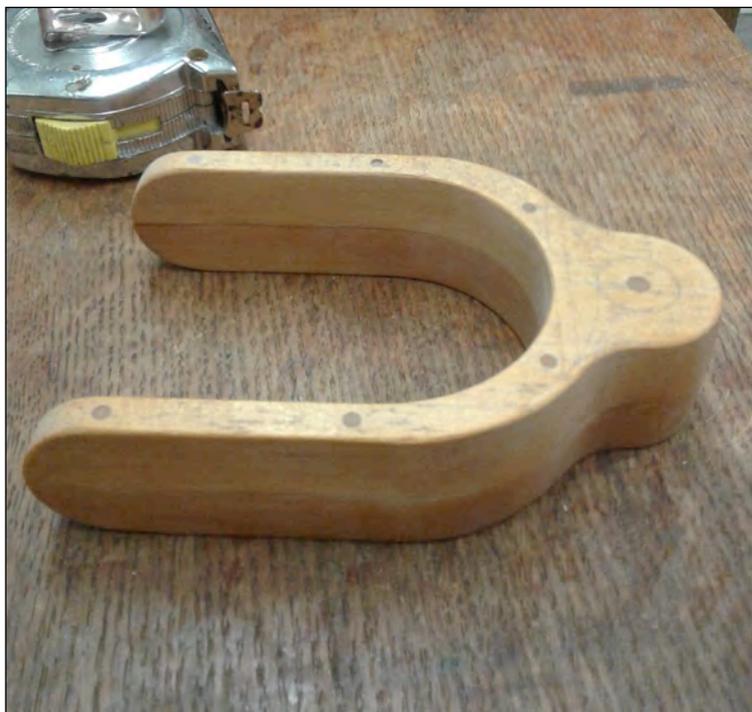
Flicka 20 Gudgeon pattern from Port Townsend Foundry.  
*Photo: Jamie White © 2020*

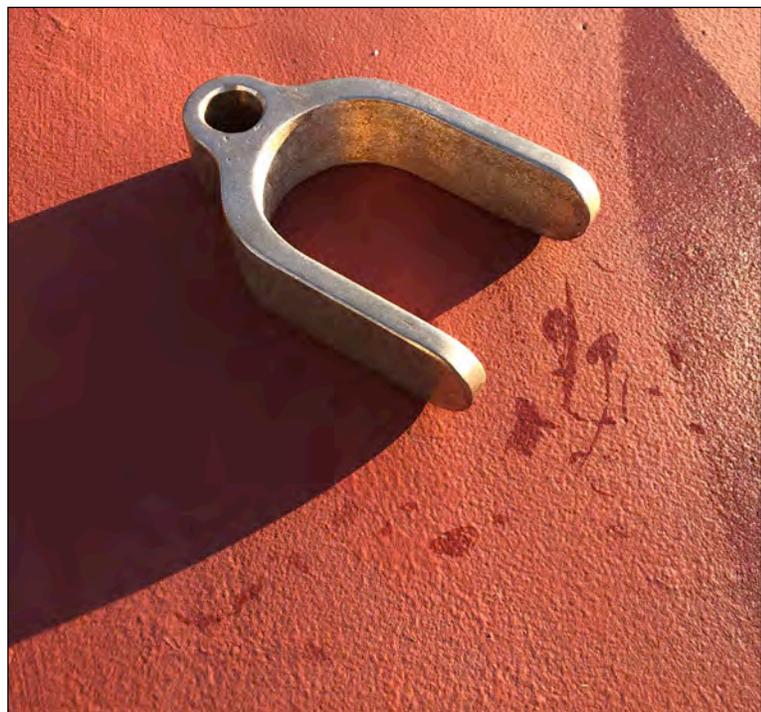
Lower Gudgeon for the Flicka 20 from the Port Townsend Foundry.  
*Photo: Jamie White © 2020*

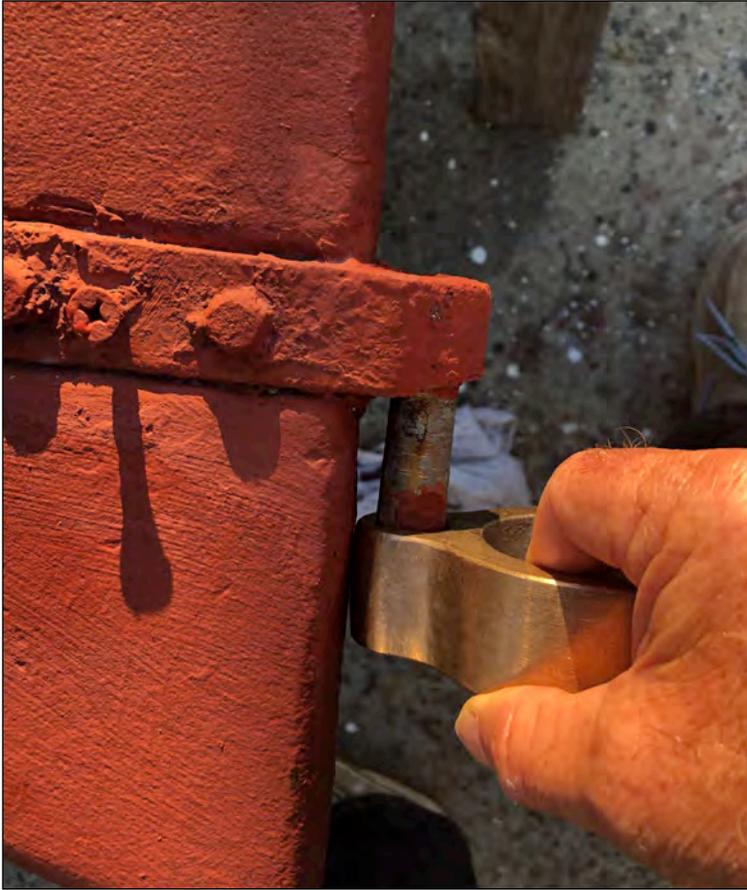
Test fitting of the new gudgeon.  
*Photo: Jamie White © 2020*

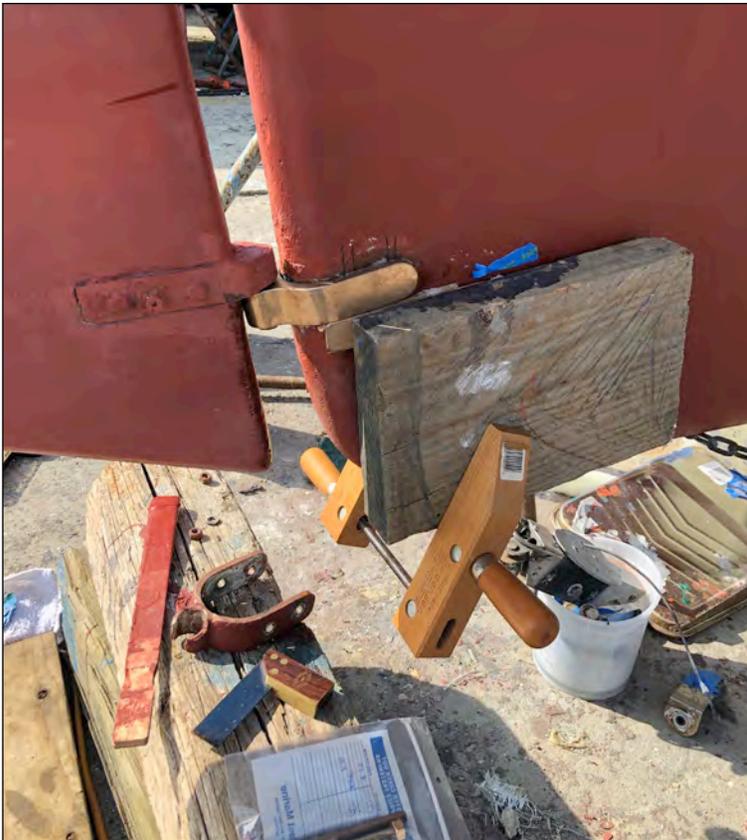
A wooden block was used as a stop for fitting the gudgeon.  
*Photo: Jamie White © 2020*

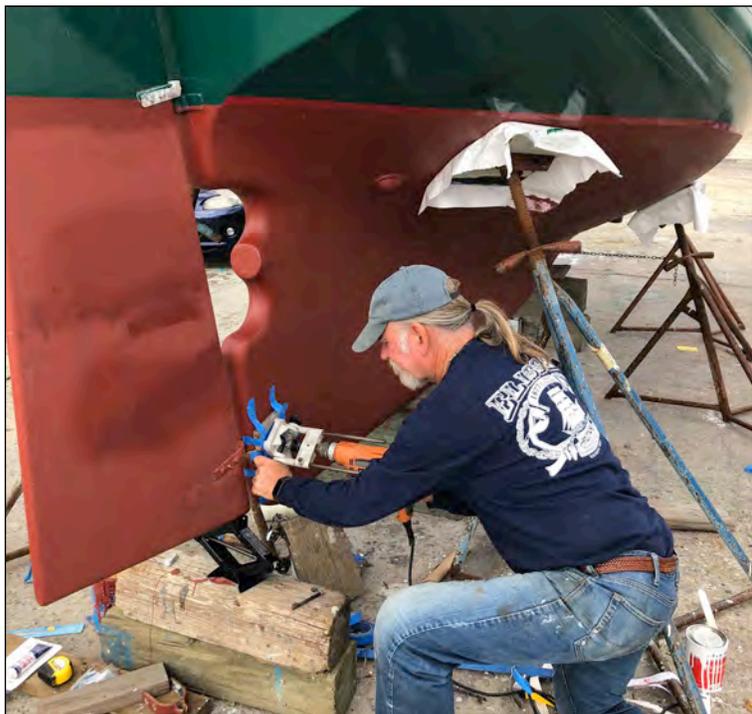
A long shank drill bit was required.  
*Photo: Jamie White © 2020*

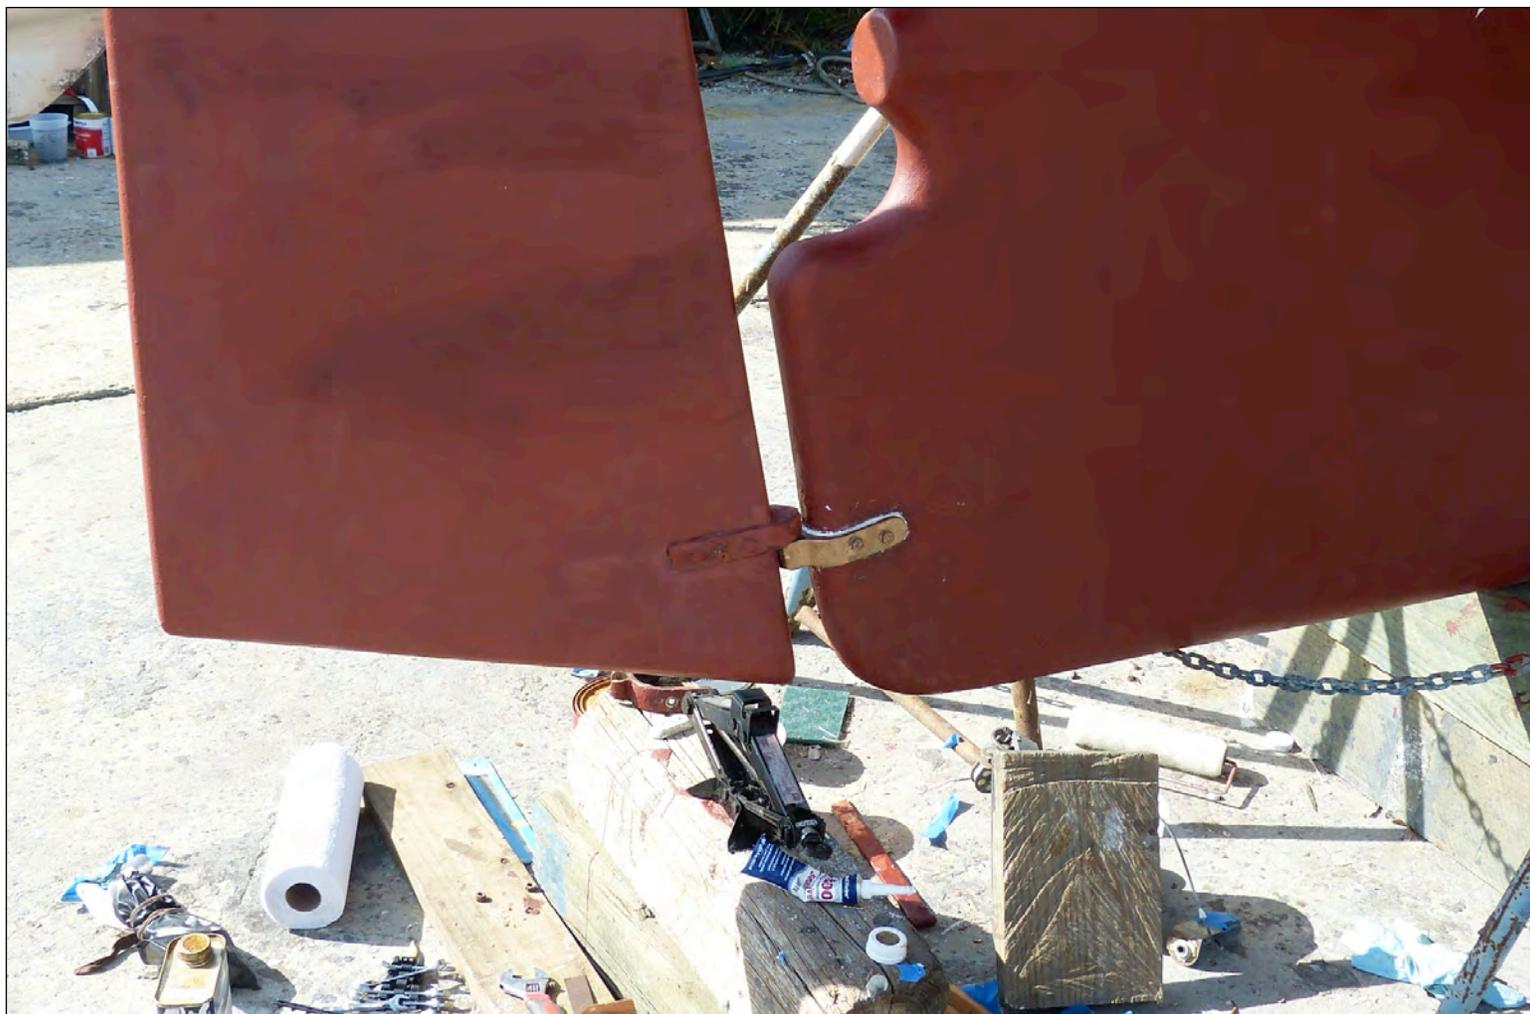
Completed replacement of the lower gudgeon of s/y *DULCINEA*.  
*Photo: Jamie White © 2020*

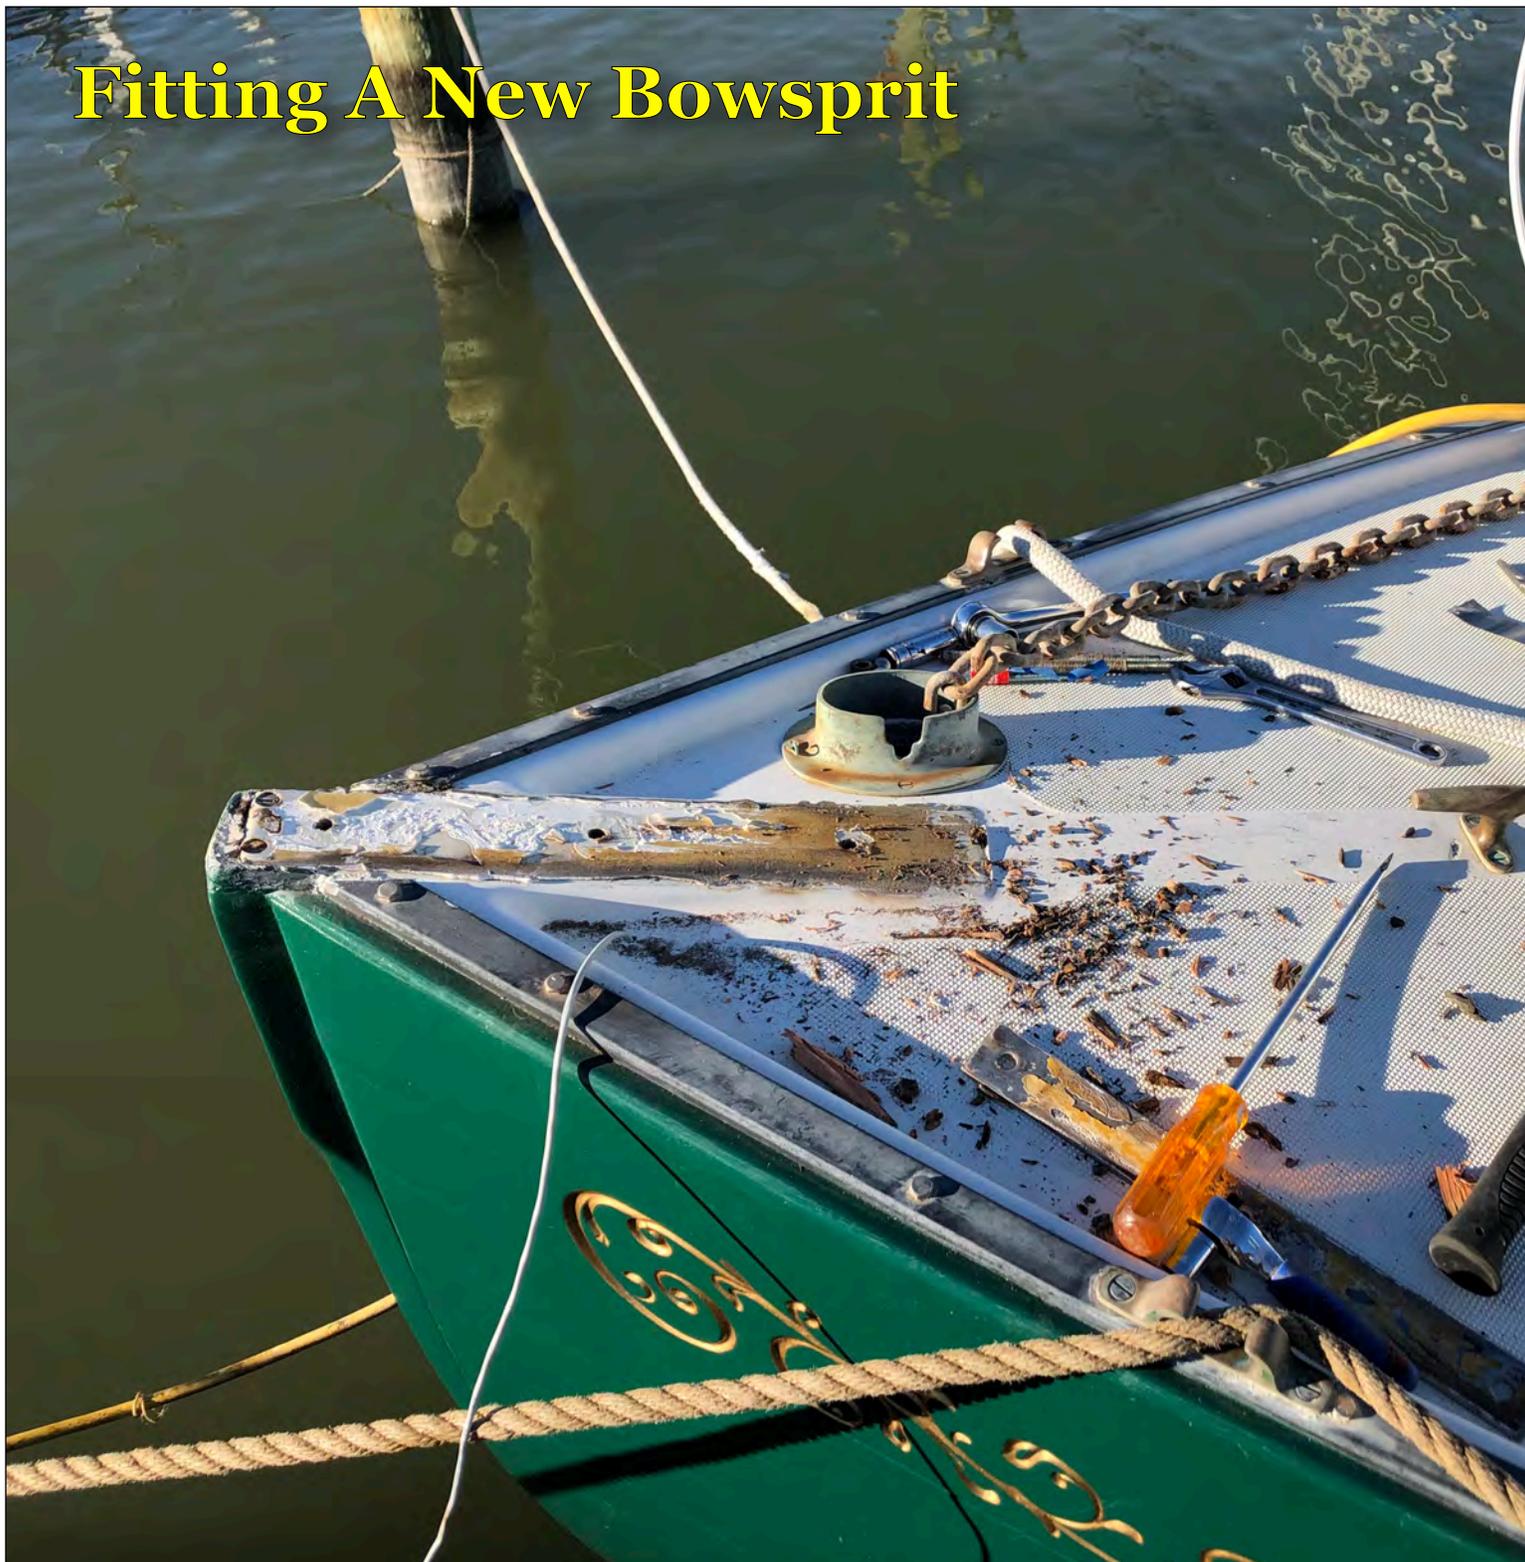
Success! The old bow sprit has been finally removed!
