# Flicka Friends

*Issue # 71*

*Refitting s/y DULCINEA*

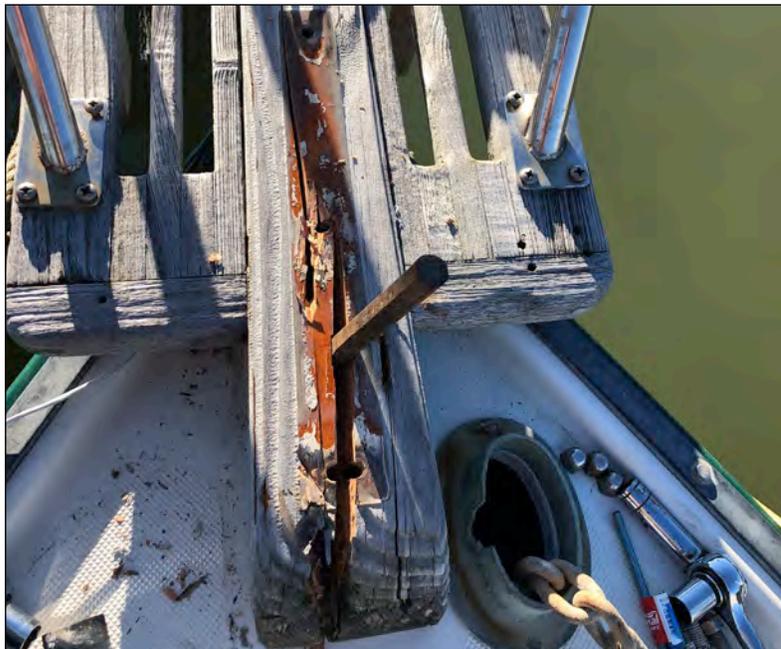
I tried using heat to weaken the seal between deck and old bowsprit, and tried the old trick of using a guitar string to slice (or more accurately, saw) through the old adhesive. In the end I had to resort to using a chisel and blowing out the spar along the grain to finally extricate it from its long-time home.

Resorting to a chisel after failing to unseat the bowsprit using heat and guitar string garrote.  
*Photo: Jamie White © 2020*

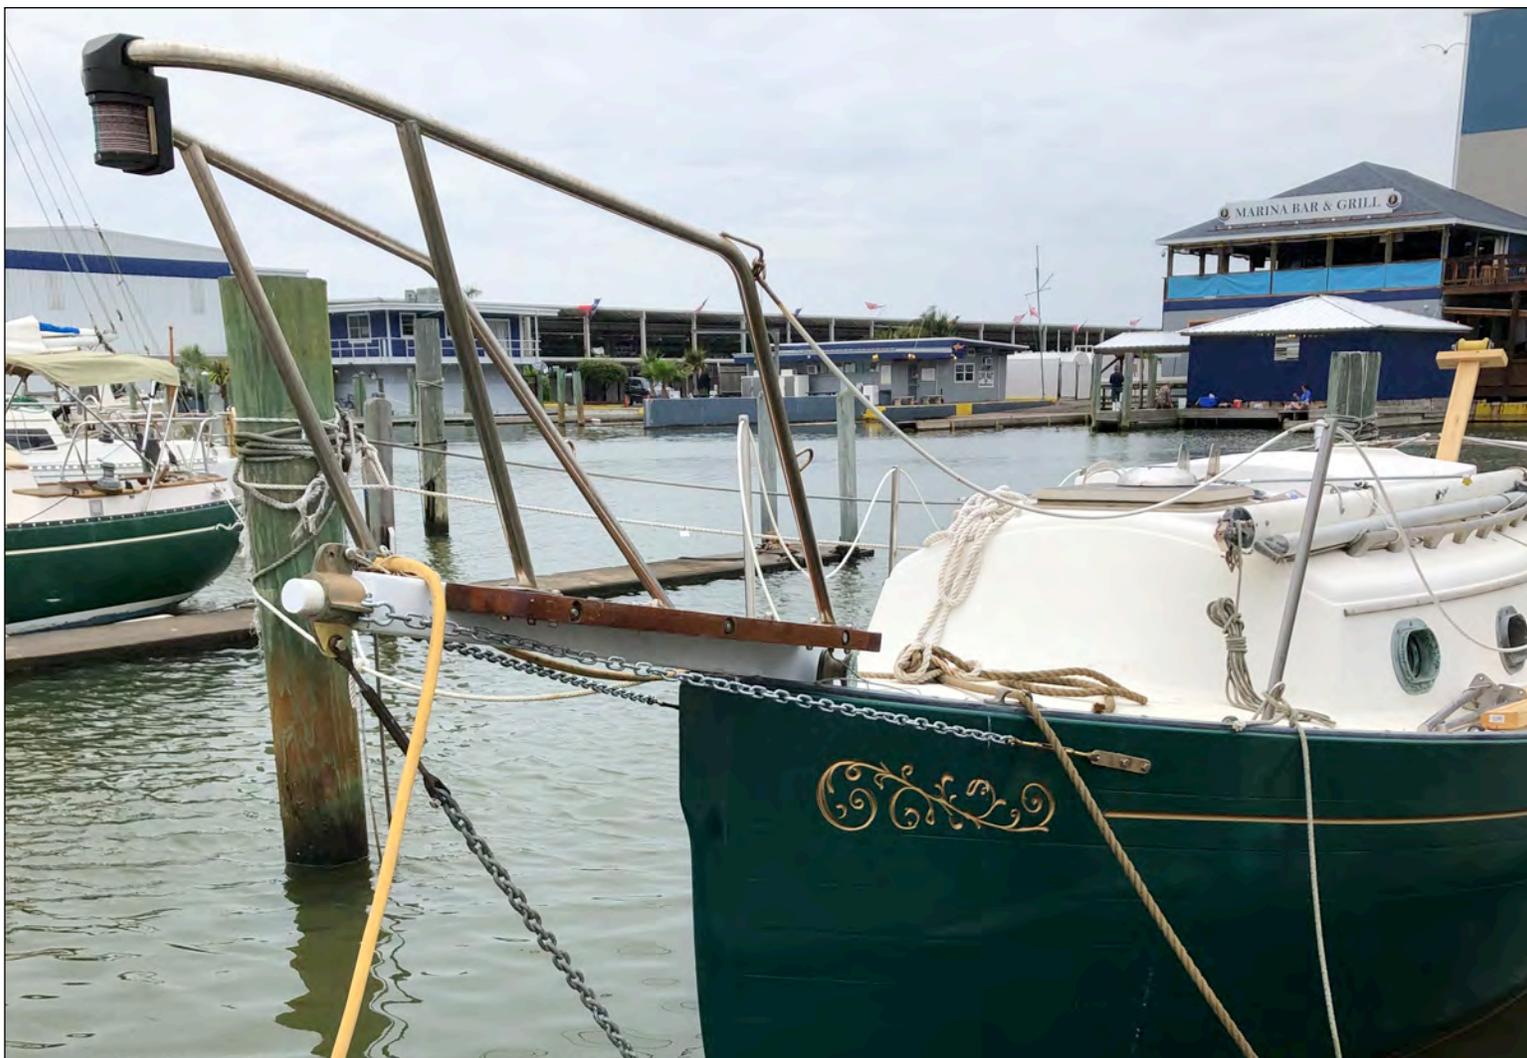
New bowsprit fitted with new galvanized chain bobstay and bowsprit shrouds.  
*Photo: Jamie White © 2020*

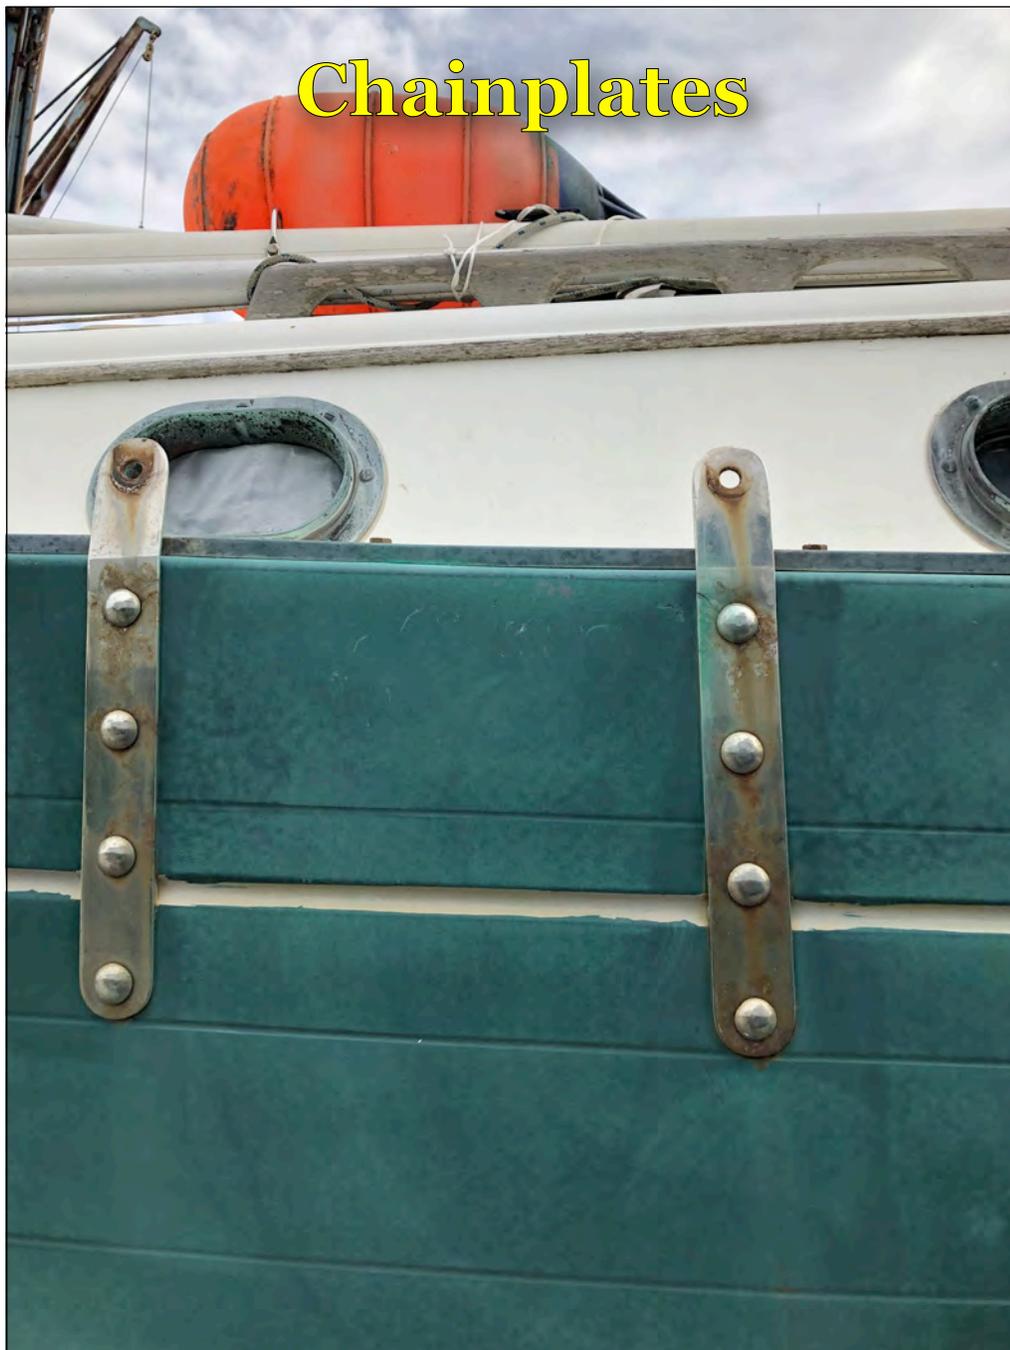
All this vibration leads to "work hardening" of the stainless chainplates. The work hardening coupled with crevice corrosion and stress risers are a leading cause of rig failures. As a general rule of thumb, any boat over 15 years old should have all the chainplates removed and inspected, especially those that pass through the deck (which fortunately is one

A small crack in the starboard Bowsprit shroud tang prompts additional inspections. The chainplates were checked as well, and replaced.

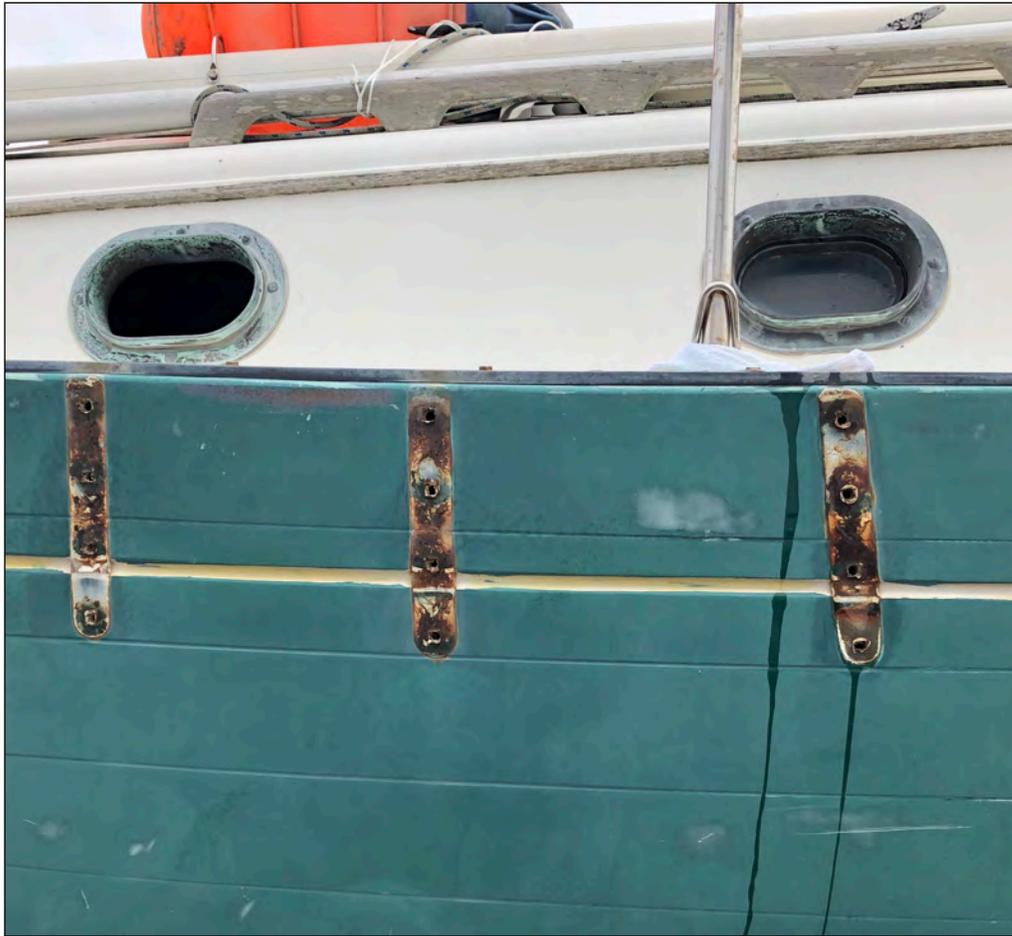
Port view of the hull after removal of the chainplates.  
*Photo: Jamie White © 2020*

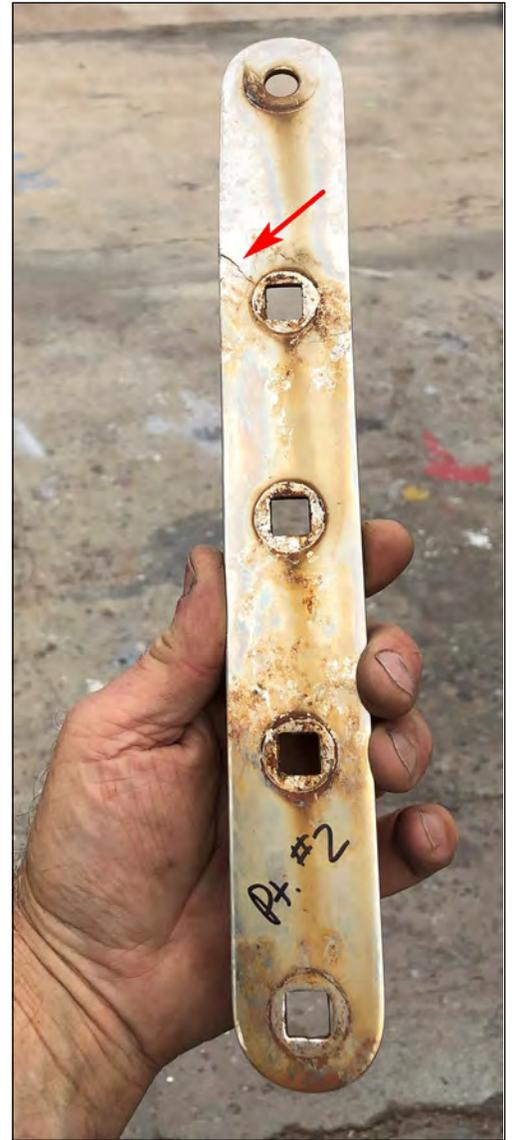
Port #2 chainplate. Note crack.  
*Photo: Jamie White © 2020*

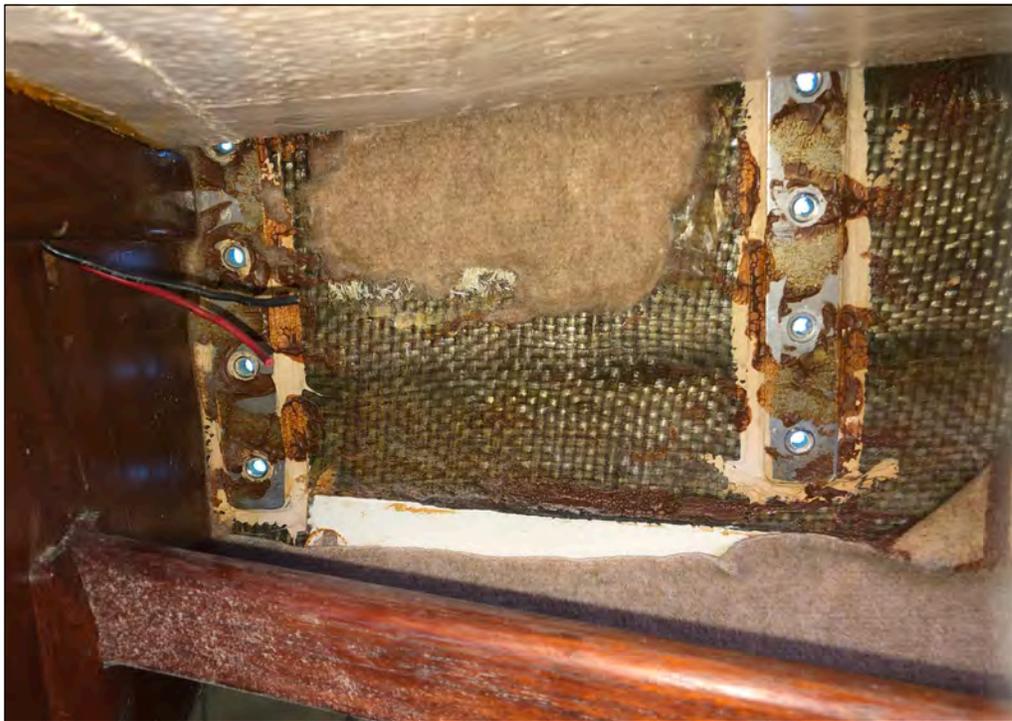
The hull liner carpet was partially removed when I took over stewardship of *DULCINEA* so it was simple to remove the rest of it to gain access to remove and then tighten the carriage bolts.  
*Photo: Jamie White © 2020*

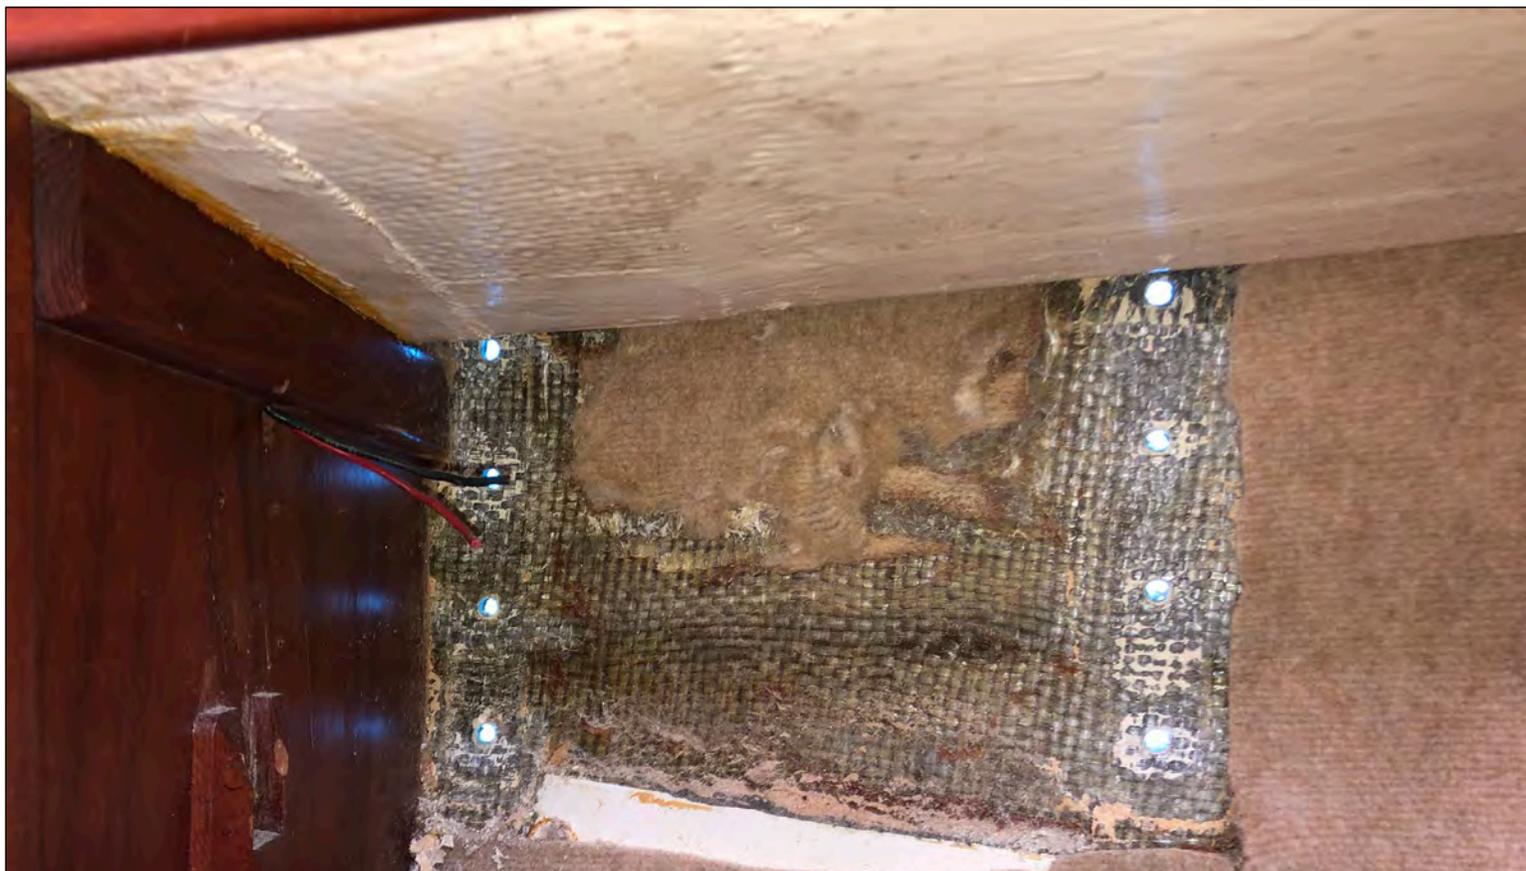
After cleaning up the faying surfaces of the hull liner to obtain a good watertight seal under the backing plate.  
 Note the thick heavy fiberglass roving our Flickas were laid up with by Pacific Seacraft. Stout!  
*Photo: Jamie White © 2020*

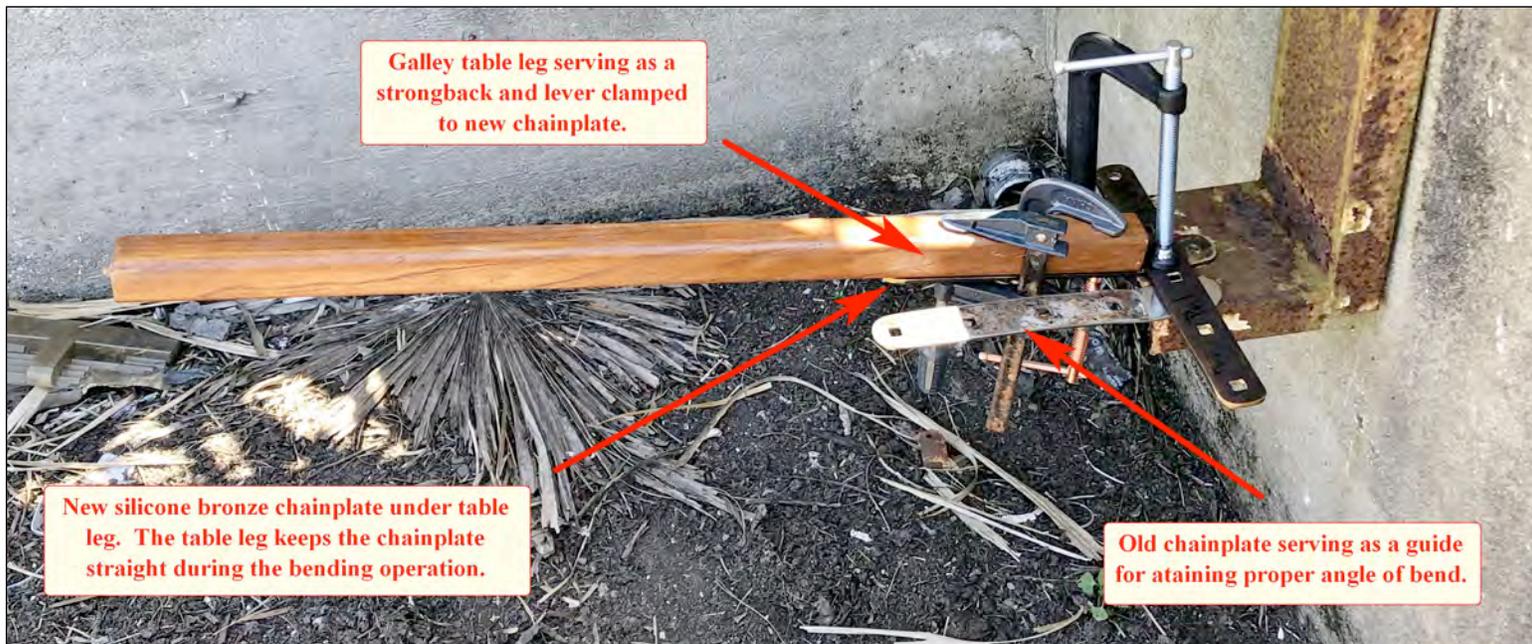
After drilling holes and squaring them off with a file, it was time to devise a jig to bend them. I decided to use silicon bronze carriage bolts, as the square holes in the bronze do not result in the same stress riser problems found in stainless steel.

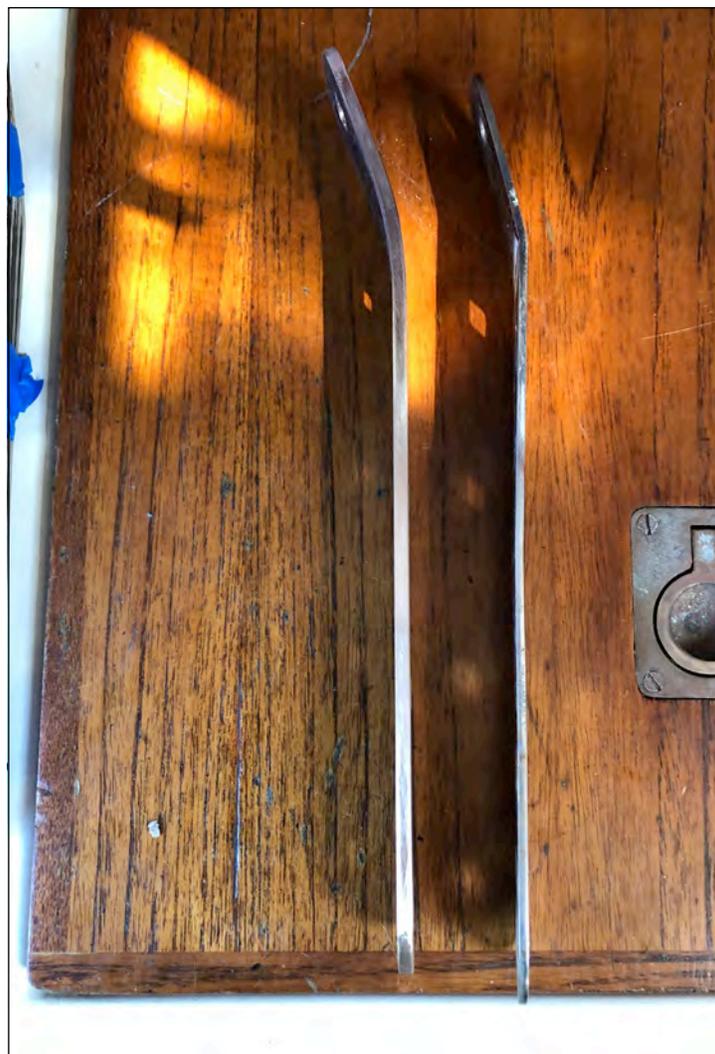
Note the silicon bronze 3/16" thickness compared to the 1/8" thickness of stainless steel.

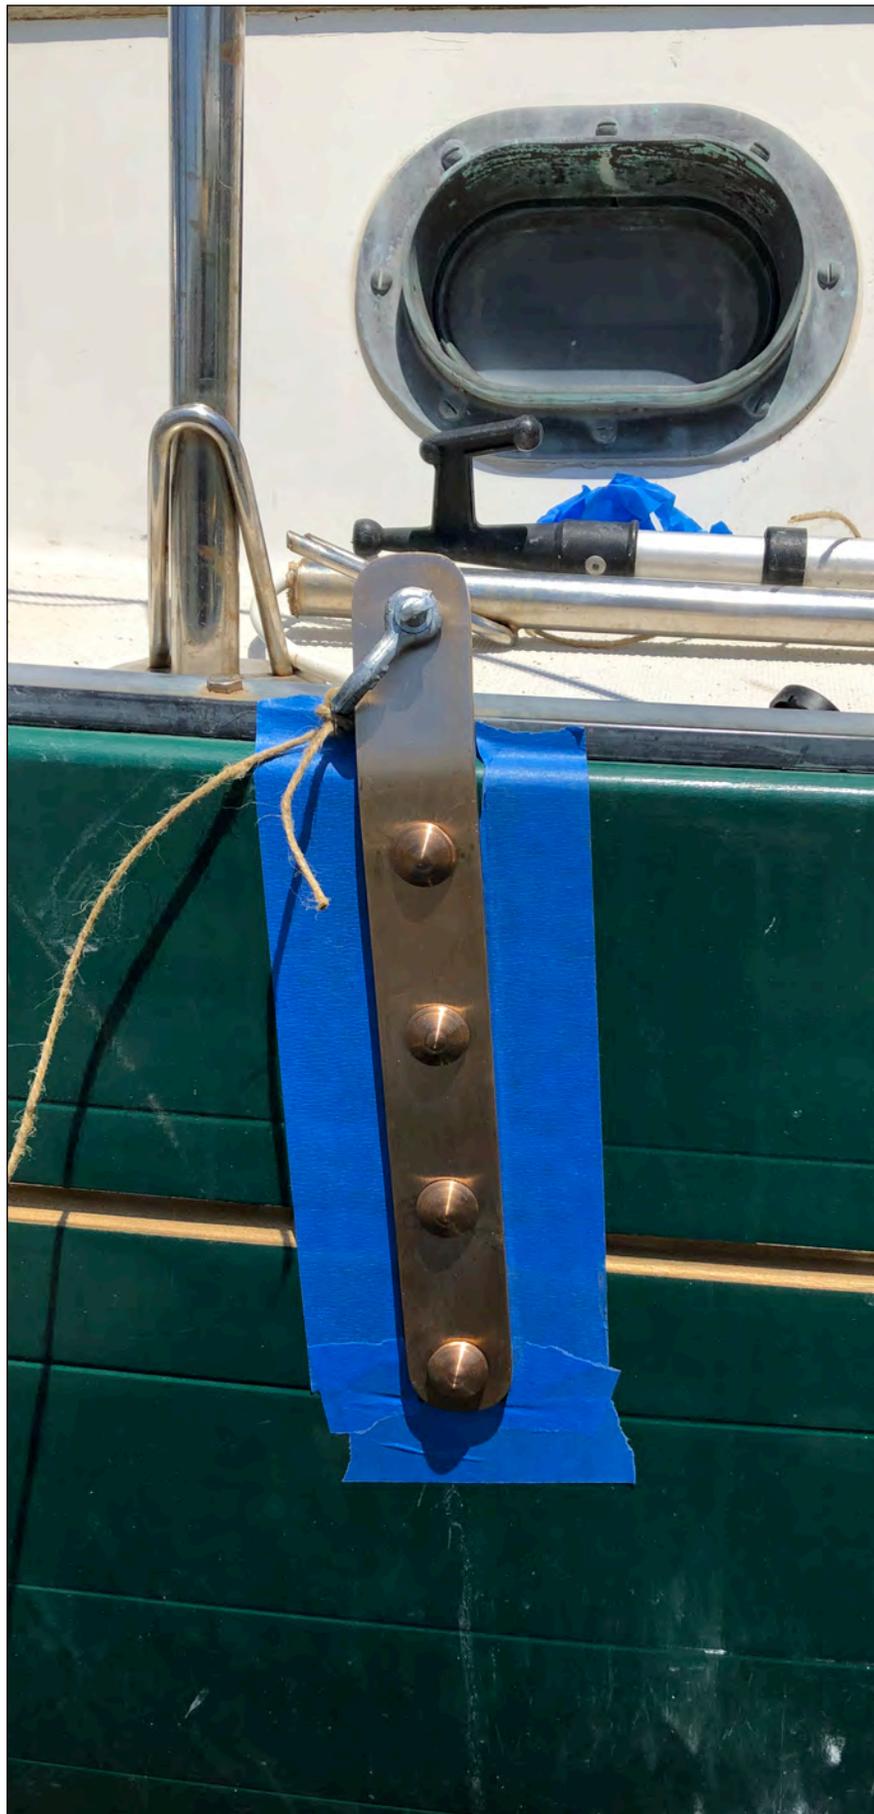
Portside chainplate installed and bedded with 3M 4000 polyurethane sealant.  
Photo: Jamie White © 2020

The completed chain plate installation showed the beauty of bronze!

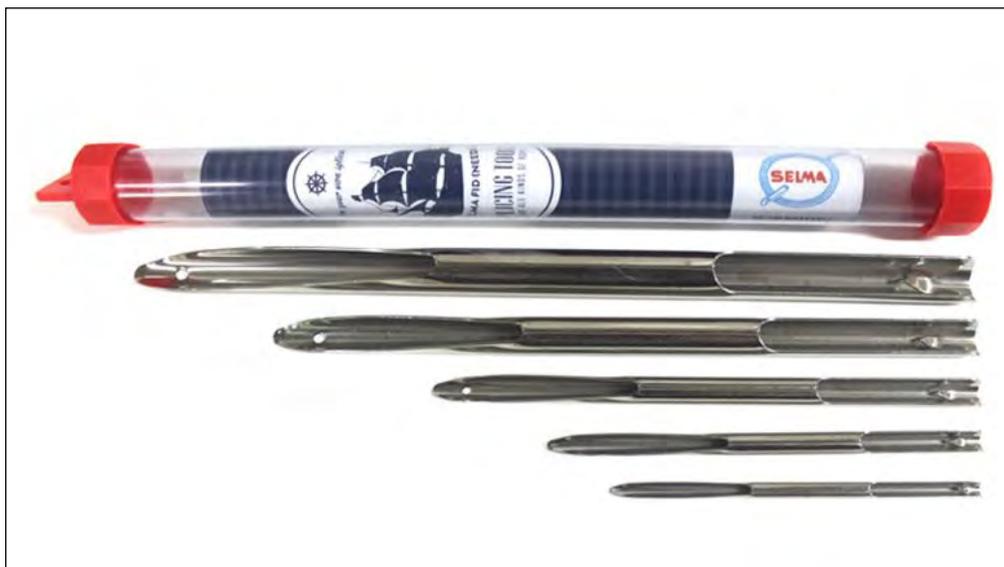
The Selma splicing fids set used on the Dyneema rigging of s/y *DULCINEA*.  
*Photo: Jamie White © 2020*

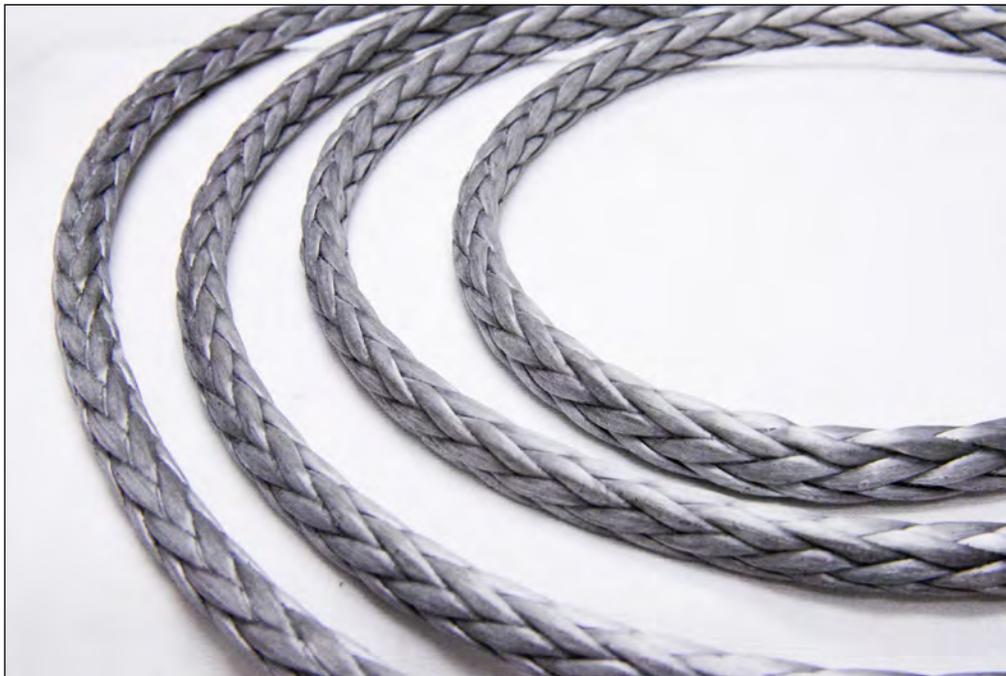
New England Ropes STS-HSR Heat-Set Dyneema.  
 Photo: Jamie White © 2020

It is a synthetic rope made by New England Ropes of HMPE (high modulus polyethylene) fibers which are heat-treated, under tension, at temperatures above 212°F/100°C. This heat-treating imparts extra strength and all but eliminates the creep found in Spectra and other non-heat set Dyneema. The control of creep is something that has plagued HMPE fiber ropes. Creep is a characteristic of HMPE, in that the fiber is sensitive to long-term static loads and will elongate proportionally with time. [New England Ropes Heat Set Dyneema video.](#)

Since NE STS HSR Dyneema should be sized based on similar stretch characteristics of stainless steel wire rather than breaking strength, I purchased 5 mm to replace the 3/16” diameter lower shrouds and backstay and 7 mm to replace the 3/16” cap shrouds and fore stay. For a stretch equivalent chart see [Colligo’s Web Page.](#)

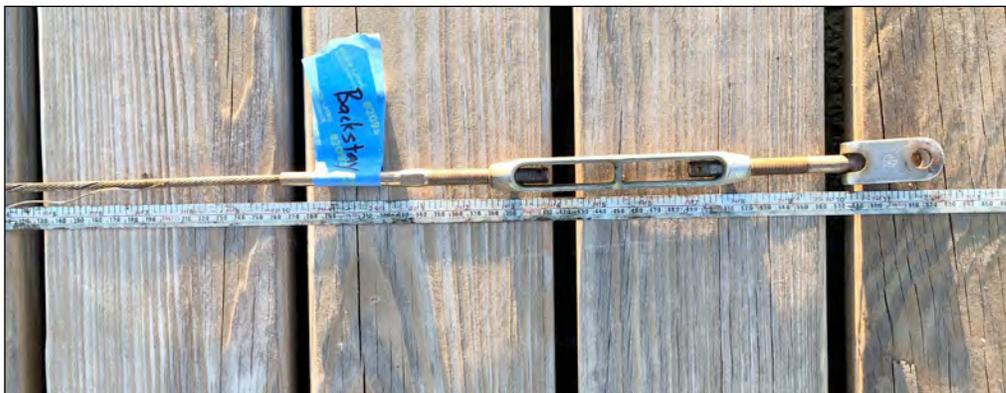
When measuring rigging, I ensure the turnbuckles are set at between 1/3 to 1/2 of their take-up.  
 Photo: Jamie White © 2020

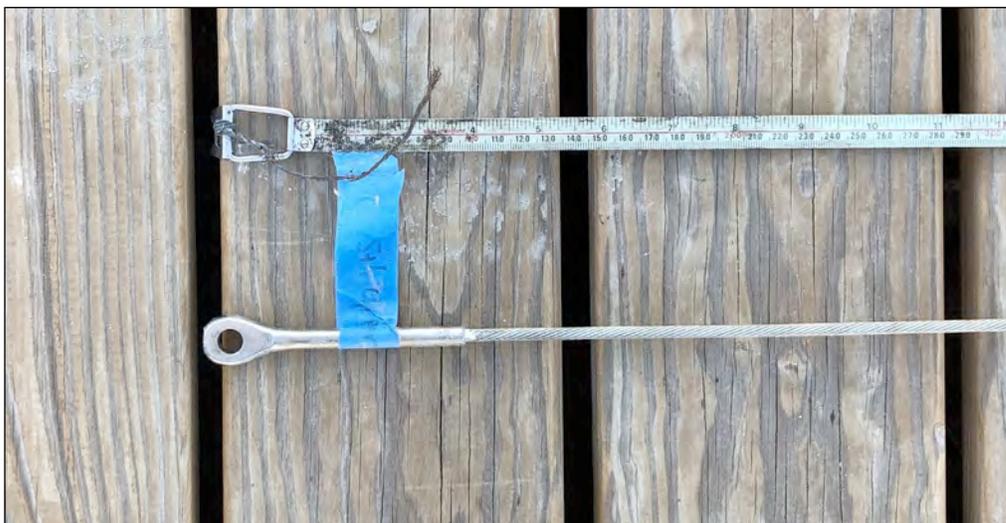
Measurements are taken from the bearing surface of the upper end swage (as in this photo) or the bearing surface of the clevis pin at the lower end turnbuckle toggle (previous photo).  
 Photo: Jamie White © 2020

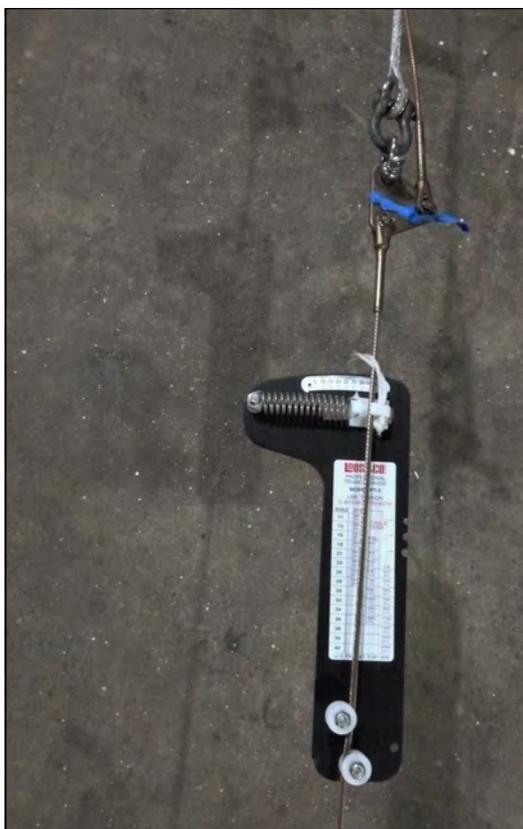
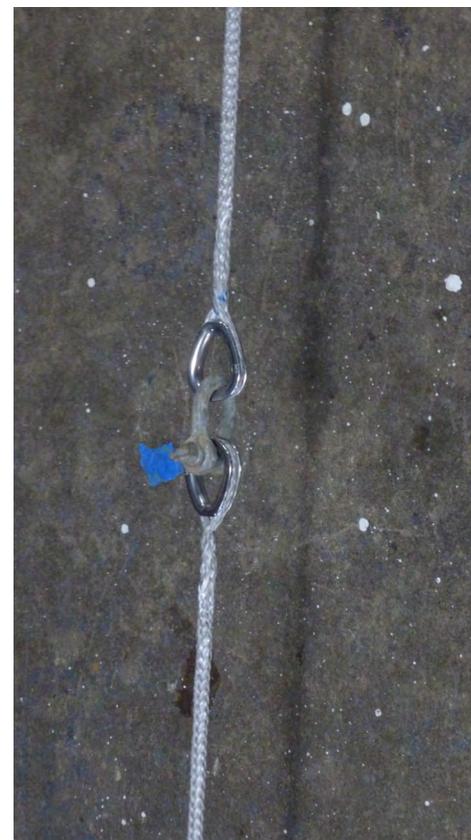
When leading the rig restoration of the brig **SWIFT of IPSWICH**, I had access to a forklift as an anchor point and heavy chain-falls to pre-tension the splices for **DULCINEA's** rigging. Note the use of the Loos Gauge to measure the tension of the Dyneema.

The pre-tension the splices for **DULCINEA's** rigging was to almost 10% of minimum breaking strength to reset the braid.

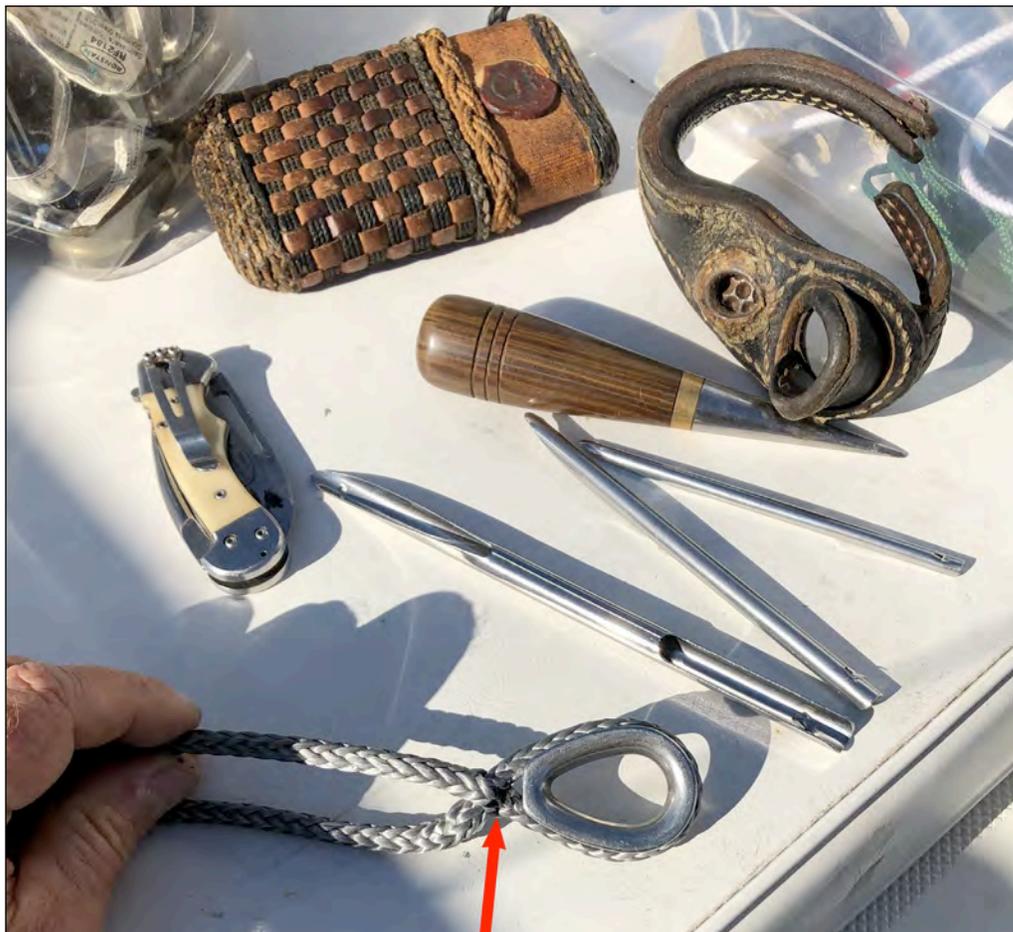
**Step A** - The first pass of a locking Brummel splice. I like to leave the thimble just slack enough that it can later be removed for splicing the other end or for changing the thimble due to damage while in service.

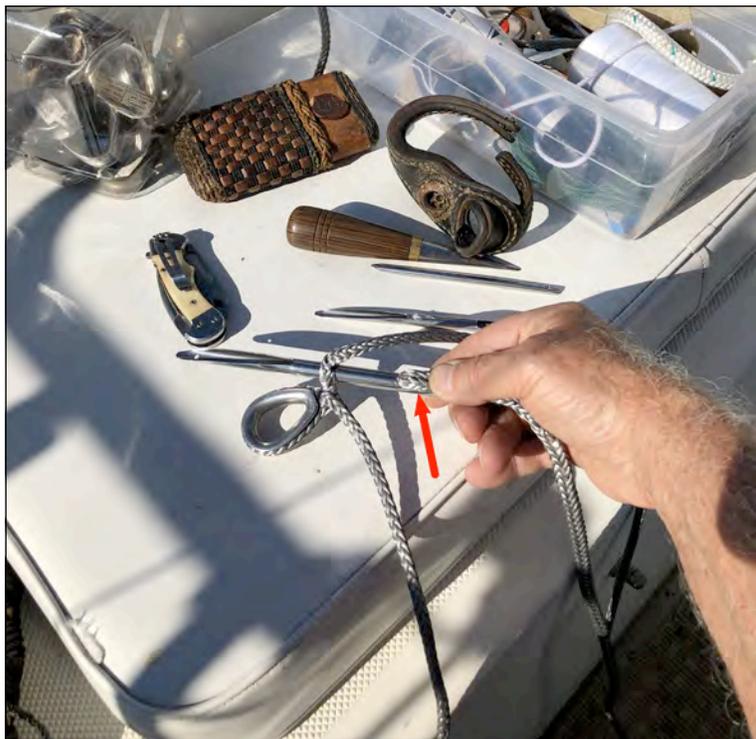
**Step B** - Second or locking pass. I like to enter about a fid width from the first pass. Note I am passing the already spliced eye (standing part) through the working end leg. To do this, I remove the thimble and squeeze the eye into the Selma fid so the spur on the fid grips the eye.  
*Photo: Jamie White © 2020*

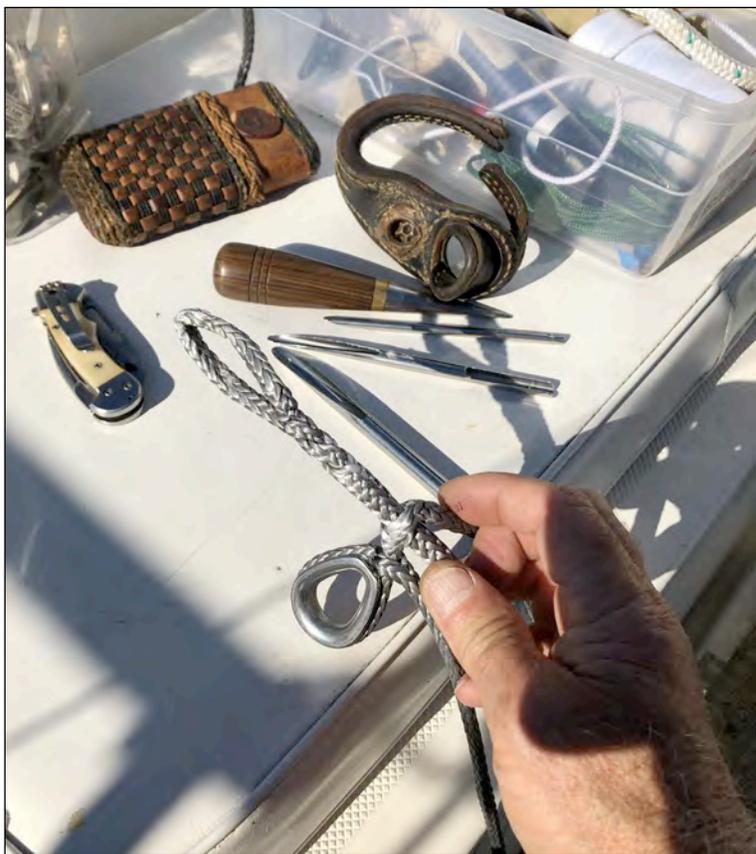
**Step D** - The standing part eye passed through the working end eye. Note the a splice has already been made in the opposite end of the line.  
*Photo: Jamie White © 2020*

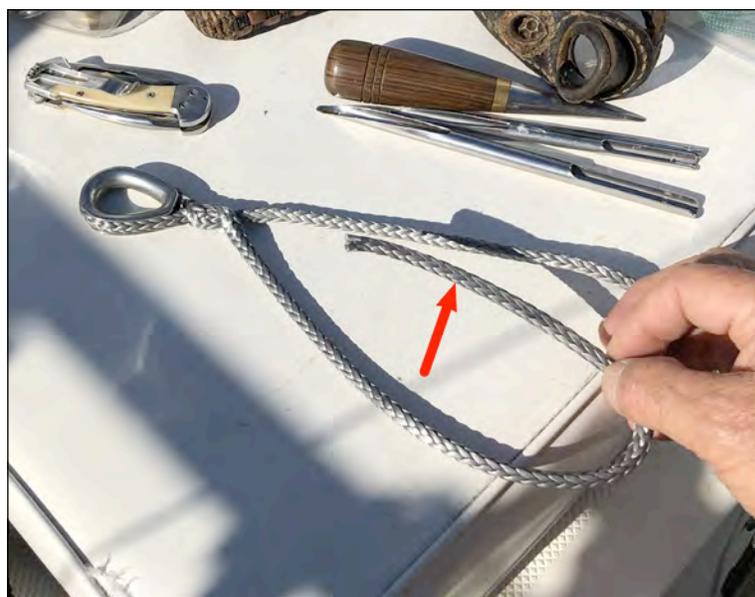
**Step E** - Complete locking Brummel tucks with the tail ready to be passed through the hollow core of the braid. Some riggers like to taper the tail at this point, but I prefer to taper it after passing it through the hollow body of the standing part  
*Photo: Jamie White © 2020*

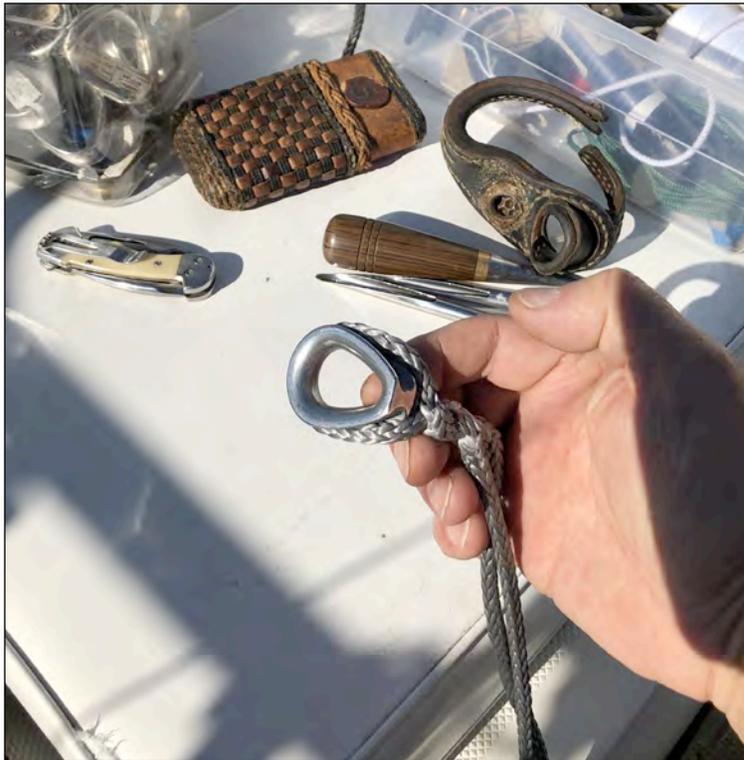
**Step F** - Before going further, I check to make sure the thimble fits into the eye and is able to be removed.  
*Photo: Jamie White © 2020*

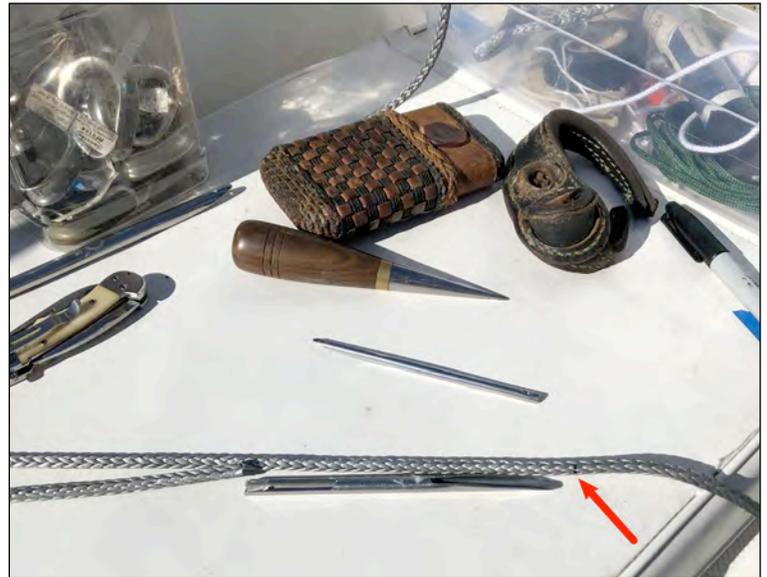
**Step G** - I determine where to exit the hollow body of the standing part one fid length from the end of the tucking strand.  
*Photo: Jamie White © 2020*

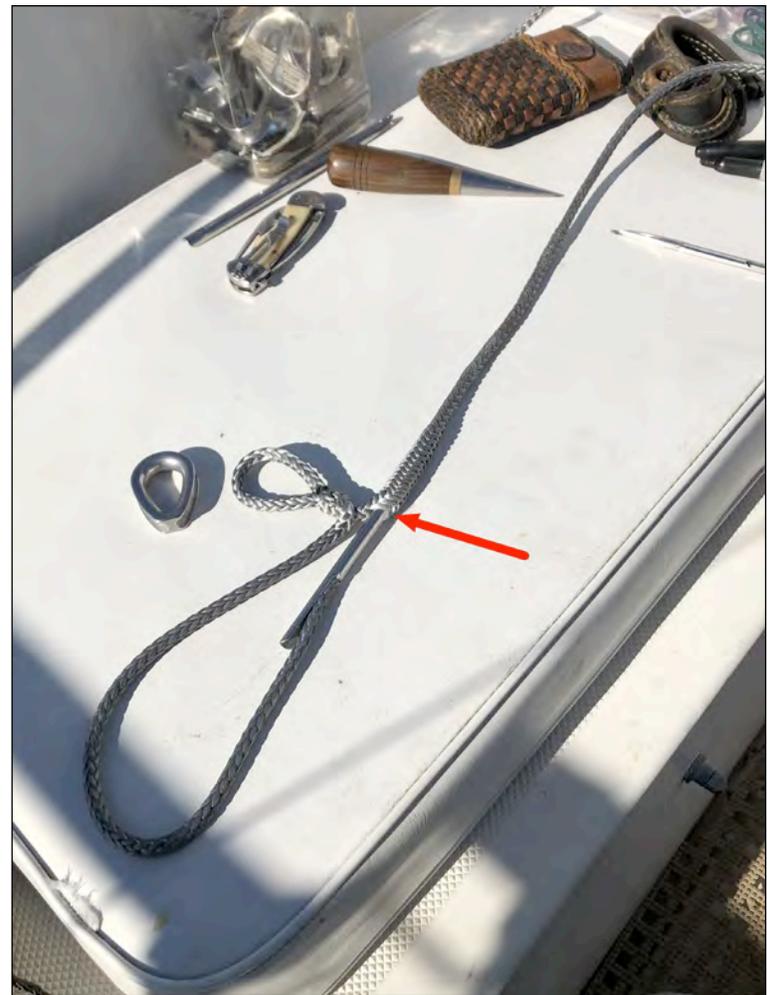
**Step I** - The fid entering the hollow core of the standing part. Pull just enough tail through to leave a small bight at the thimble.  
**Do not pull the tail tight just yet.**  
*Photo: Jamie White © 2020*

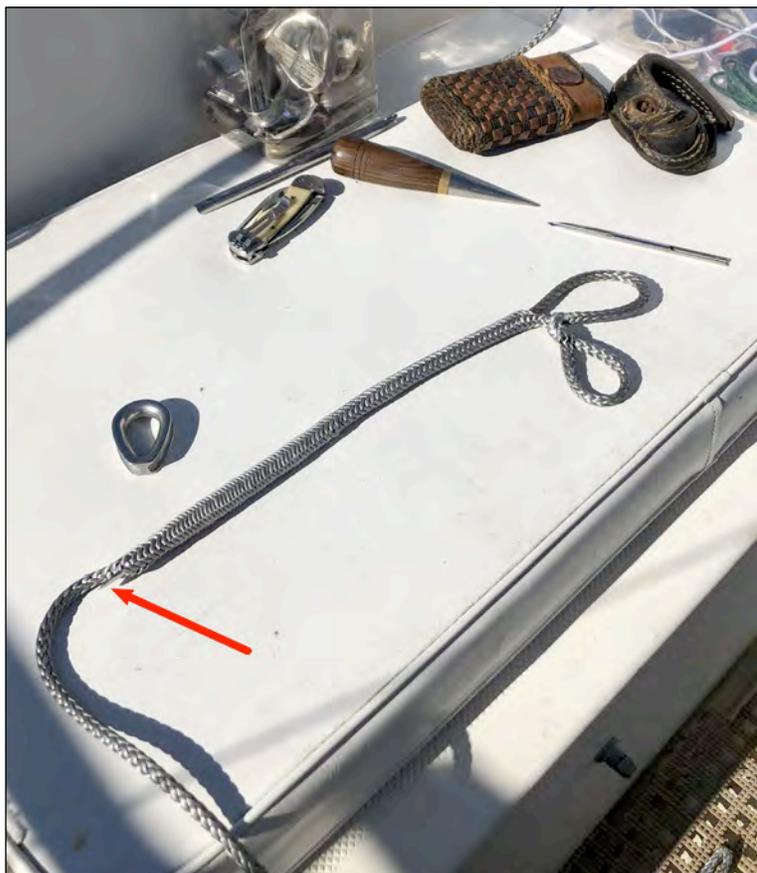
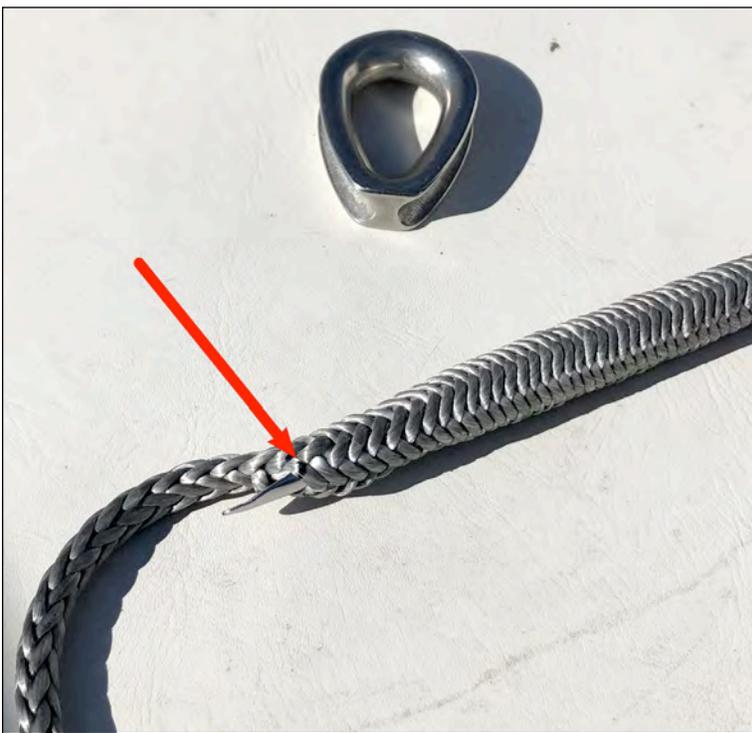
**Step J** - The fid exiting at the one and a half fid length mark.  
*Photo: Jamie White © 2020*

**Step K**- The fid exiting at the one and a half fid length mark.  
*Photo: Jamie White © 2020*

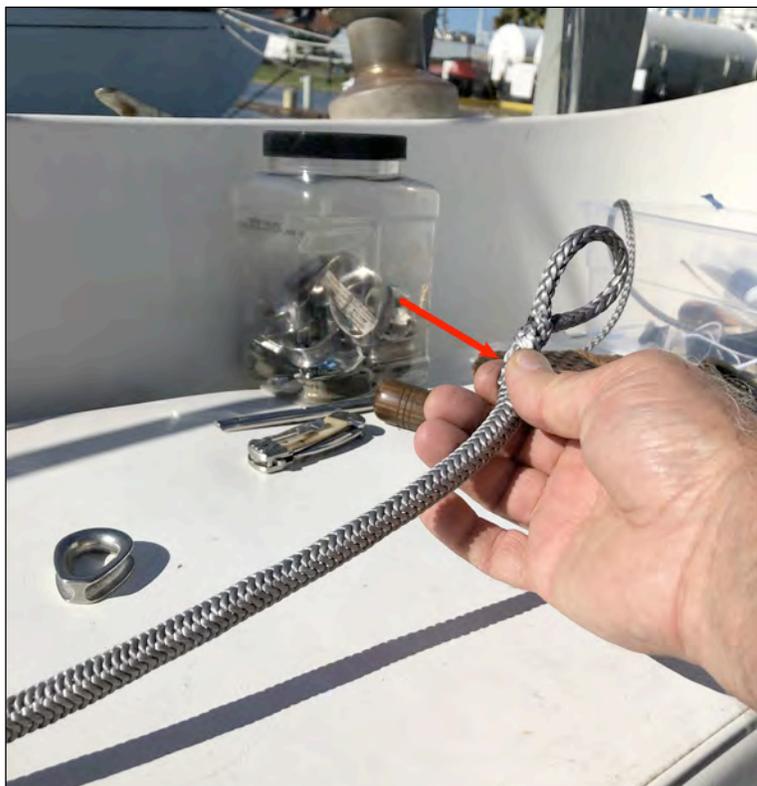
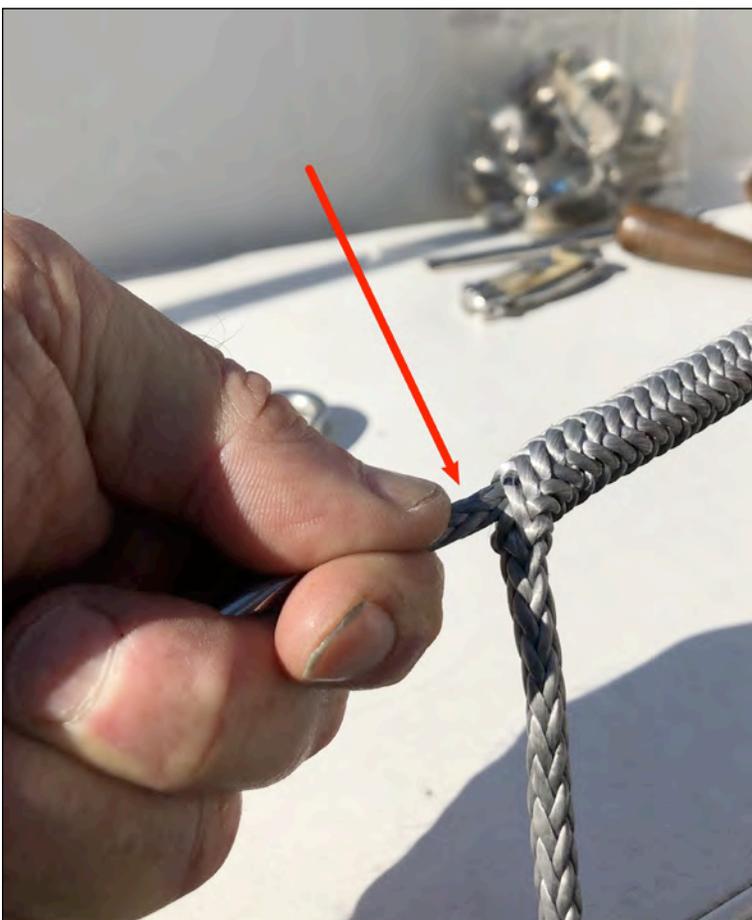
**Step L** - Pinch the Brummel cross over where the tail entered the body and only then pull the tail tight. Occasionally some gentle massaging of the pass through is necessary.  
*Photo: Jamie White © 2020*

**Step M** - Pinch the Brummel cross over where the tail entered the body and only then pull the tail tight. Occasionally some gentle massaging of the pass through is necessary.  
*Photo: Jamie White © 2020*

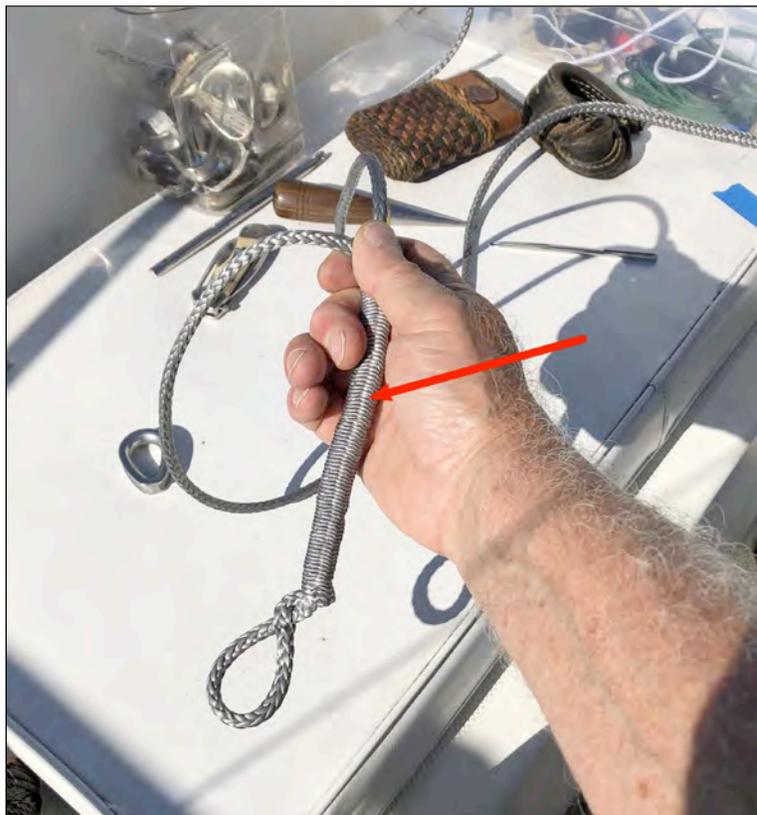
**Step N** - Slide the standing part cover down the tail until there is about 9" or about 1/3 of the tail exposed depending on line diameter. This 9" section will be tapered before being drawn back into the standing part braid. This taper will ensure that the splice tapers nicely into the standing part. A lump at the termination of the splice will cause a weakness in the finished splice.
