# Flicka Friends

*Issue # 71*

*Refitting s/y DULCINEA*

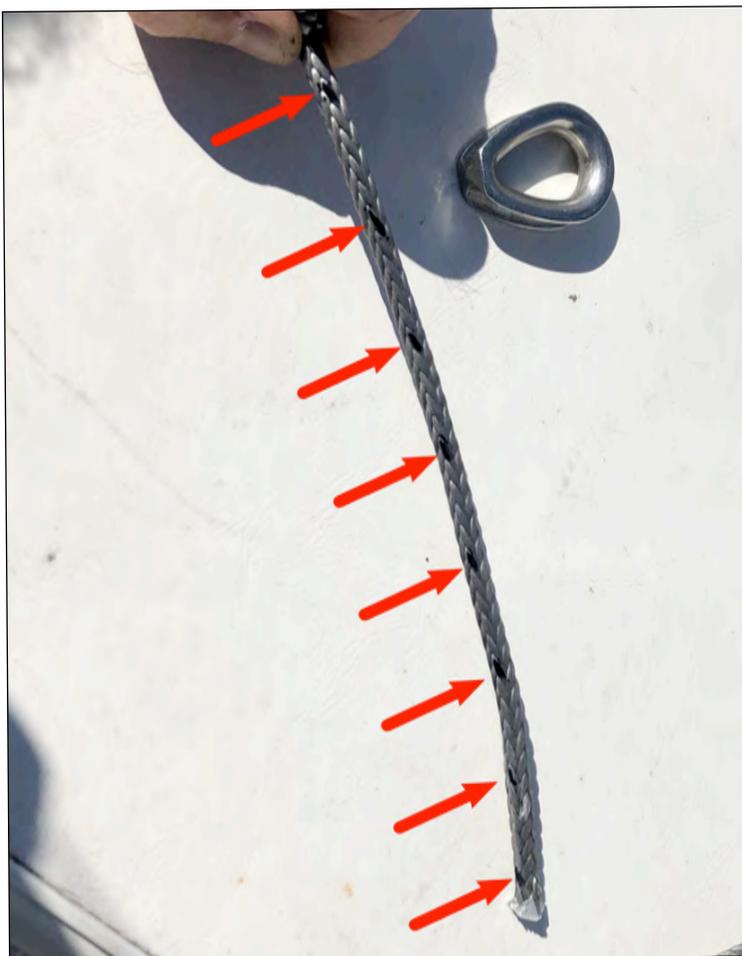
**Step O** - I mark every fifth yarn which will be pulled out and cut off to form a gentle taper.

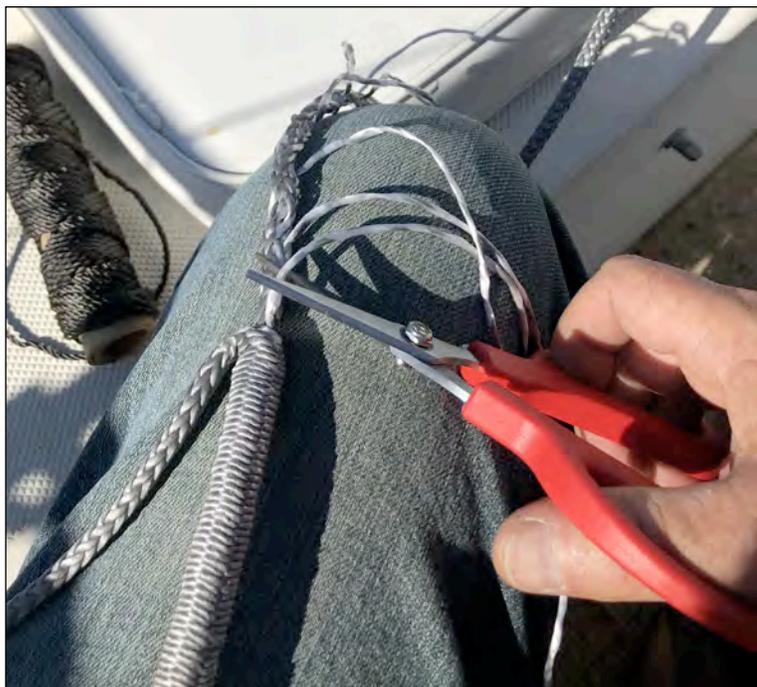
**Step P** - Trimming the pulled out yarns of the taper. I recommend a ceramic knife or serrated edge scissors designed to cut high-tech rope. I am using Ronstan splicing scissors from [West Marine](http://www.westmarine.com).

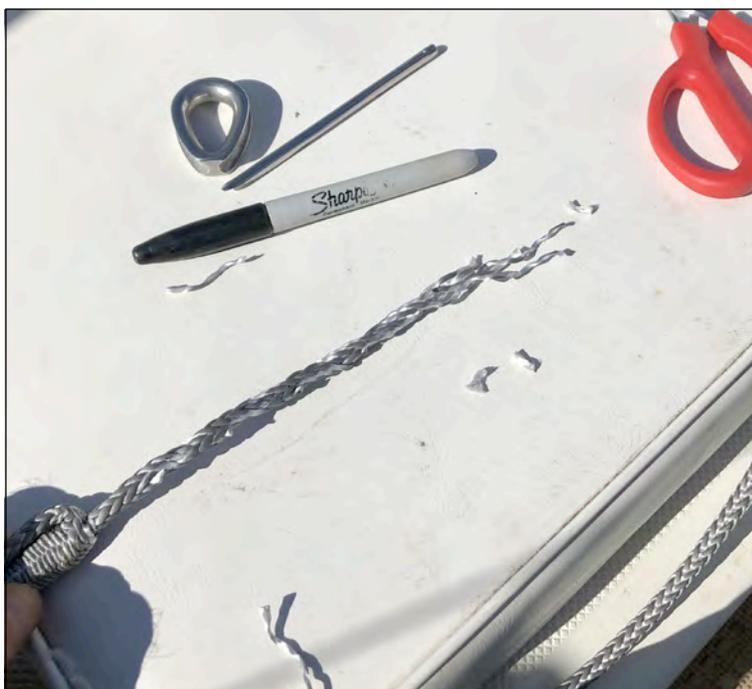
**Step Q** - Tail tapered and trimmed – ready to be milked back into body of standing part.

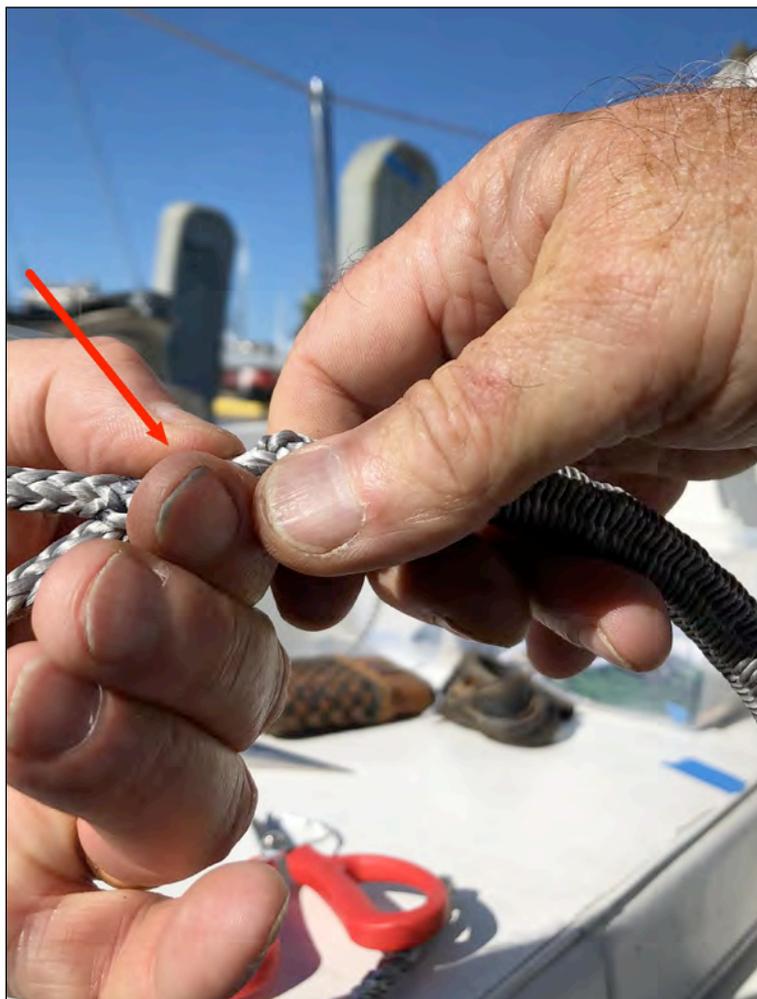
**Step R** - Hold the splice at the initial Brummel entry and milk the bunched up braid back over the tail. The tail will automatically disappear inside the standing during this operation.  
*Photo: Jamie White © 2020*

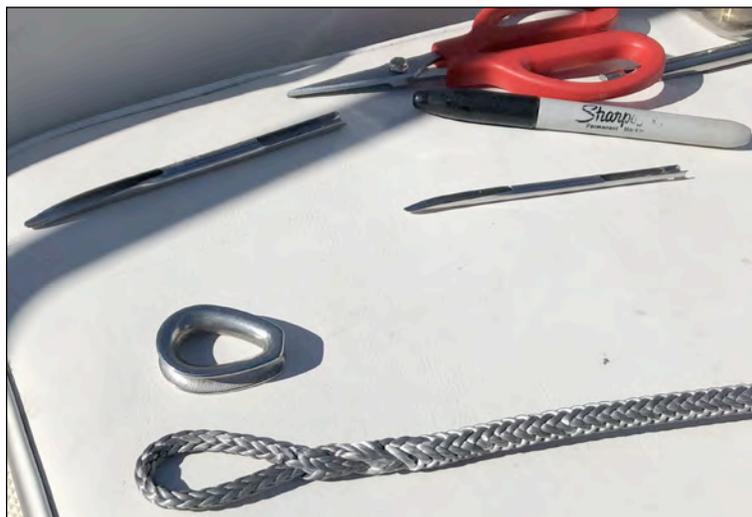
**Step T** - Once inserted before being pre-tensioned using a come-a-long or cockpit sheet winches.  
*Photo: Jamie White © 2020*

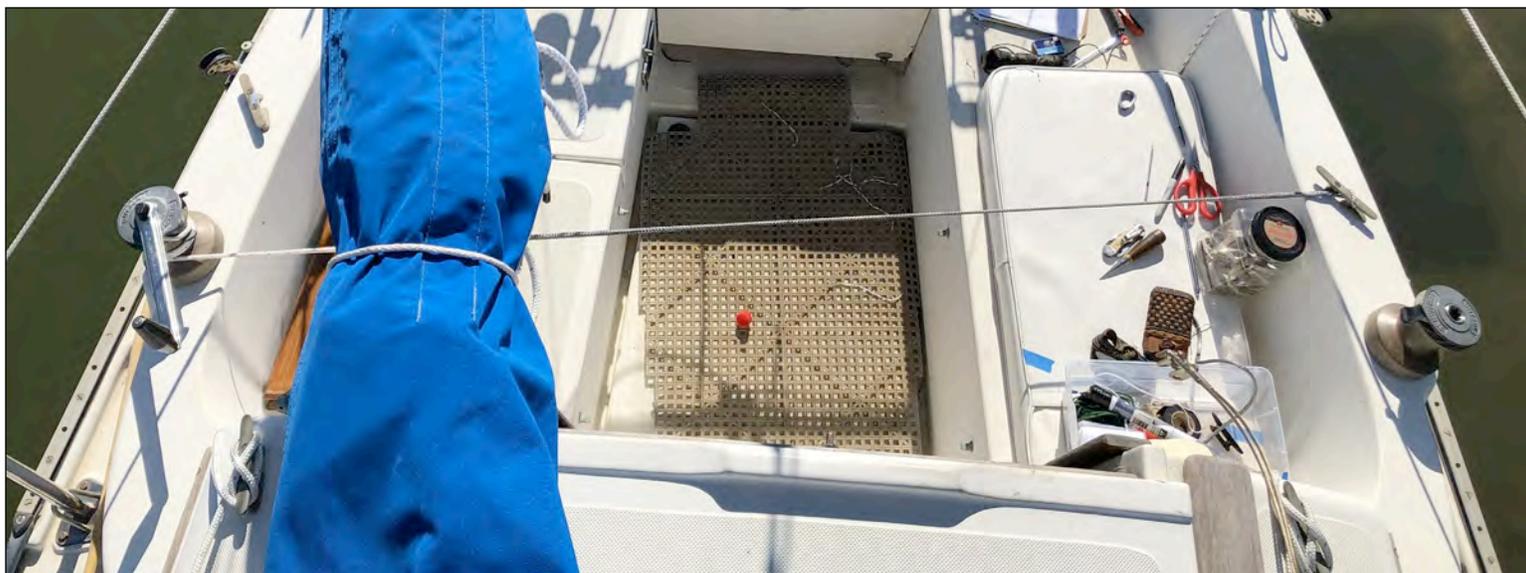
**Step U** - When heat stretched Dyneema is spliced, the braid is upset at the bury portion of the splice. This needs to be re-stretched to set the braid before you put it in service to avoid any elongation of the line after installation. I used the jib sheet winch in the cockpit to re-stretch the splices to good effect. Be sure to check that cleats and winches are soundly secured and backing plates are installed to prevent them from being wrenched out.  
*Photo: Jamie White © 2020*

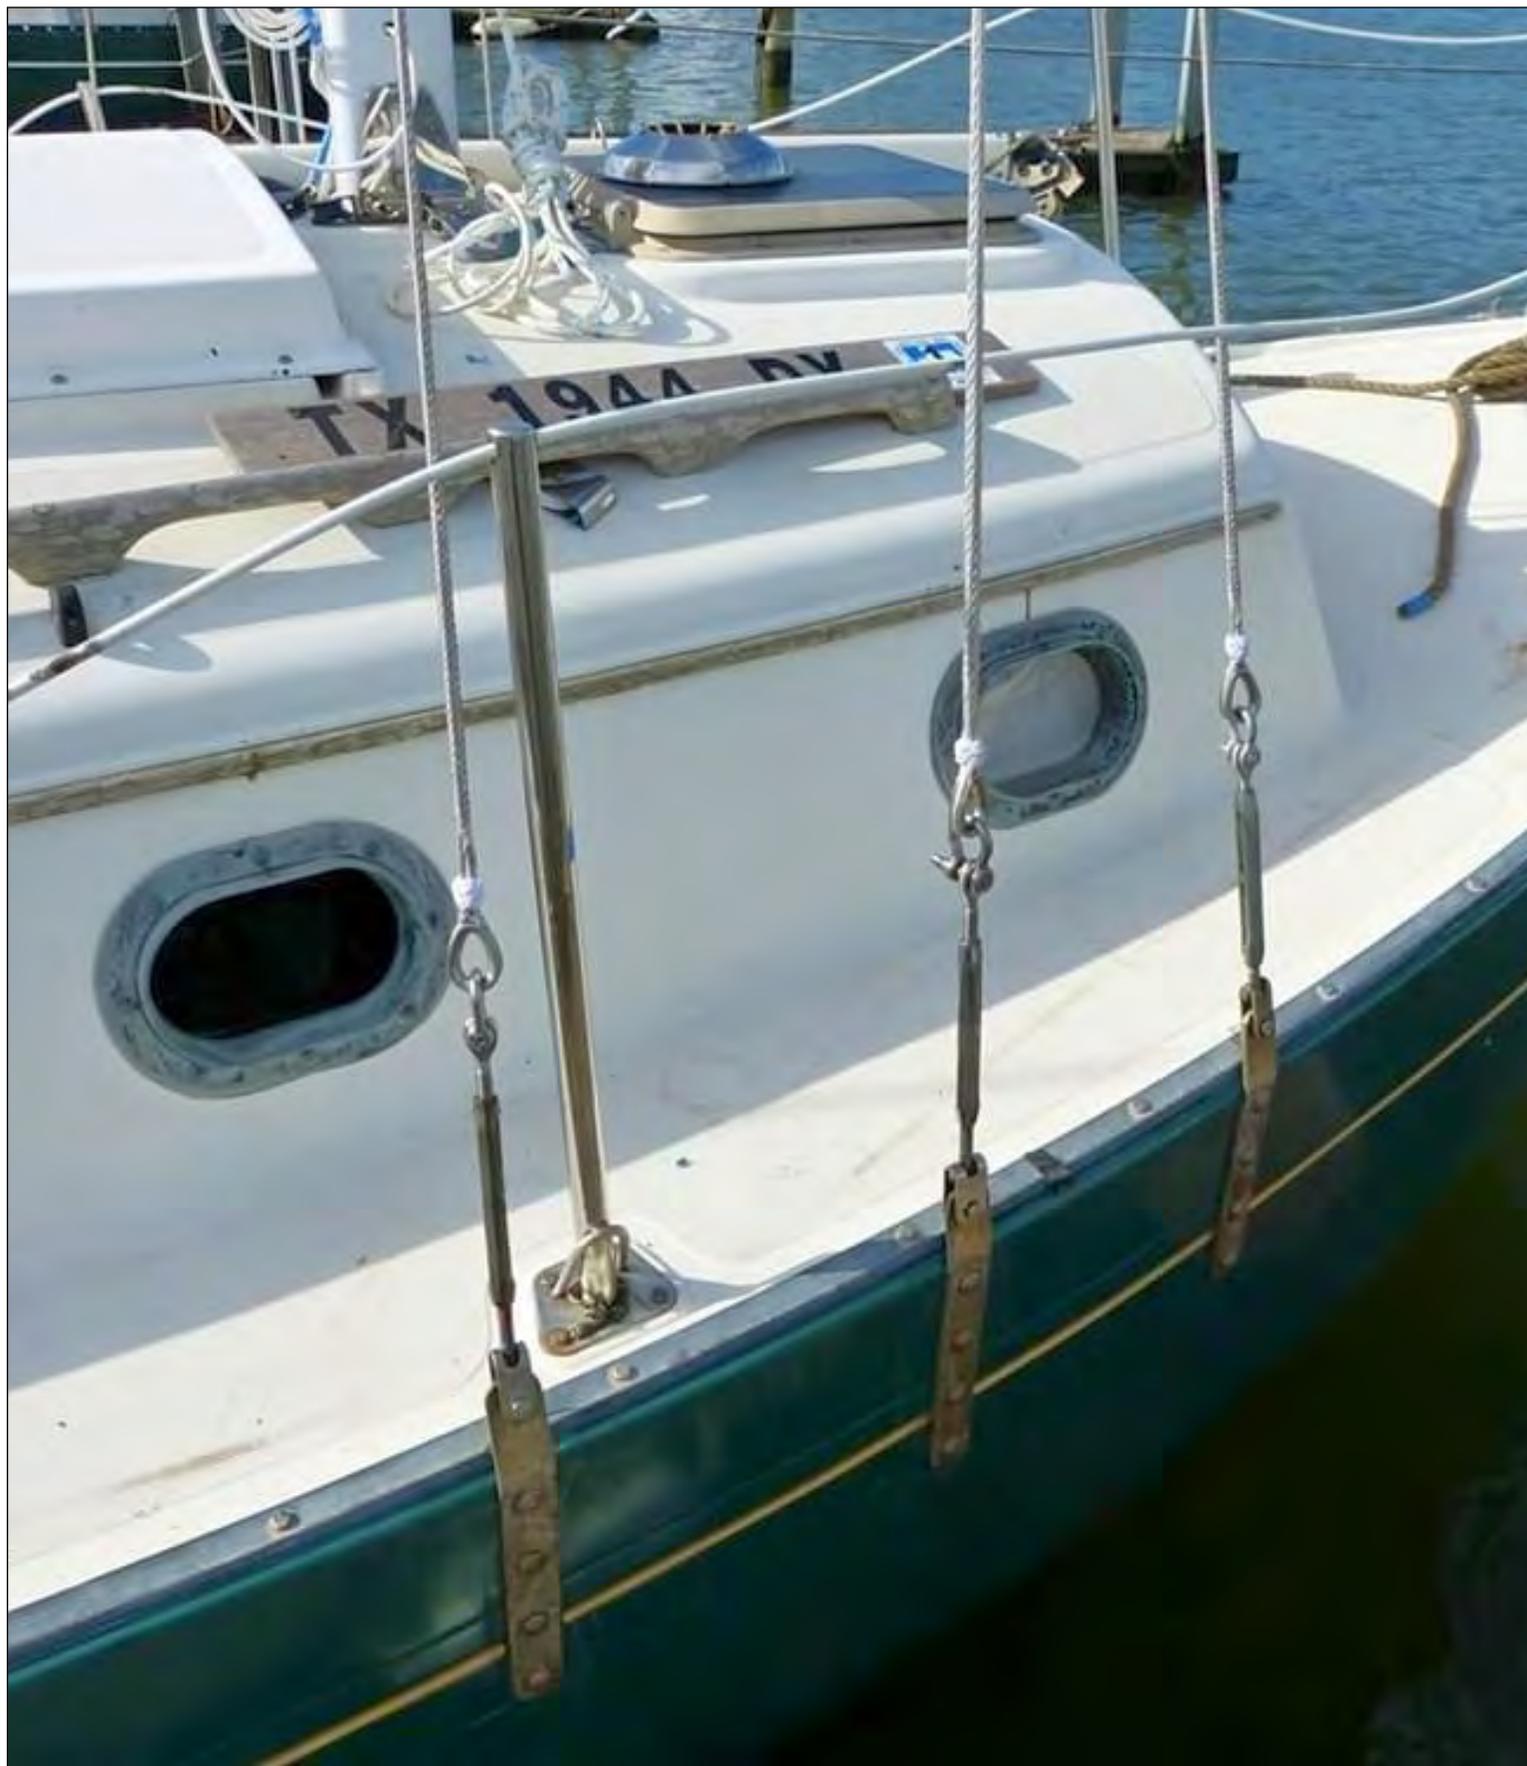
The finished splices with a 4x3 Turks Head as an embellishment.  
Note – I will mouse all shackles and dog all turnbuckles after the rig settles in after the initial couple of sails.  
*Photo: Jamie White © 2020*

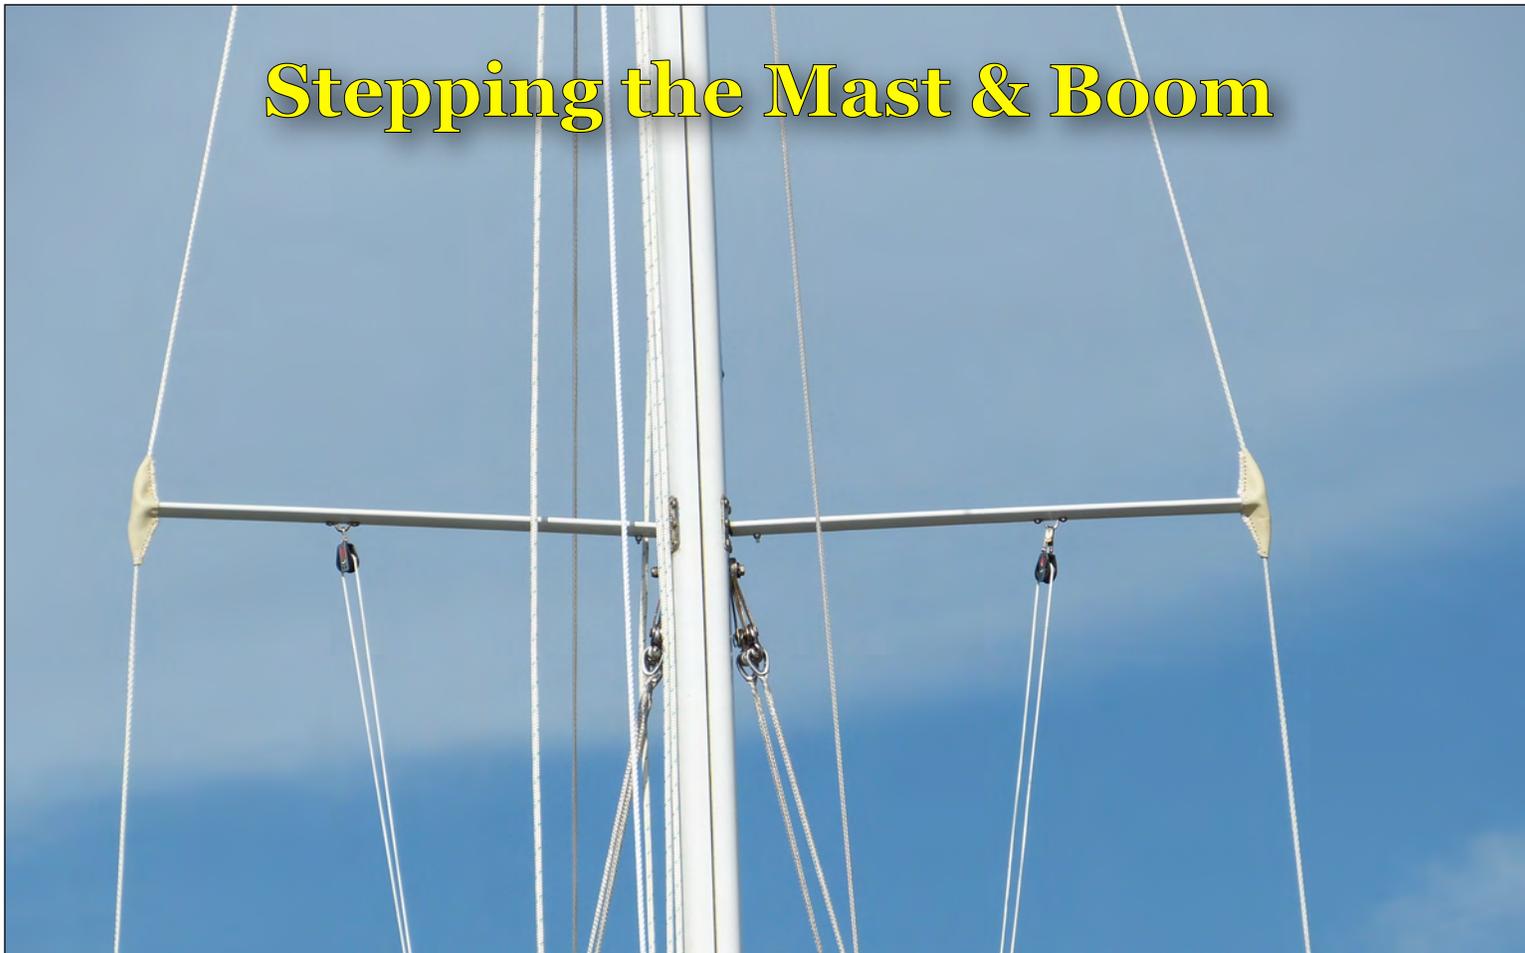
Detail of spreader boots and the new Dyneema rigging aboard s/y *DULCINEA*.

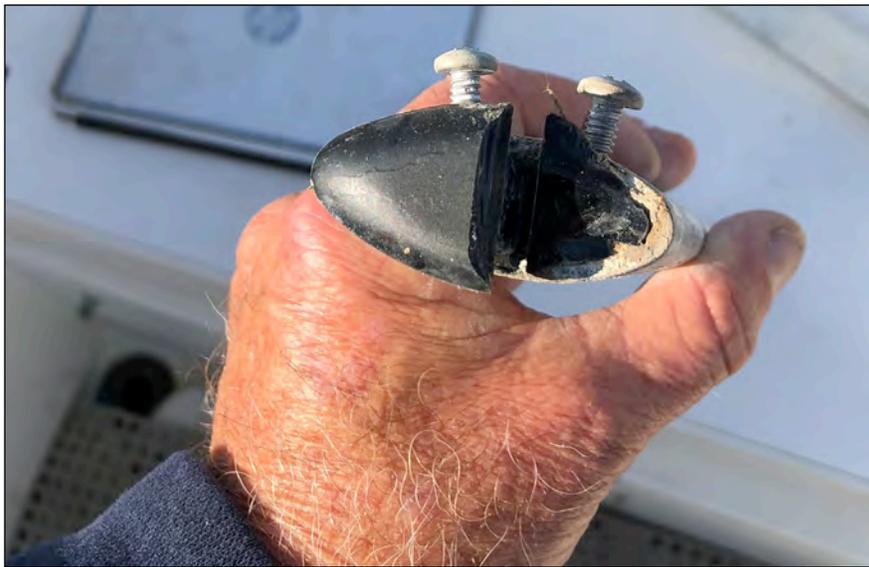
Both spreader end caps were broken.  
*Photo: Jamie White © 2020*

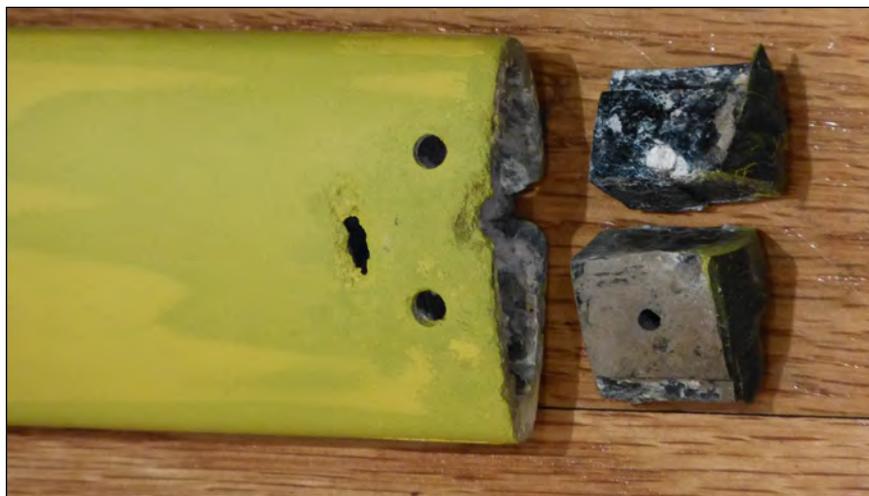
There was corrosion of the aluminum spreader ends  
*Photo: Jamie White © 2020*

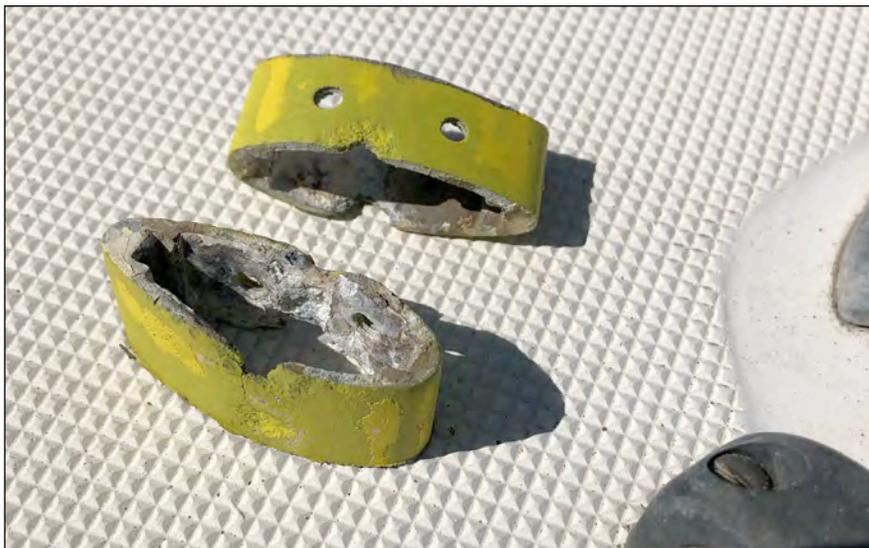
I decided to trim the last 1/2" off the spreaders and built it back up using two-part marine epoxy filler.  
*Photo: Jamie White © 2020*

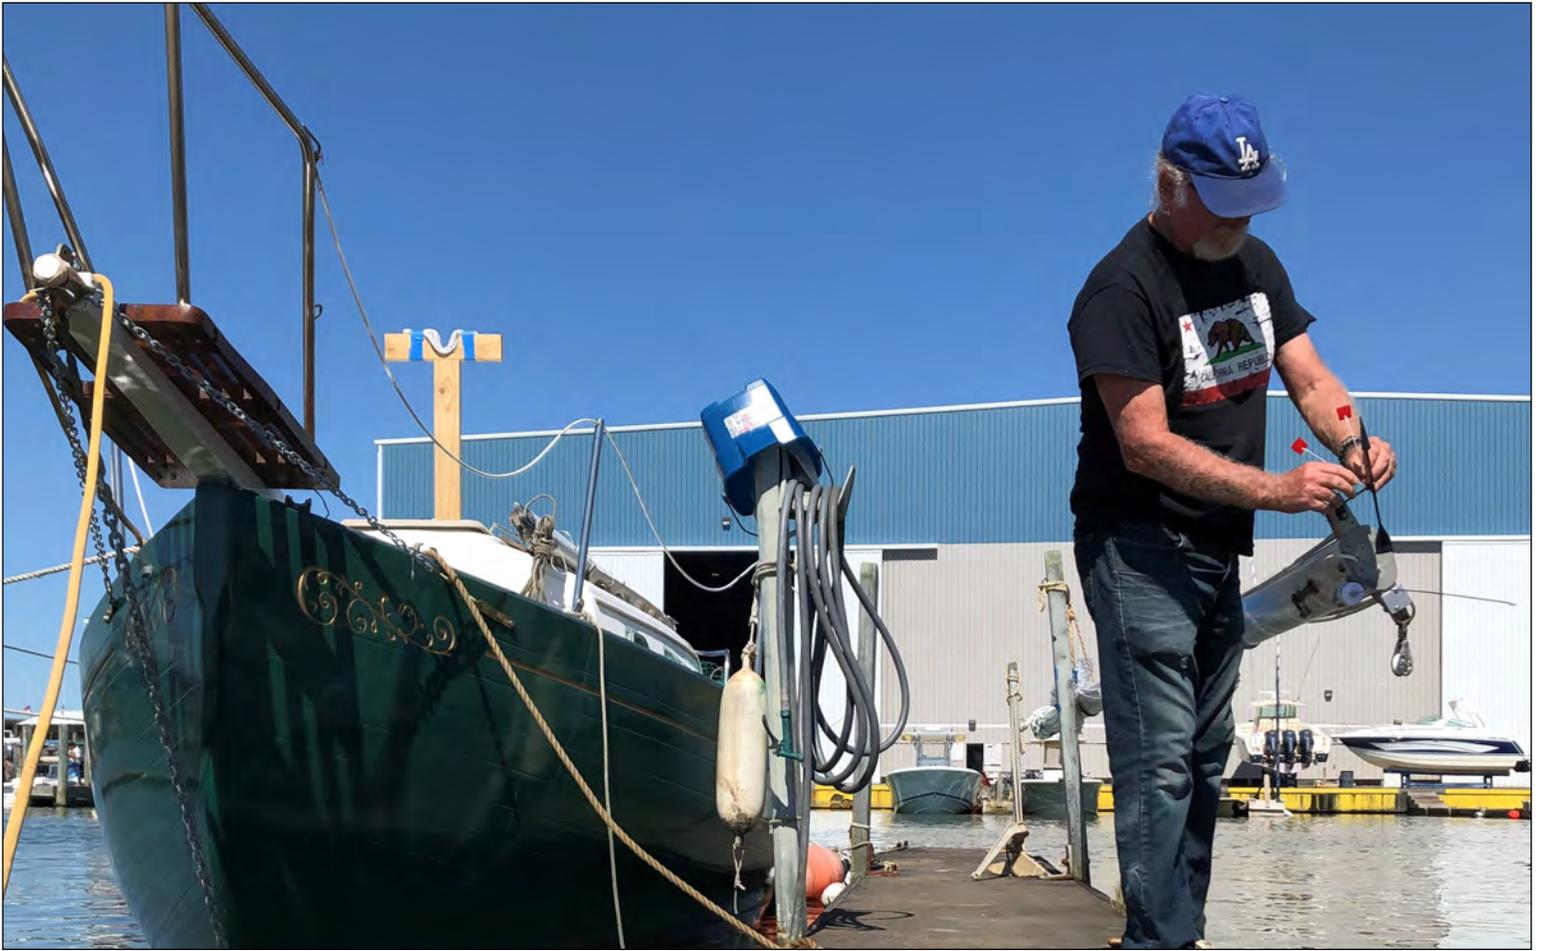
Adjusting the arms of the Windex.  
*Photo: Ruth Downes © 2020*

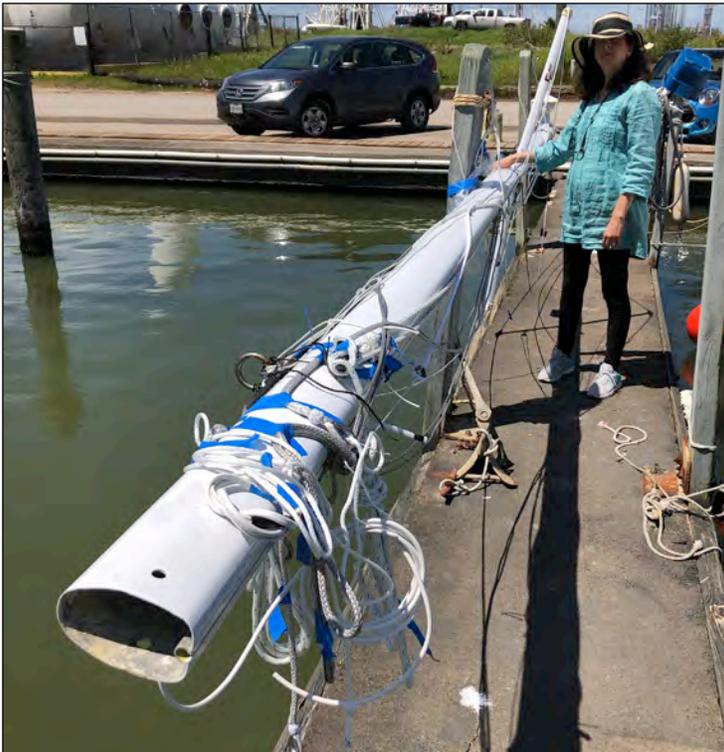
Mast dressed and ready to moved aboard.  
*Photo: Jamie White © 2020*

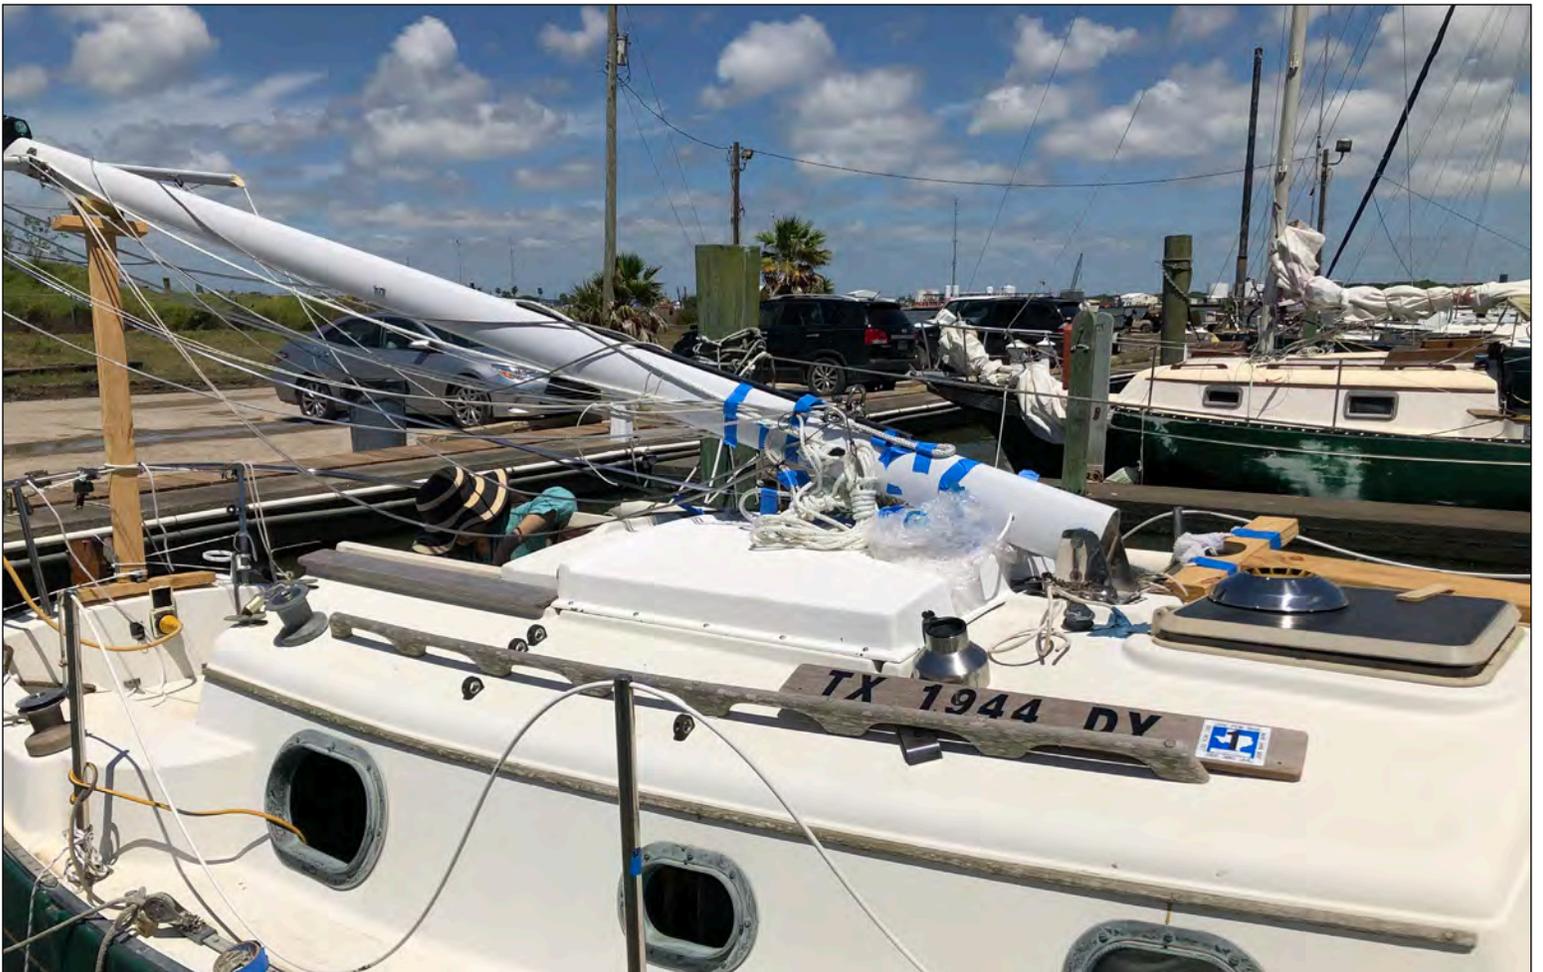
Preparing the mast and rigging for hoisting.

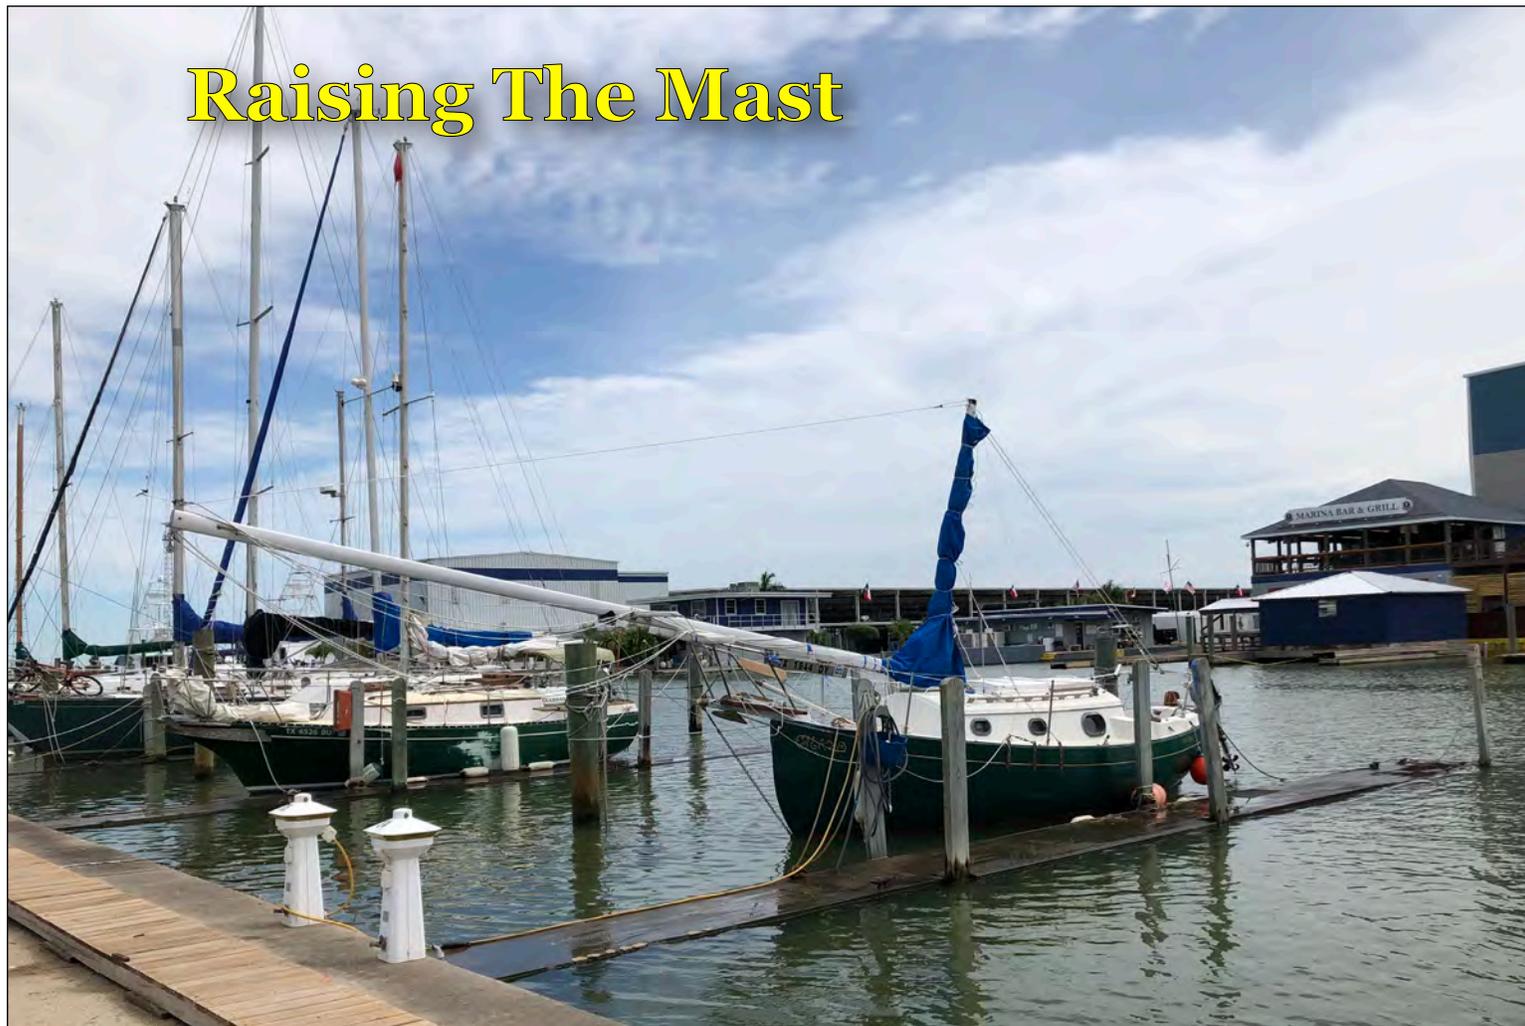
Mast resting on the bow pulpit.

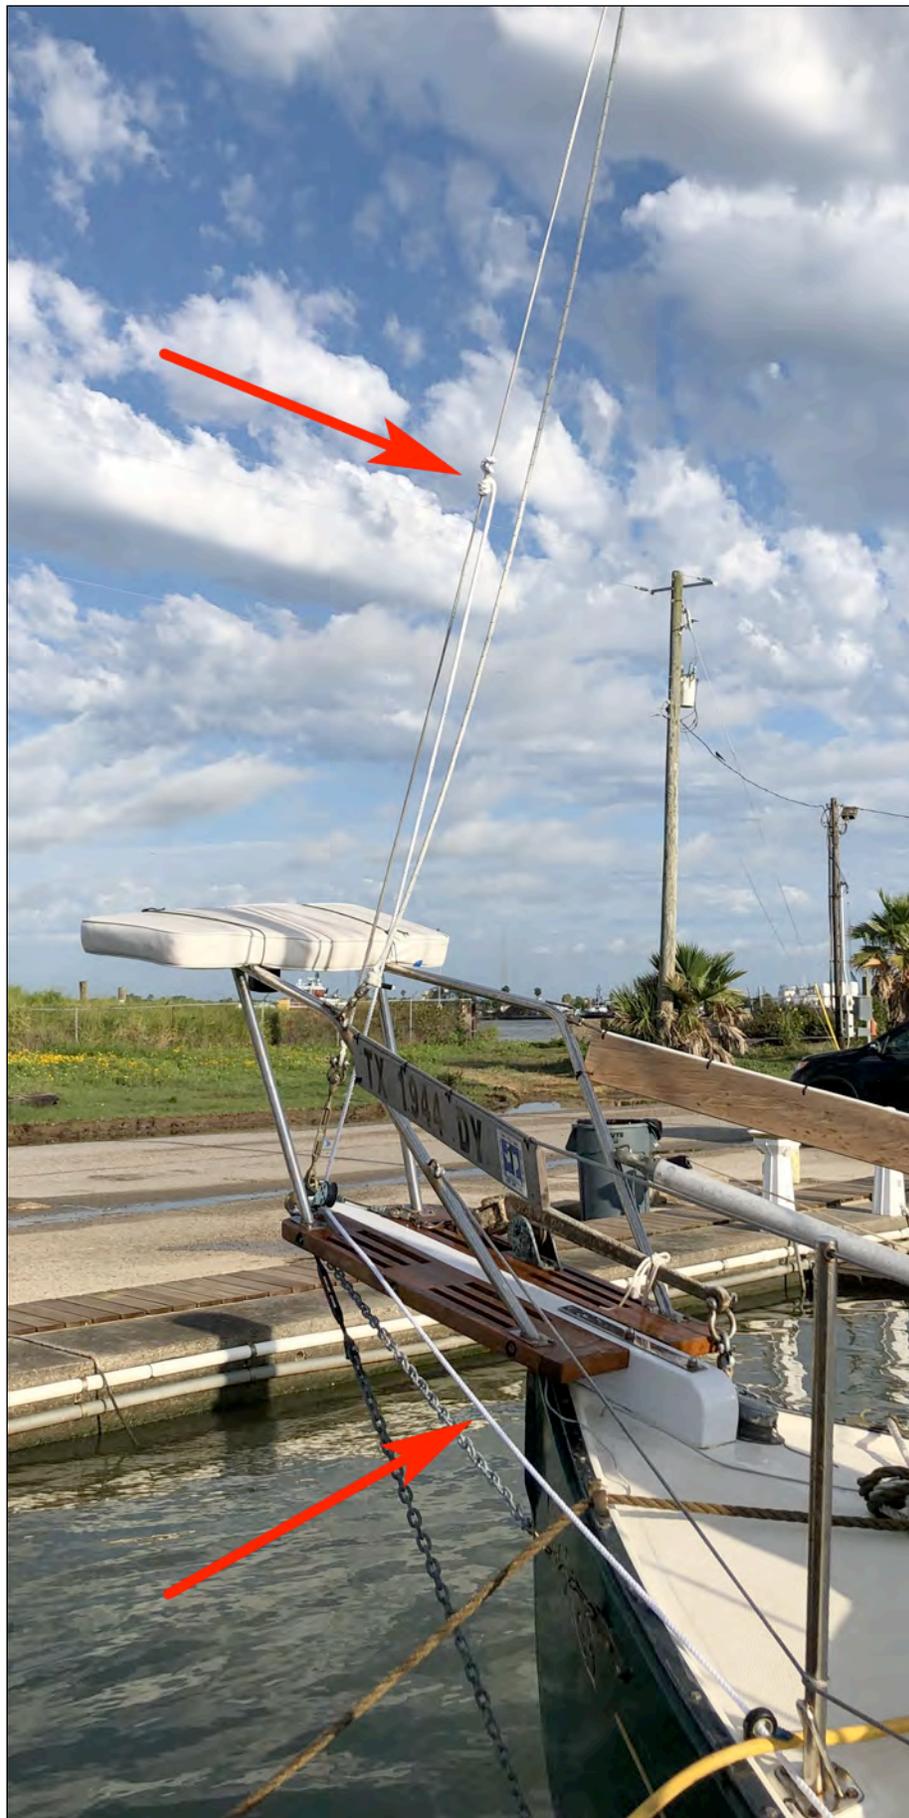
Jib downhaul bent on to jib stay.  
 Photo: Jamie White © 2020

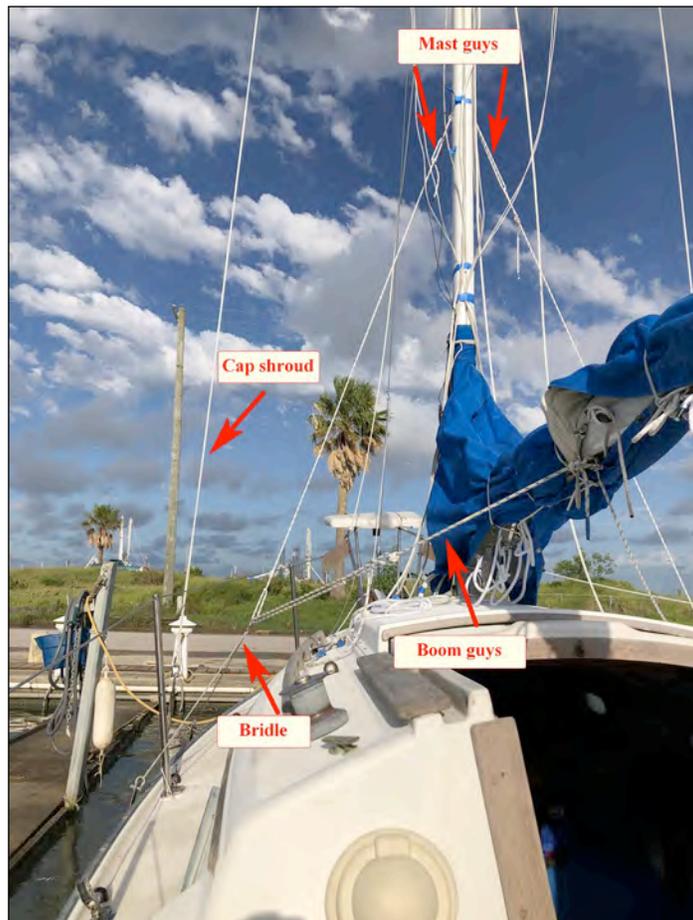
Bruce Bingham's main sheet mid-boom bail modification blends well with using mid-boom stabilizing guys instead of rigging the guys at the end of the boom.

6. Fit a bail on the boom in the position noted in Bruce's book, showing how he set up the mainsheet arrangement on his Flicka **SABRINA**. (I plan on re-rigging **DULCINEA's** mainsheet to utilize this mid boom bail – an added benefit!). Rig your boom stabilizing guys from this mid boom bail instead of from the end of the boom forward to the bridle (next to the mast padeye lateral guys). This is a much better staying angle and helps with controlling the mast in windy conditions.

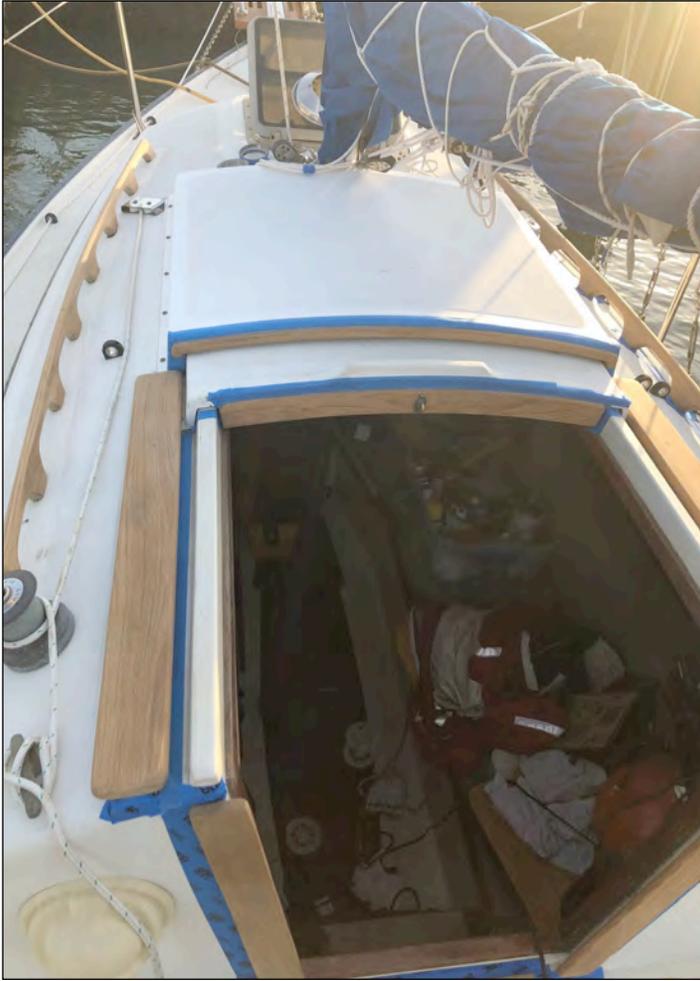
Taping the teak for refinishing.  
*Photo: Jamie White © 2020*

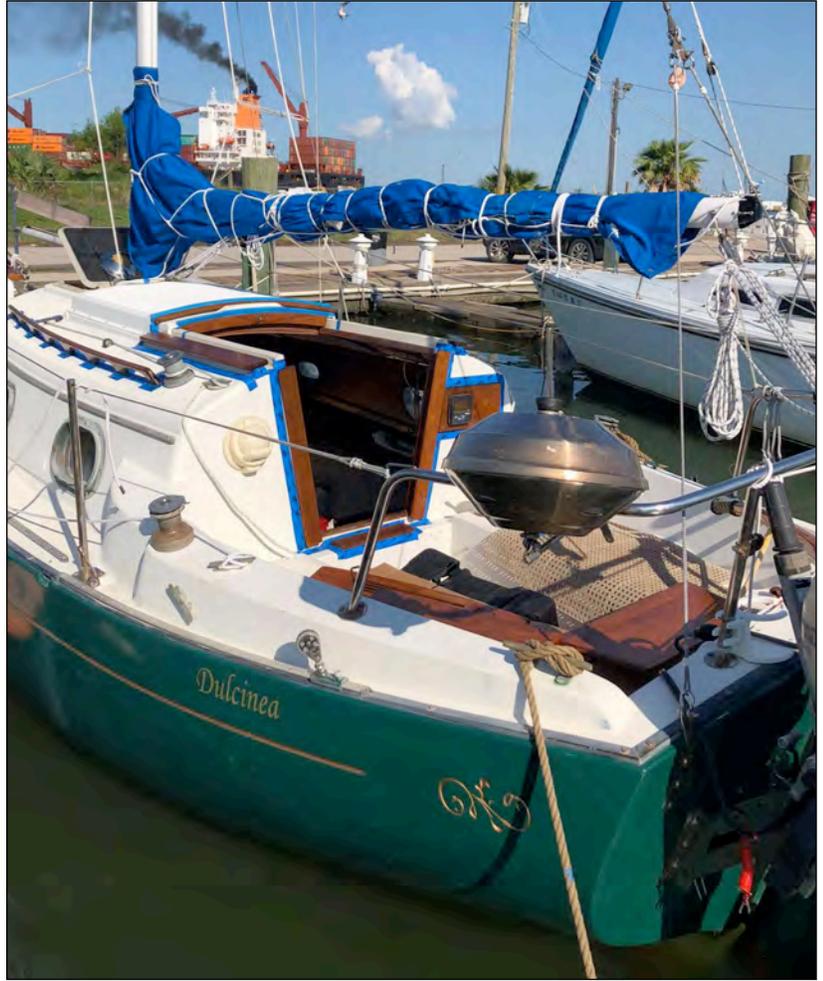
The teak is looking much better.  
*Photo: Jamie White © 2020*

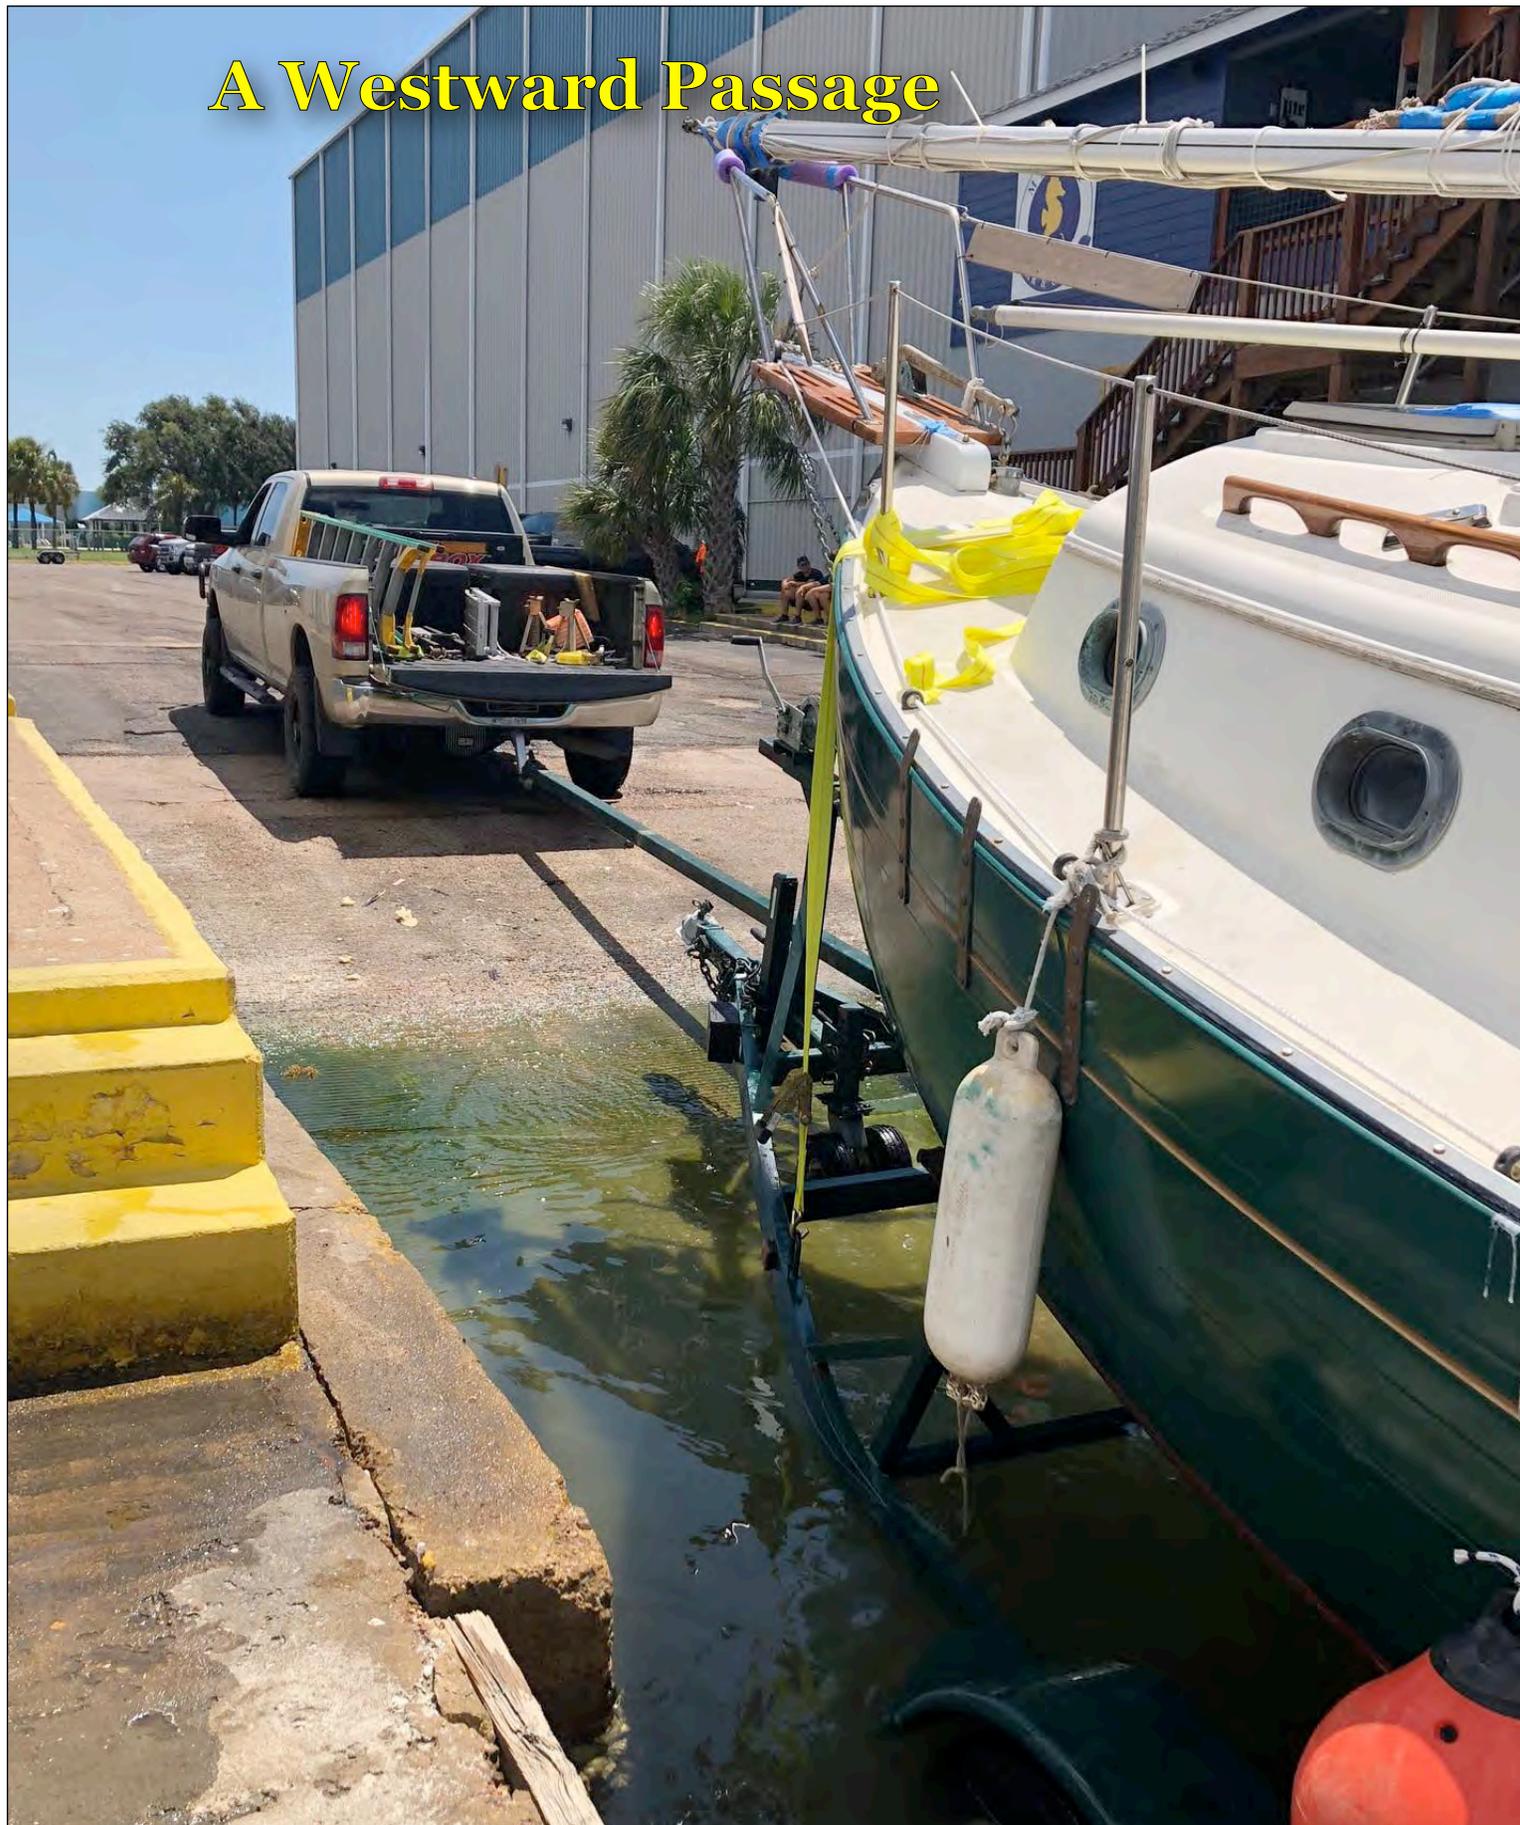
The trailer extension allows the trailer to get under s/y *DULCINEA* for loading.  
*Photo: Jamie White © 2020*

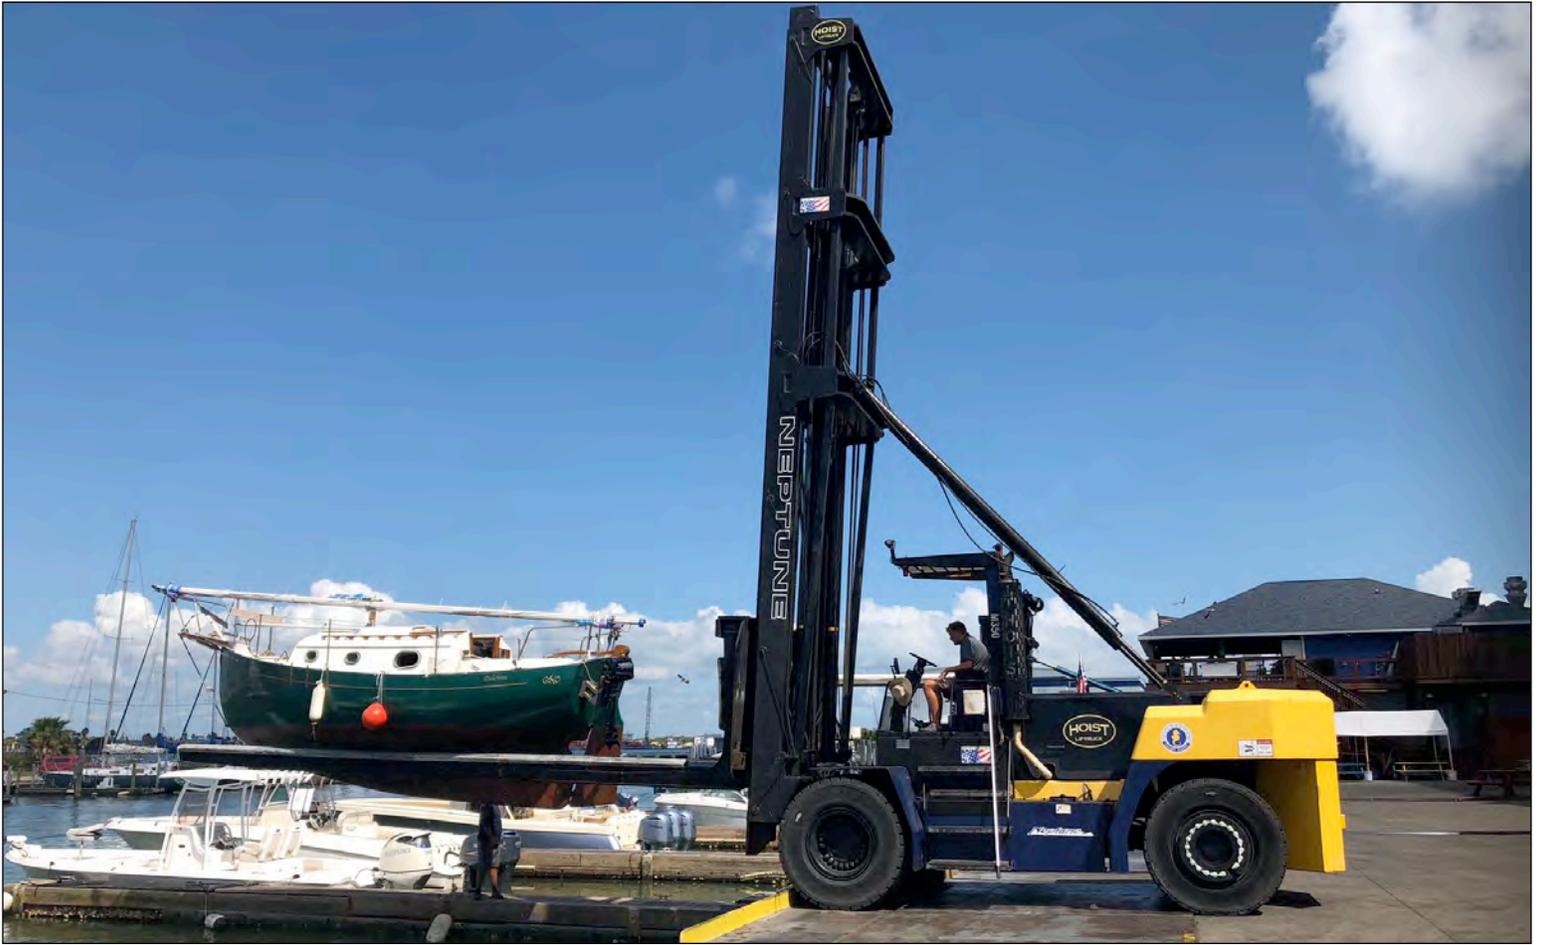
Lifting *DULCINEA* to attempt loading onto a Triad Trailer.  
*Photo: Jamie White © 2020*
