# Flicka Friends

*Issue # 71*

*Refitting s/y DULCINEA*

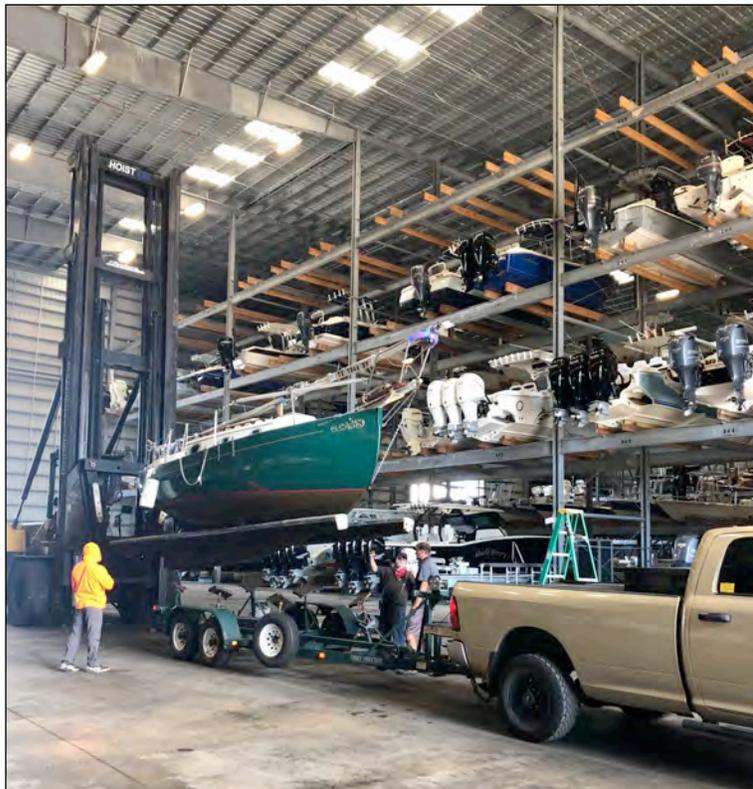
Placing the Flicka onto the trailer wasn't possible.  
*Photo: Jamie White © 2020*

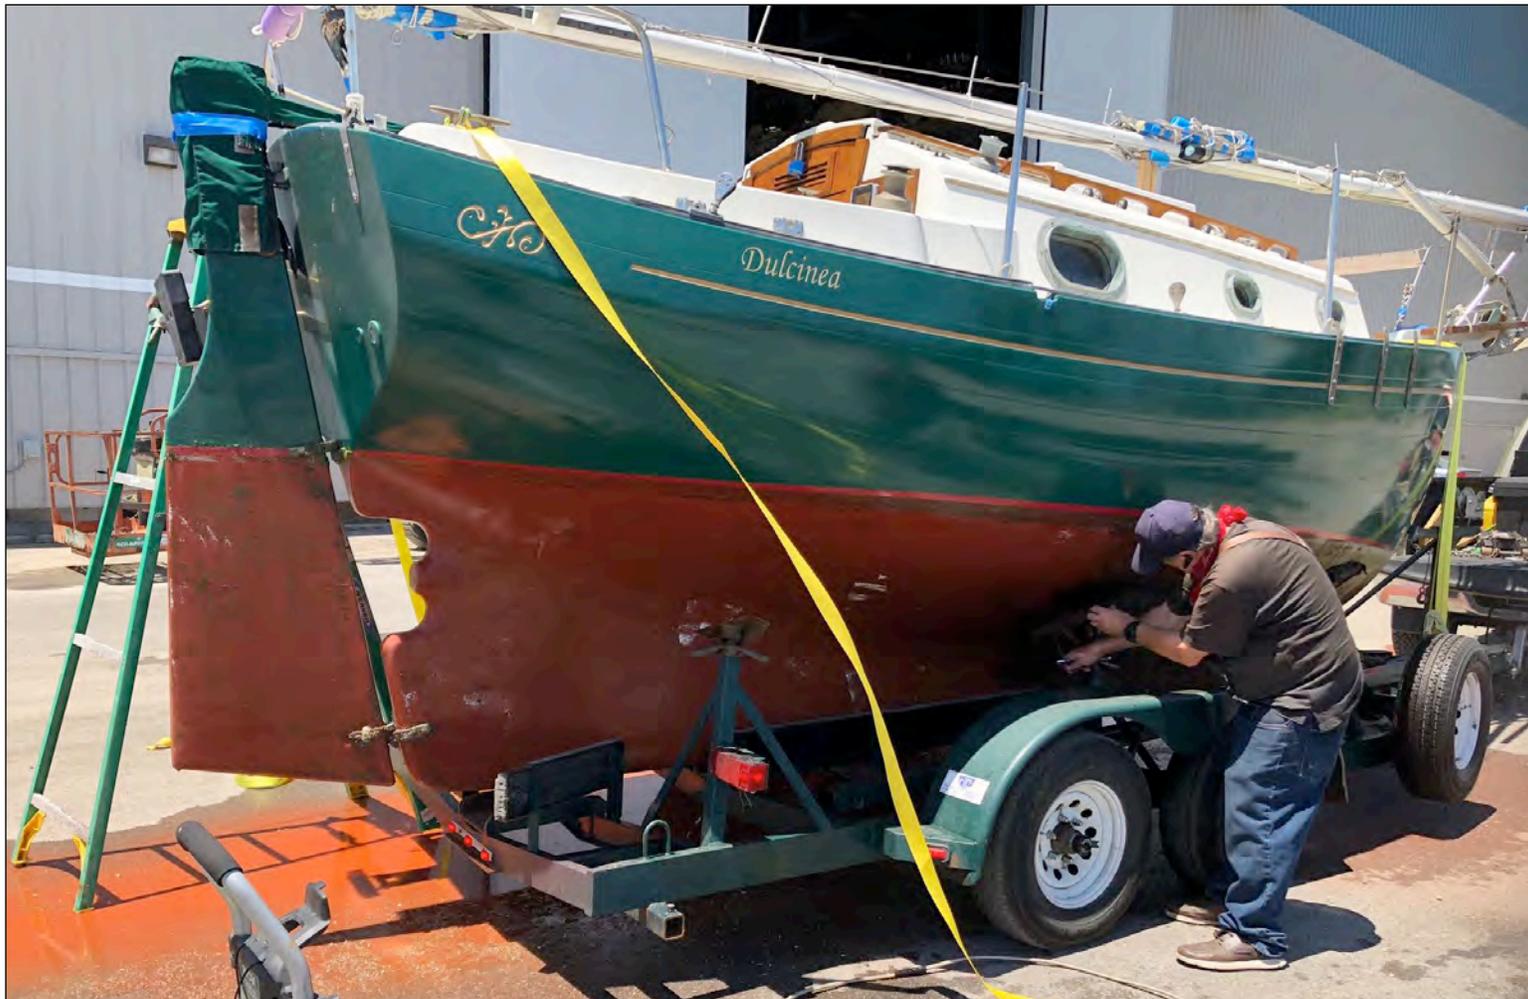
Tuning the Triad trailer to **DULCINEA** for the road trip to California.  
*Photo: Jamie White © 2020*
